February 21, 2023
Town of Freetown
Debbie Pettey, Town Administrator

Review Of Council on Aging Building:

ACG recently visited the site of the current “Town Hall Building”. Not much has changed since our initial survey of 2014. The building is a typical 1830 wood frame construction placed on a rubble stone foundation. The lot is small and has limited parking.

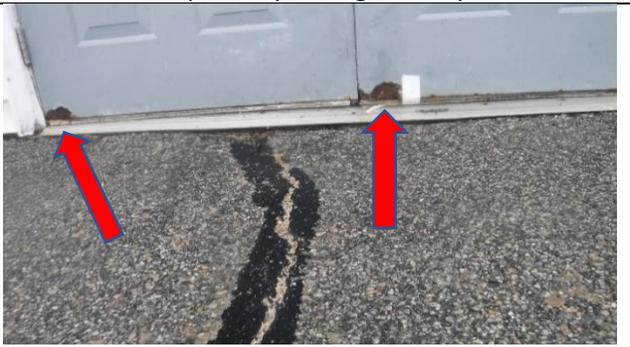
- Septic system occasionally gets pumped out
- Front double doors corroded at bottom, duct taped in 2 places
- Front of building loose vinyl siding gap,
- Areas of mold mildew on siding all sides,

Front doors rust, corrosion, hole, duct tape

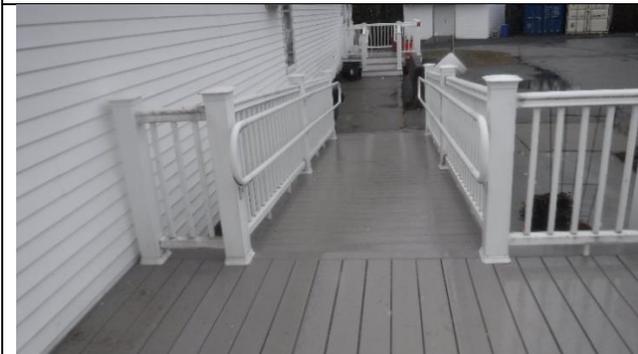
Raised metal, trip hazard

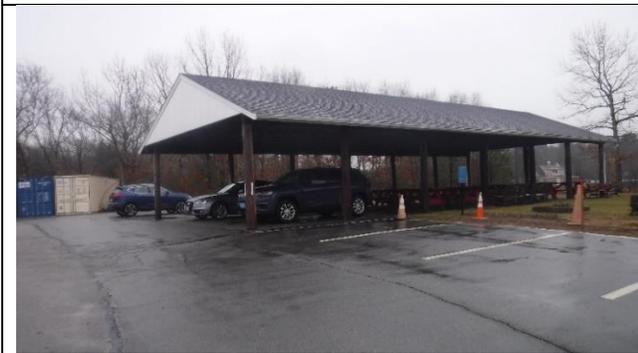
- Front gutter is sagging on rotted fascia boards
- Rake edges, wood trim paint peeling and wood decay
- Decks are in newer condition some mildew
- Recreation Room deck railings at bottom of ramp missing 2 end caps

Northwest corner rake edge decay

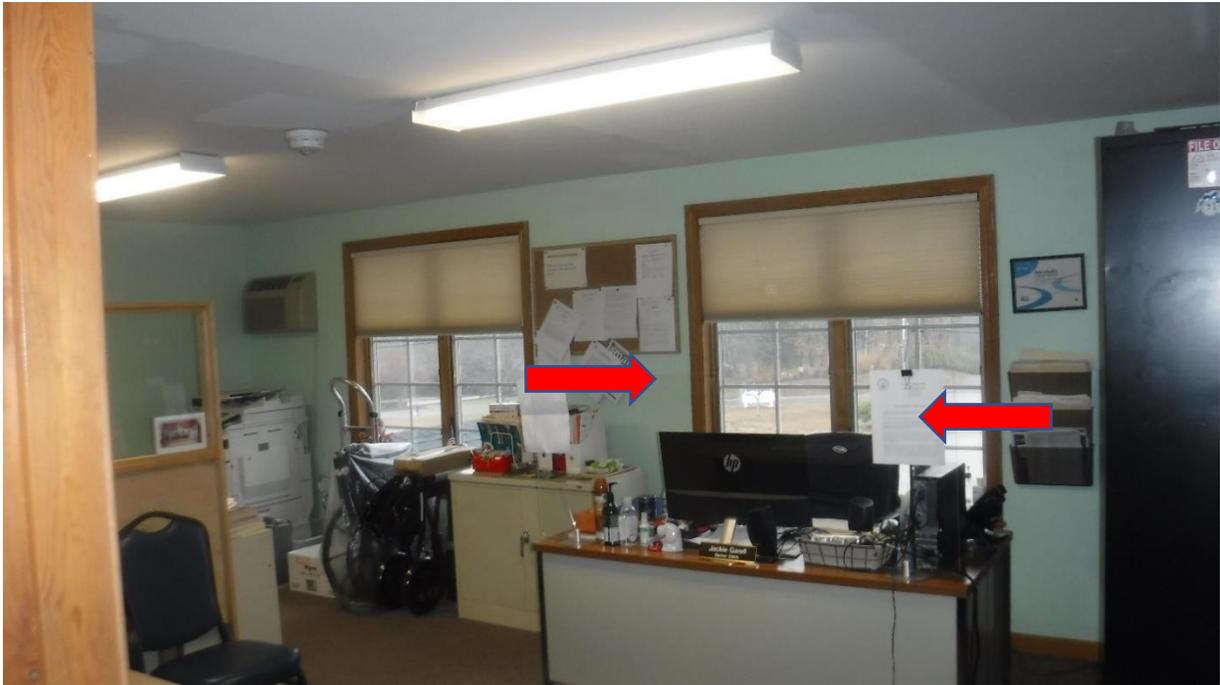
- Reception door opens when windy door open alert goes off all day
- Metal doors are significantly rusted

Reception door rusted, opens in wind

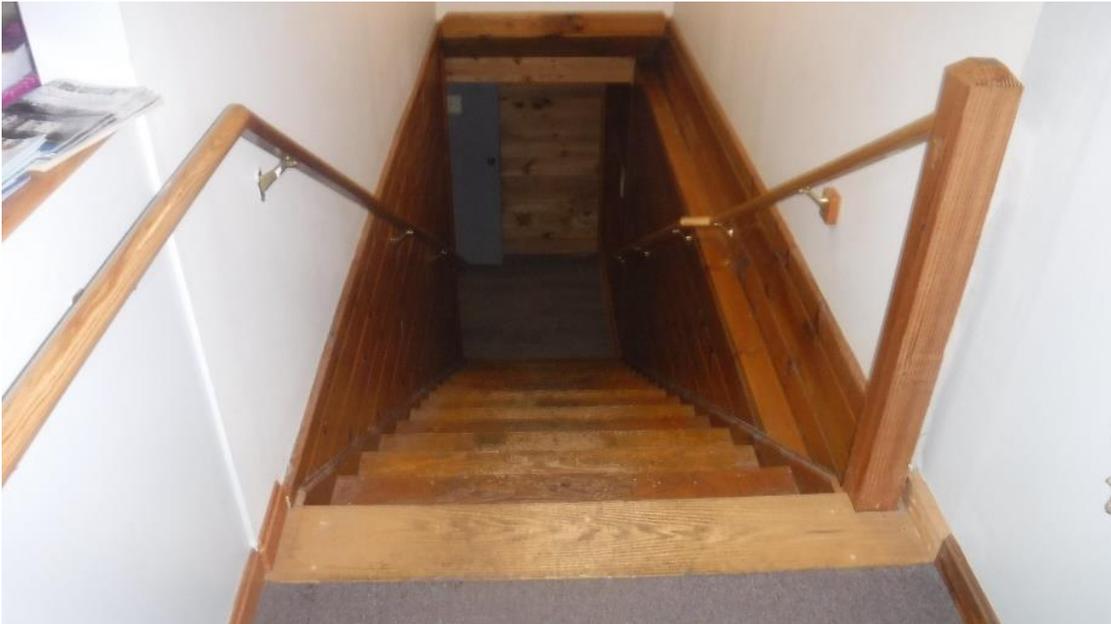
Old, worn, frayed wall to wall carpeting

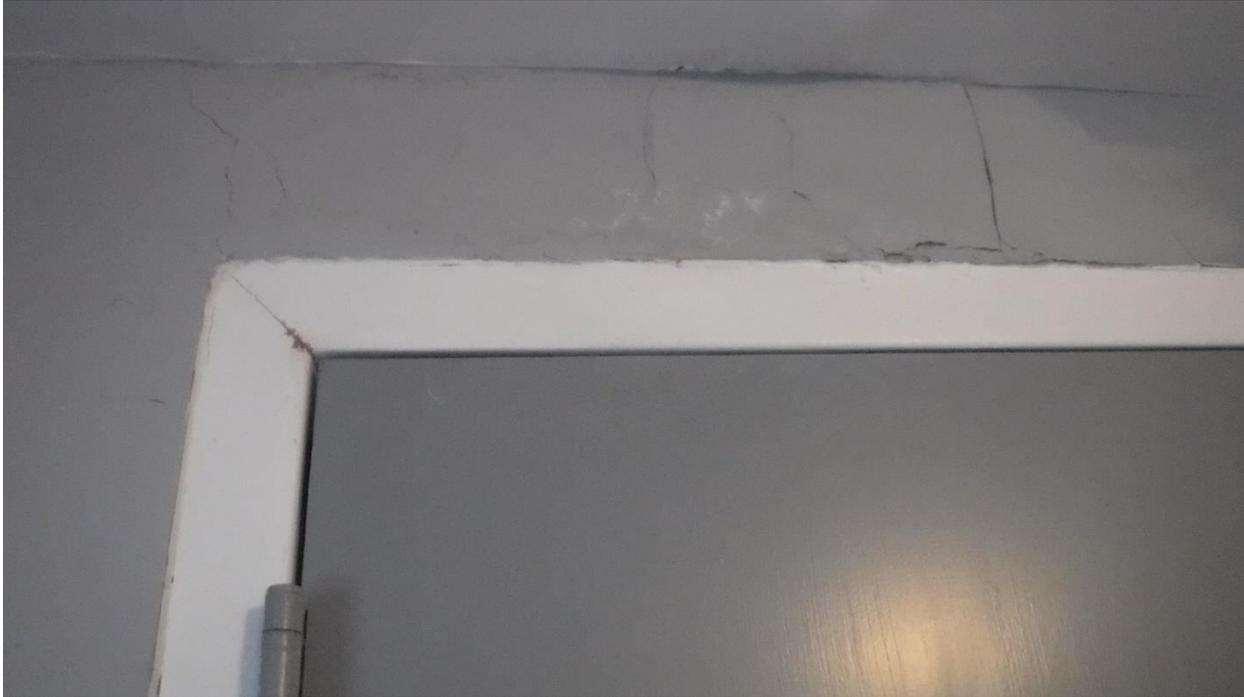
- Vestibule outer double metal doors rotted through at bottom duct taped
- Vestibule drywall in disrepair, paint peeling, water damage
- Staff would like a room for the van drivers – an equipment room

Vestibule close up view paint peeling

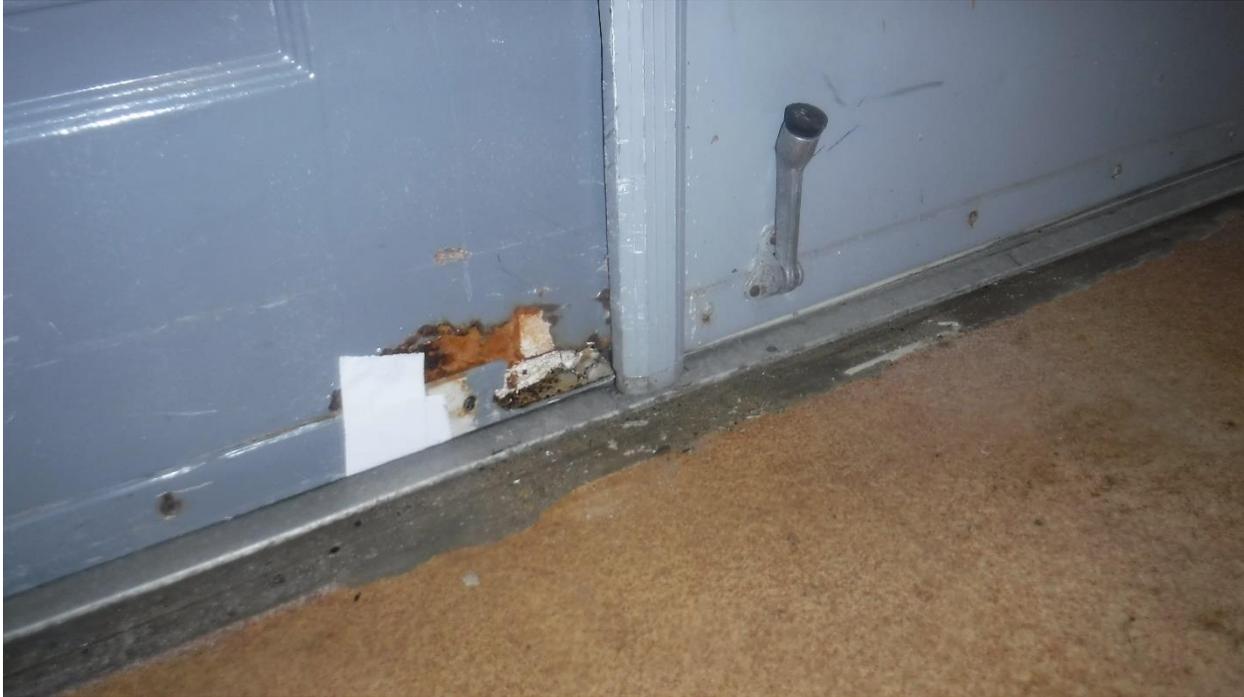
Handicap Double Doors rusted, rotted, holes, duct taped

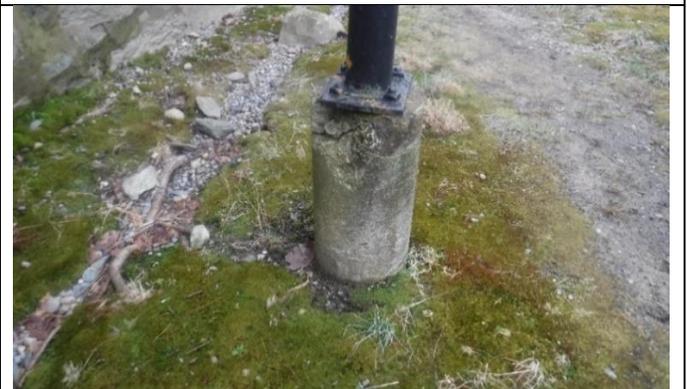
- Rear of building 2 old broken light fixtures hanging from building
- Front of building roof staging bracket at unpainted highest peak
- Fire escape is corroded possibly unusable concrete supports deteriorating

Corroded untested fire escape

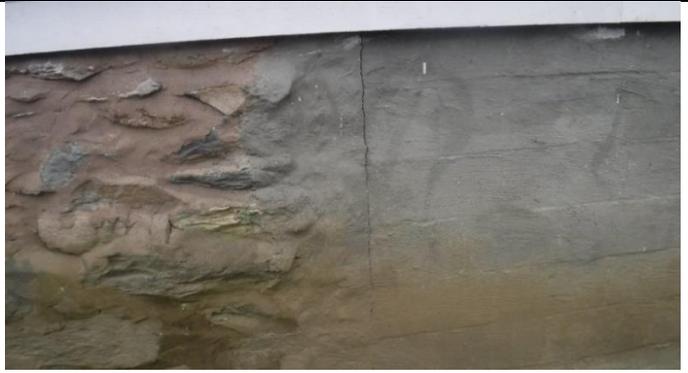
Crack in foundation

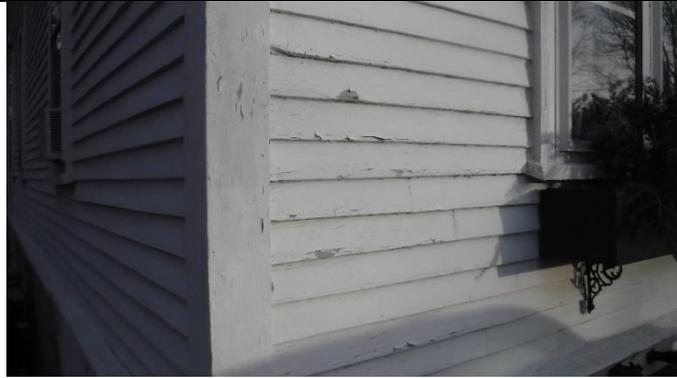
Mitered corner wood decaying

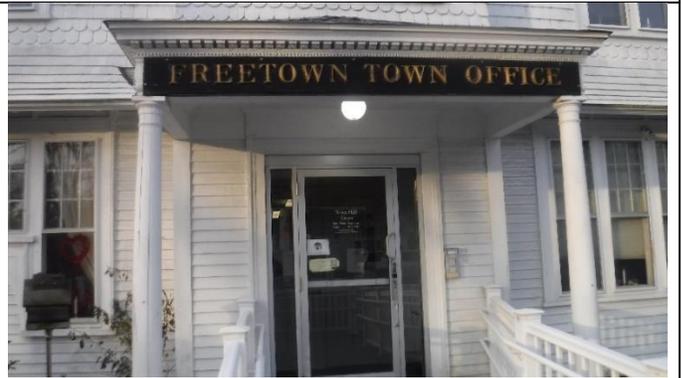
Damaged wood trim

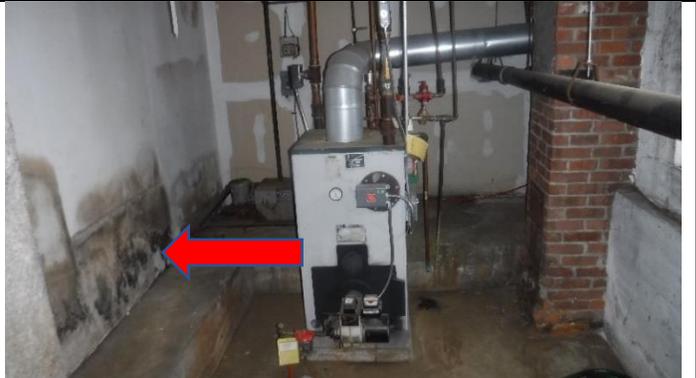
- HVAC system inadequate
- Narrow staircase to basement no railings
- Damp basement partial exposed soils floor area approximately 600 sf
- Evidence of rodents in basement

Narrow staircase to basement, no railings, suspect ACM panels

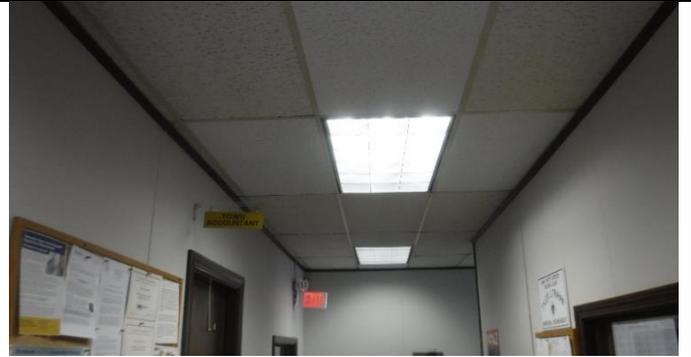
- a) ADA: No elevator to second floor, no ADA bathrooms, lack of clear space and appropriate service counter heights.
- b) Fire Code: Lack of sprinkler system, pull stations and horn strobes.
- c) Building Code: Suspected asbestos containing materials, flooring, wall coverings and pipe insulation. Condition of fire escape, deteriorating concrete supports, corroding steel and overall secureness of the fire escape is still questionable.
- d) 3rd Floor no emergency exit
- e) 3rd Floor staircase no handrails
- f) Stairs to basement no handrails
- g) 3rd Floor unguarded glass window at floor level
- h) Insufficient number of parking spaces.
- i) The building envelope is not up to code standards for air tightness and thermal performance.

Narrow width stairs to second floor no elevator

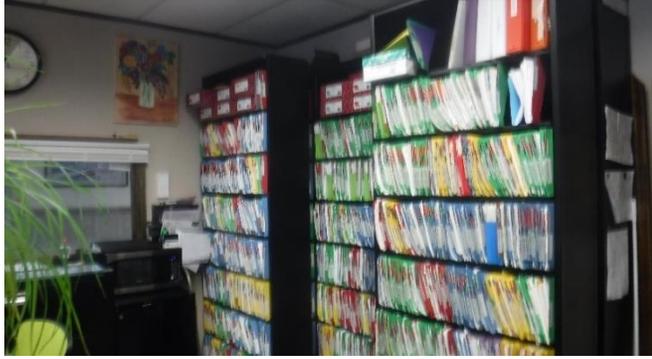
- Telephone equipment on wall not secure
- Plaster ceiling above acoustical ceiling grid plaster intermittent falling through lower ceiling tiles
- Acoustical ceiling on second floor sagging, leaking

Damaged leaking, sagging ceiling

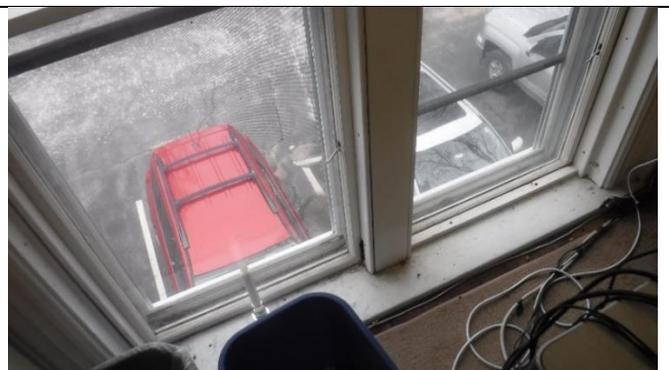
Window at floor hazard of falling out 2 stories

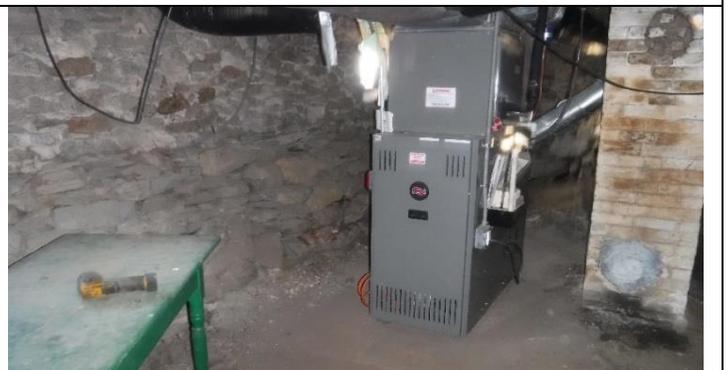
- a) Space: Inadequate working, foot traffic, meeting (private) seating, computer areas, storage space. No employee breakroom.
- b) Windows: Single pane and drafty.
- c) Parking: No parking lot, few spaces in front of building, lack of handicap parking spaces.
- d) Water: No rest rooms, no running water.
- e) Stairs, Railings: Stairs and railings are not code compliant - attic and basement.
- f) Basement: Entire basement floor is exposed soils.
- g) Security: No alarm system

Steel jack support building structure - exposed soils floor

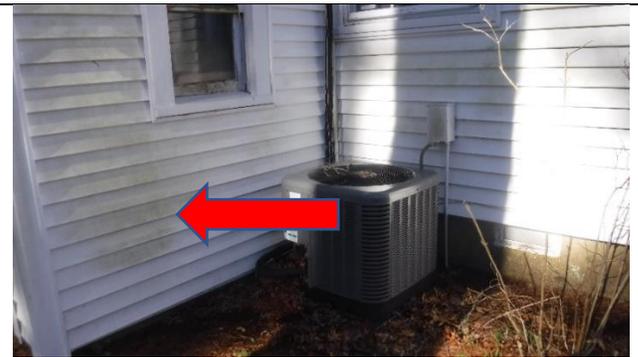
Electrical, internet, telephone wiring, mold on siding

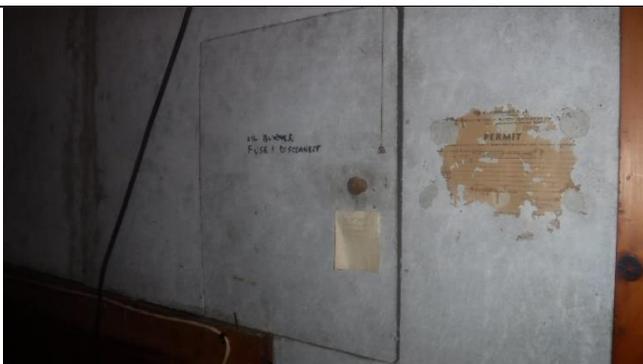
Suspected asbestos containing panels, walls, ceiling

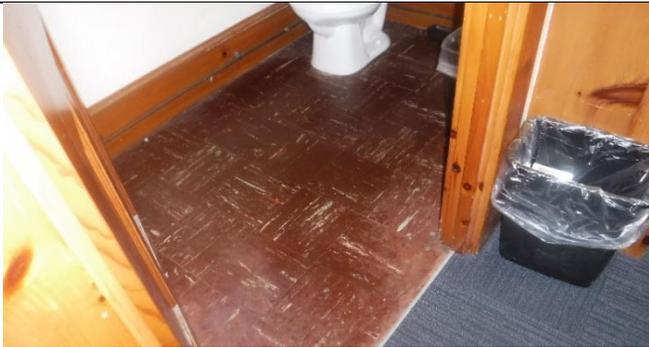
- Bathrooms are non ADA compliant
- Toilets are rust stained. Well or water may be a problem. Building may need a deeper well or water treatment system
- Utility Room for well pump and furnace bathroom area suspected materials floor, walls and ceiling

ADA non-compliant bathroom, rust in toilets

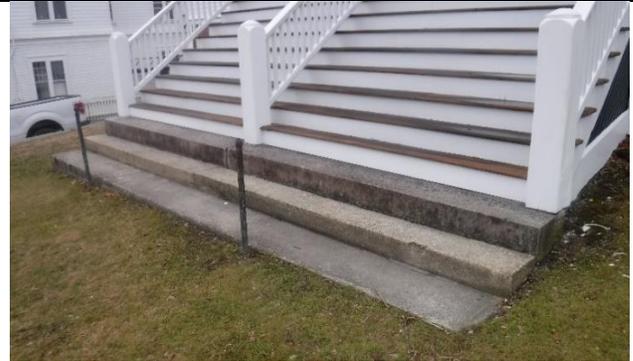
Front steps close up view recent repairs, paint

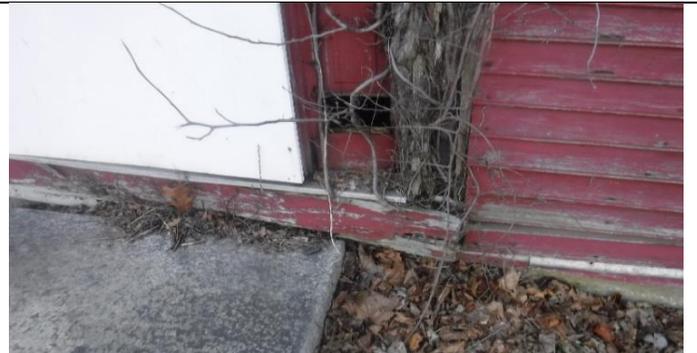
Broken windows, rotting, insect damaged wood

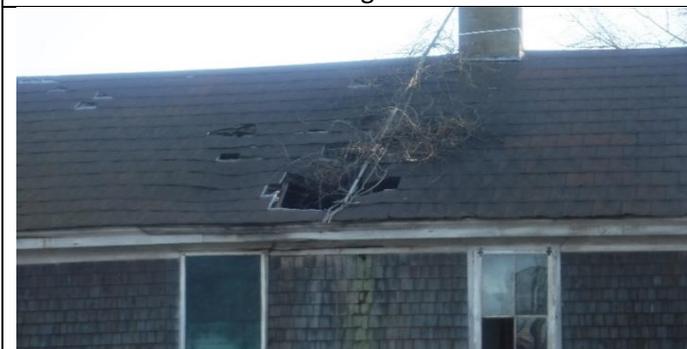
Broken windows, siding, gutters

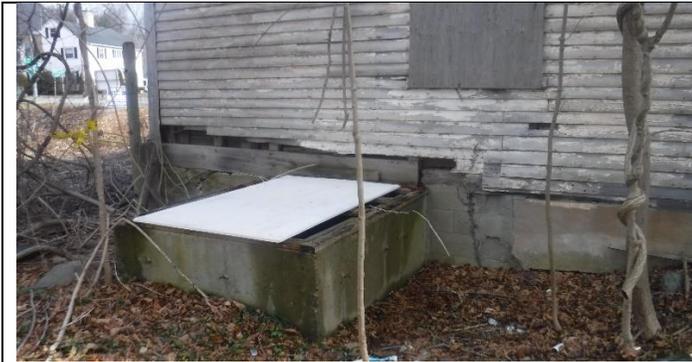
Back corner damaged siding

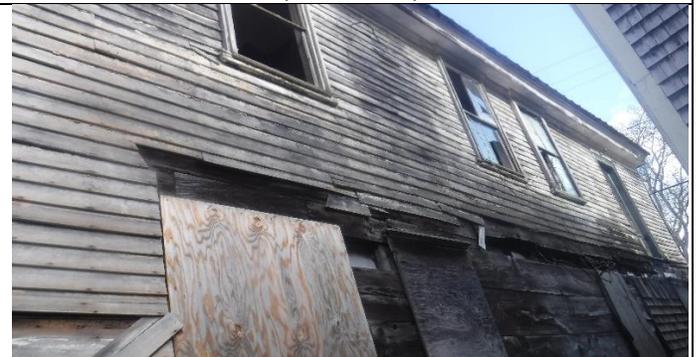
Broken windows

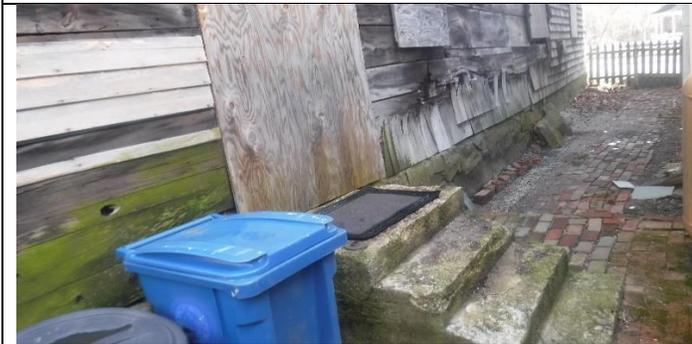
Missing siding, broken windows
