Town of Freetown Needs and Space Study

Municipal Offices, Police, Council on Aging, Library

Architectural Consulting Group, LLC, Inc.
09/24/2014

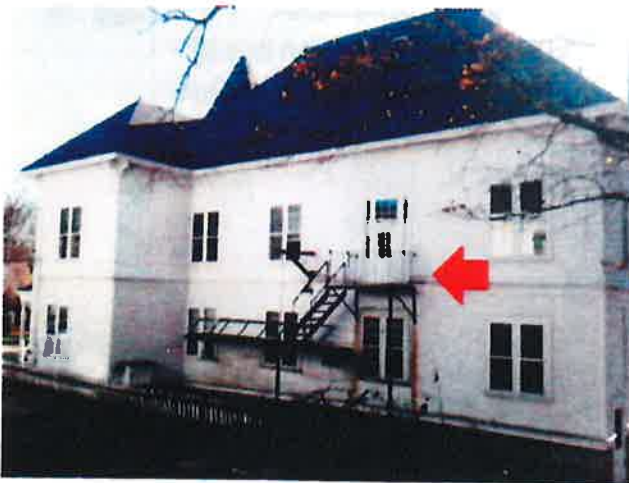
North side view – untested / rusty fire escape

North side - Rusty fire escape components; should be tested for safety.

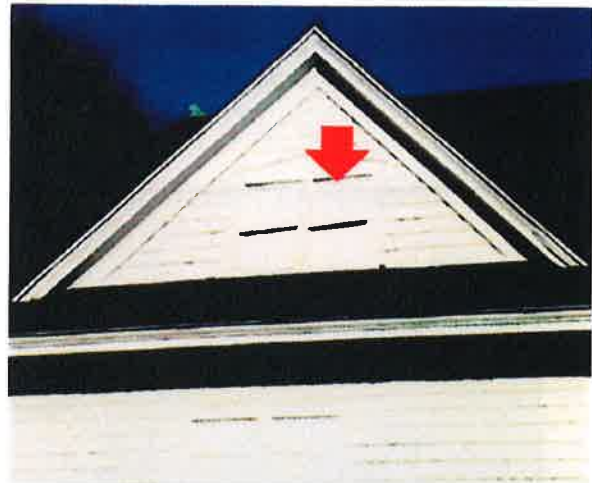
Dormer – loose / leaky windows

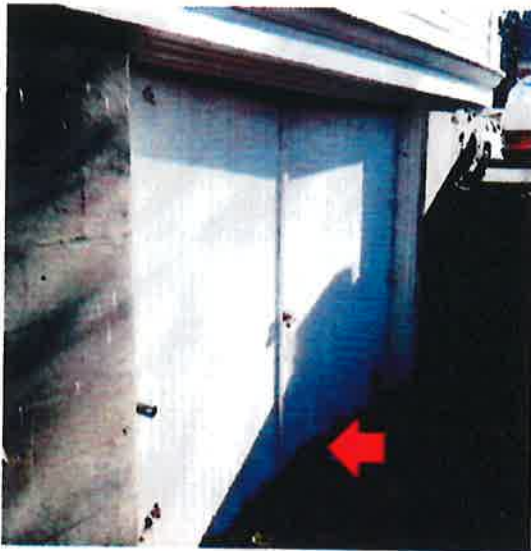
Rear basement (in-swing) double doors;
Bottom deteriorated and air infiltration.

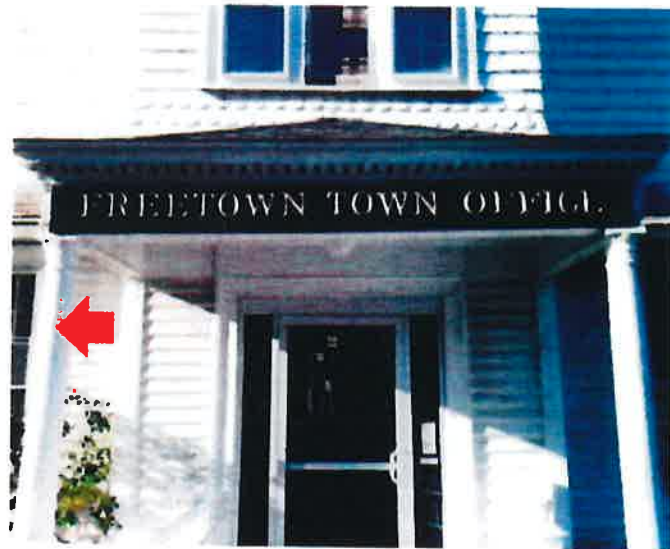
Front entrance - column out of
plumb; deteriorating wood post.

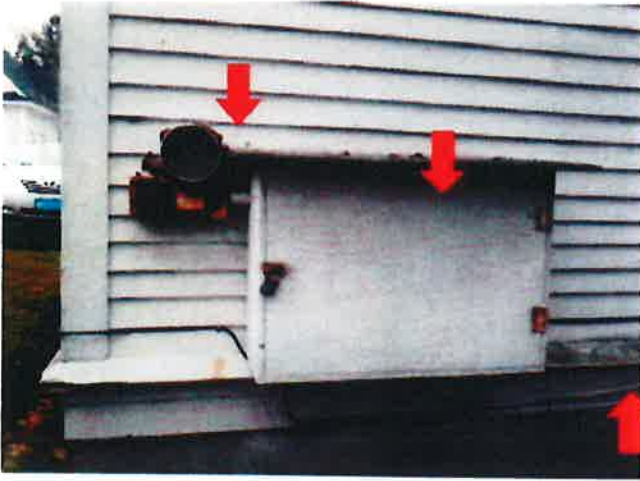
Old electric service meter, fuse box (see below), and wire should be reviewed by an Electrical Engineer.

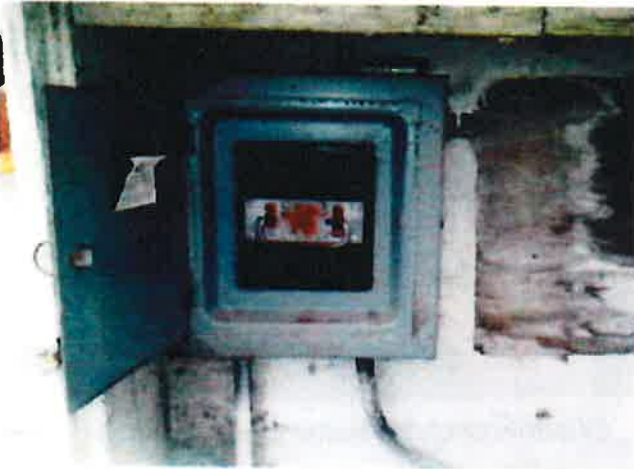
Old (generator) fuse box should be reviewed by an Electrical Engineer.

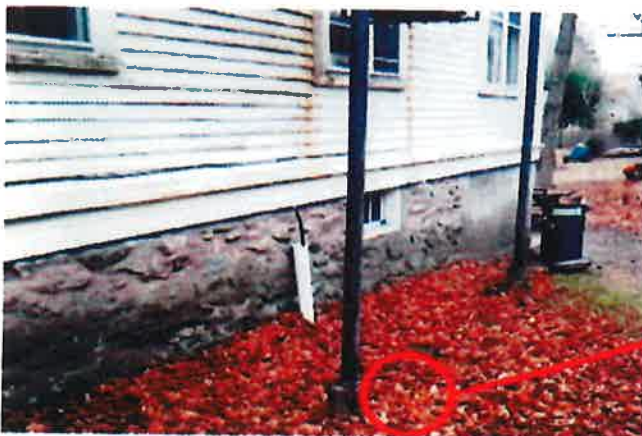
Fire escape concrete support posts; deteriorating.

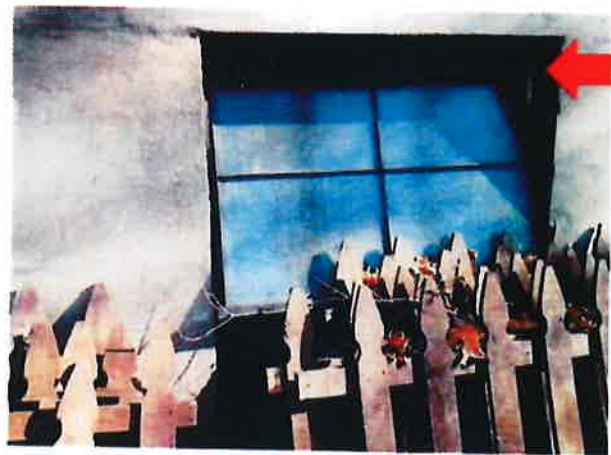
Window open for boiler combustion air.

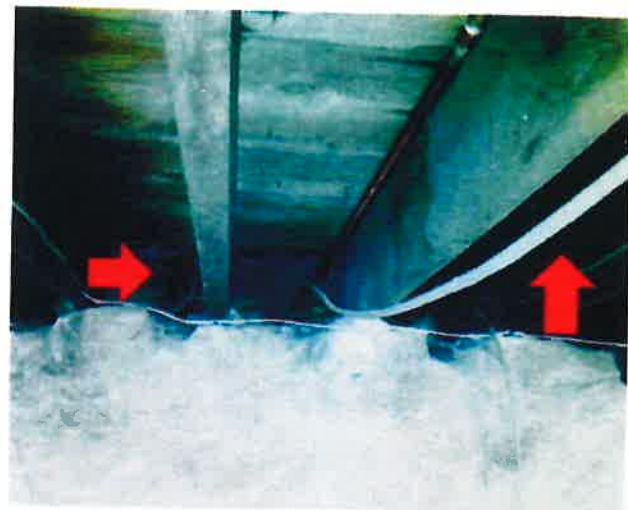
Sill water infiltration / Wiring for old electrical service.

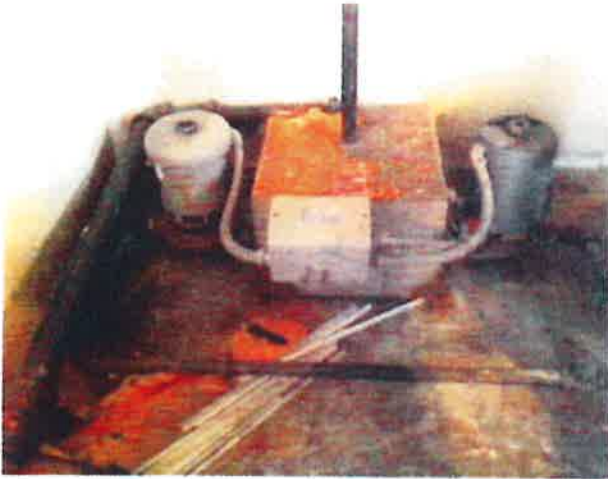
Old boiler condensate equipment – not needed.

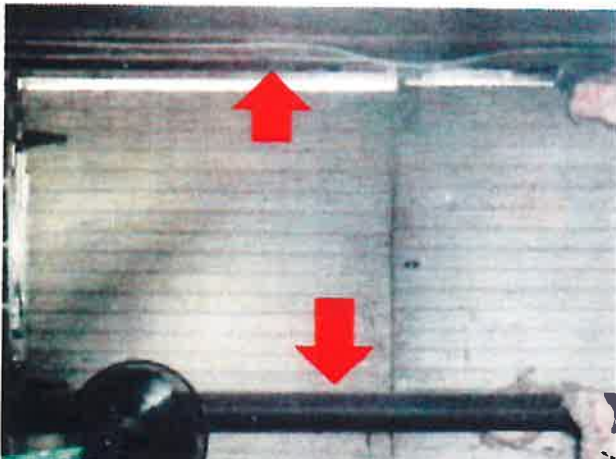
Air infiltration – rear basement in-swing double door, and 4" waste drain pipe across doorway.

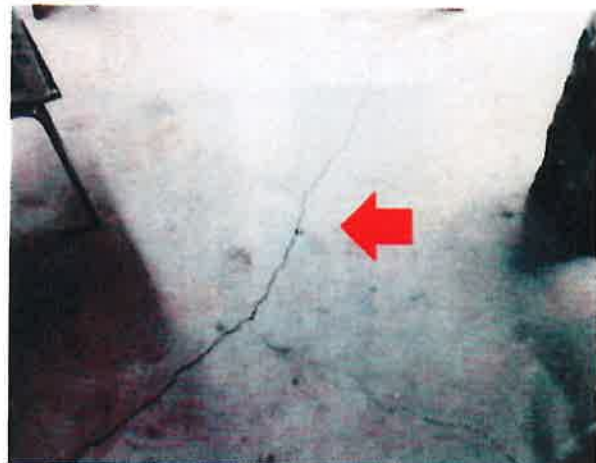
Crack in concrete floor

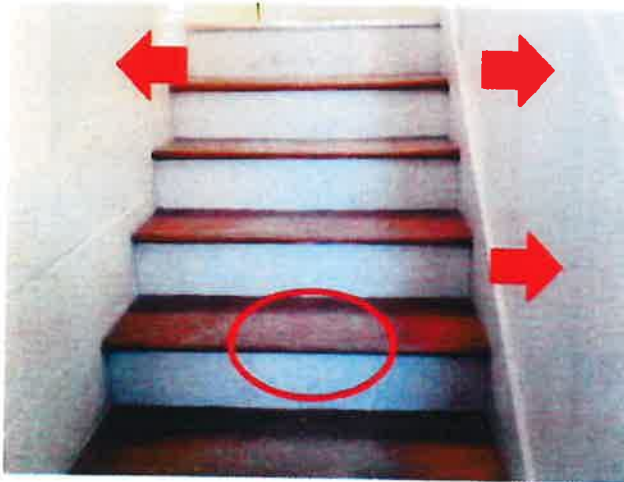
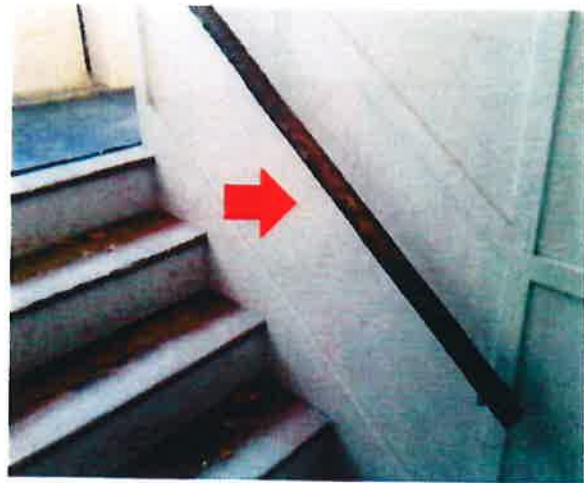
Stairway – no handrails, walls have suspected 3/8" asbestos panels (lower walls only), and stair treads are worn.

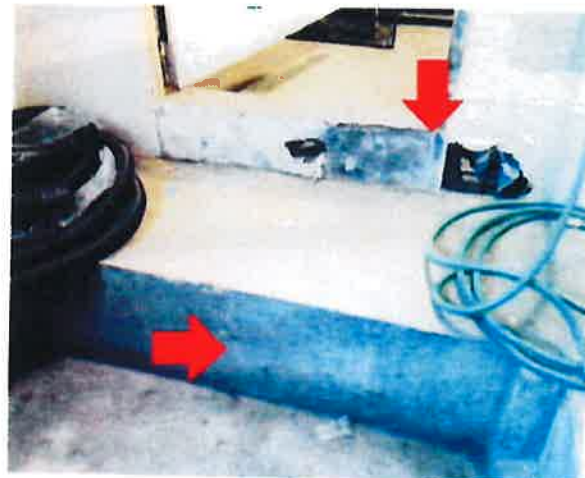
Deteriorating concrete step, and 14" step down to boiler room; may not be compliant under riser section.

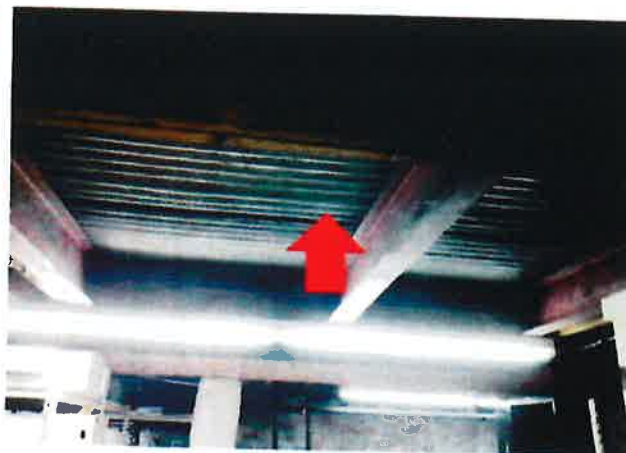
First floor repair with corrugated metal panels.

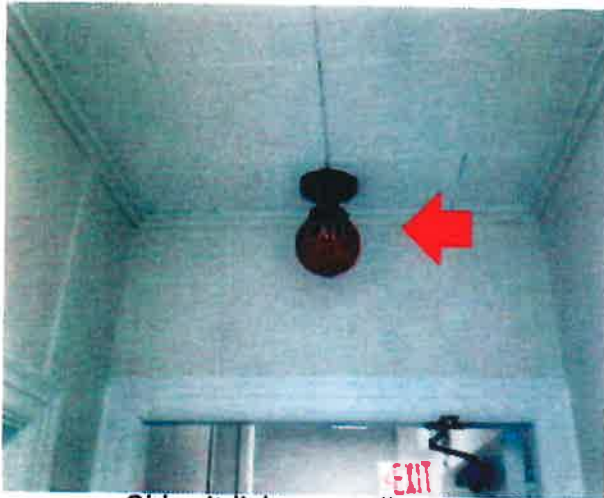
Old exit light – not illuminated.

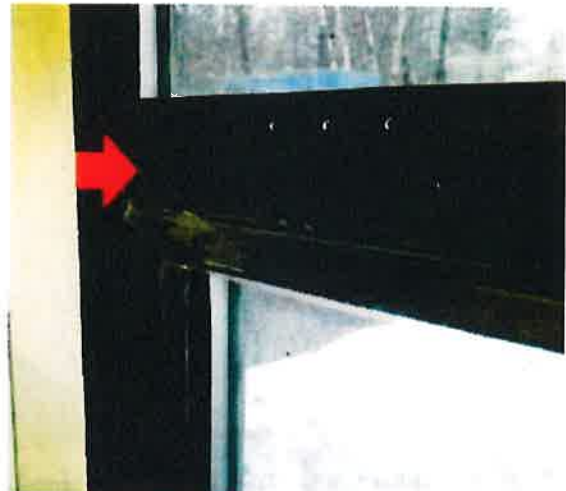
Exterior window - air infiltration; water / ice forming.

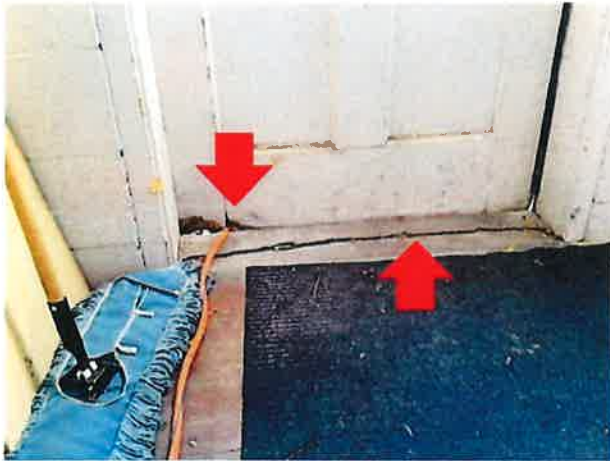
Rear entrance; wood door deteriorated, and concrete threshold is cracked.

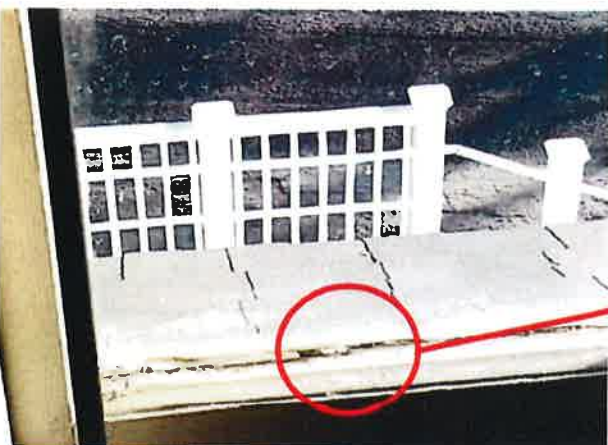
Deteriorating window frame and caulking.

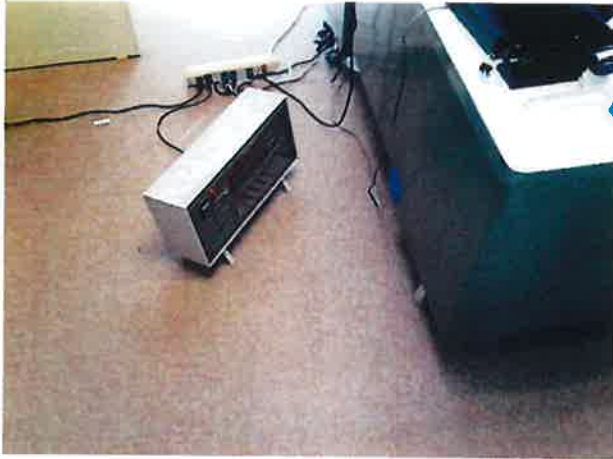
Planning Office; not enough electrical outlets (using extension cord outlet), and inadequate heating (using portable heater).

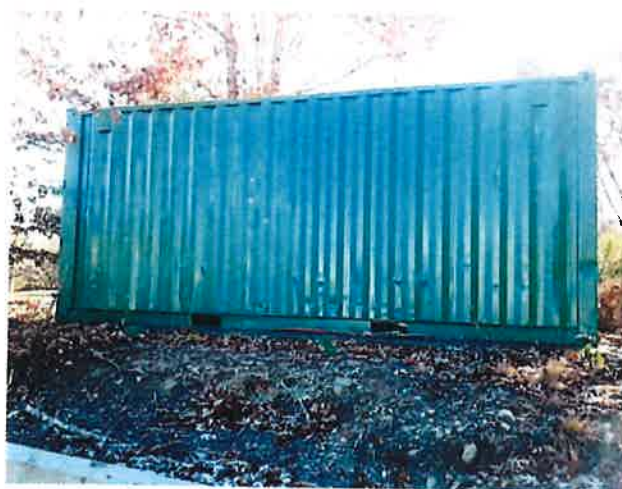
8 X 8 x 20 Container for file storage; moisture issues.

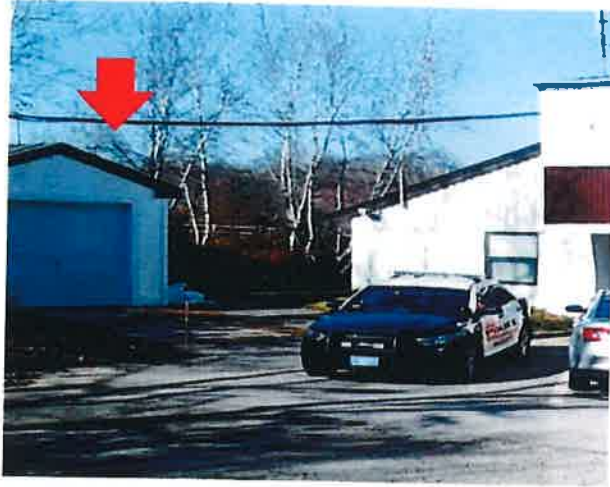
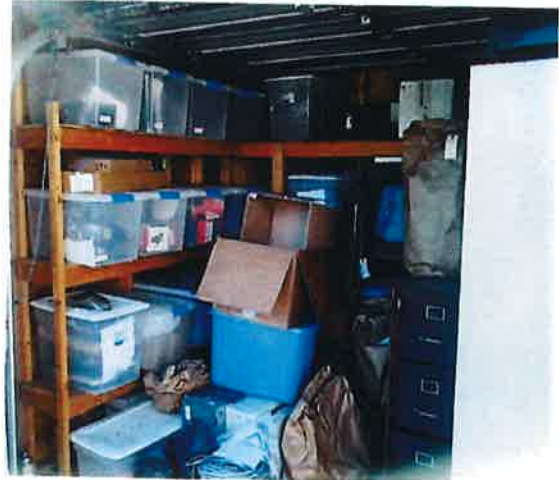
12 X 18 Storage shed off the backside of building used for file storage; moisture & rodent issues.

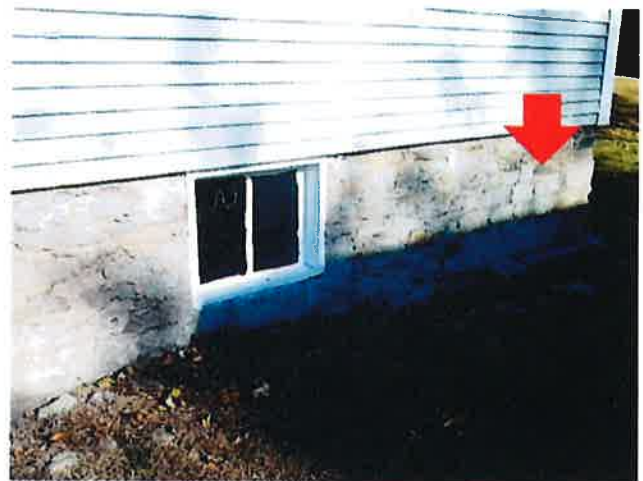
Southwest foundation; some stonework deterioration.

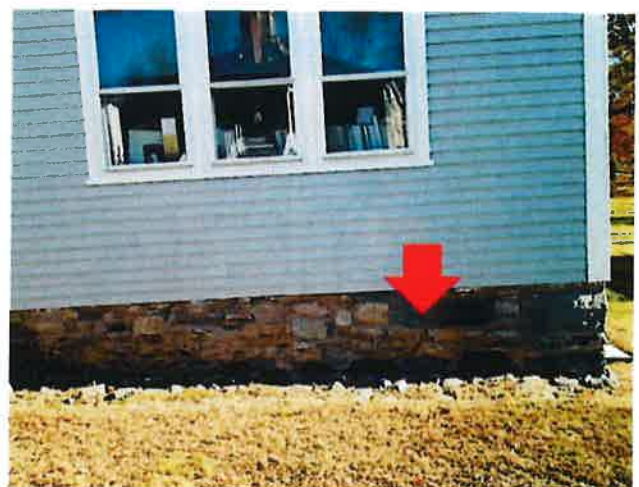
Stone foundation; some stonework deterioration.

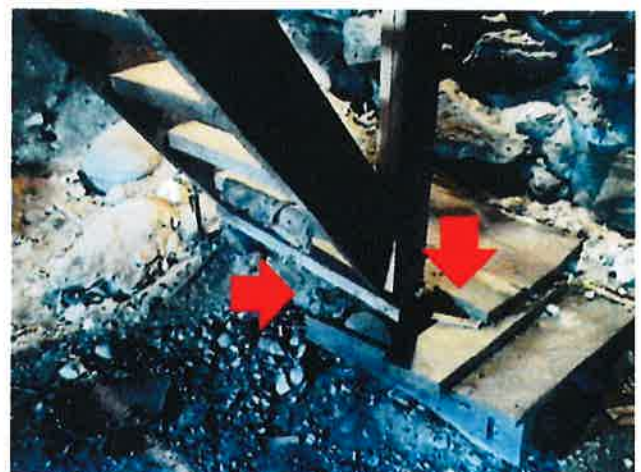
Bottom of basement stairs / landing; deteriorated.

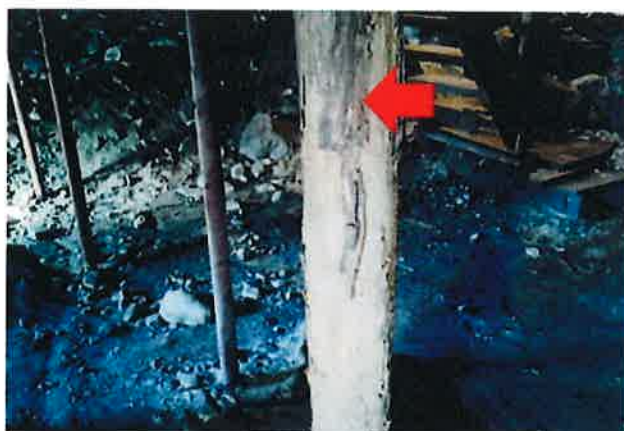
Wooden support post; insect damaged.

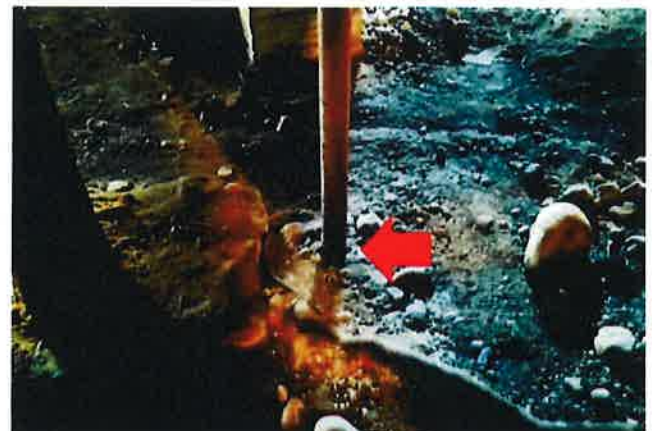
Steel support column; rusted at base, and unknown footing.

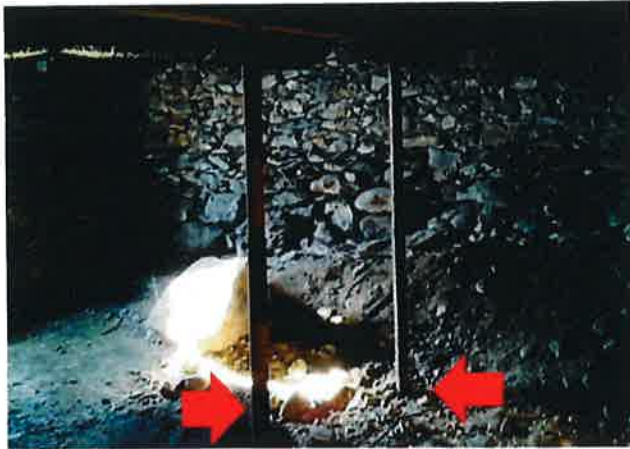
Steel support columns; rusted at bases, and unknown footing.

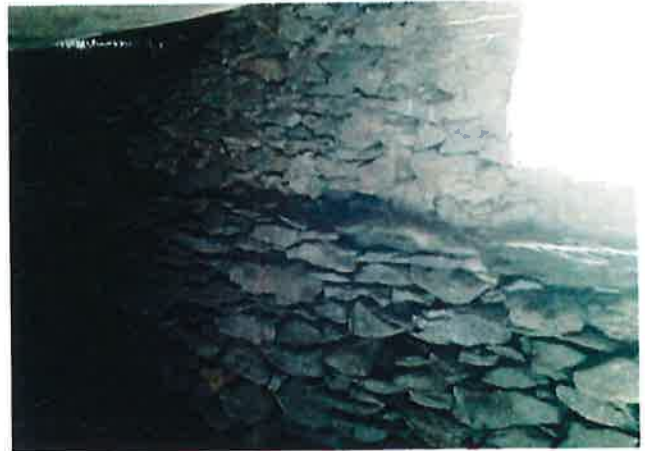
Stone foundation; some air infiltration.

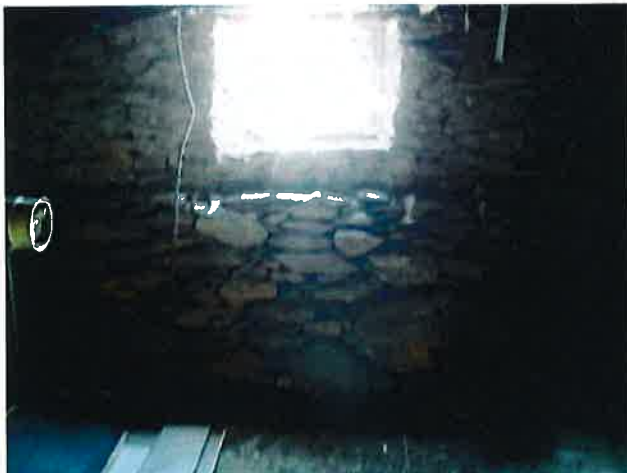
Stone foundation and basement window; some air infiltration and window is single pane.

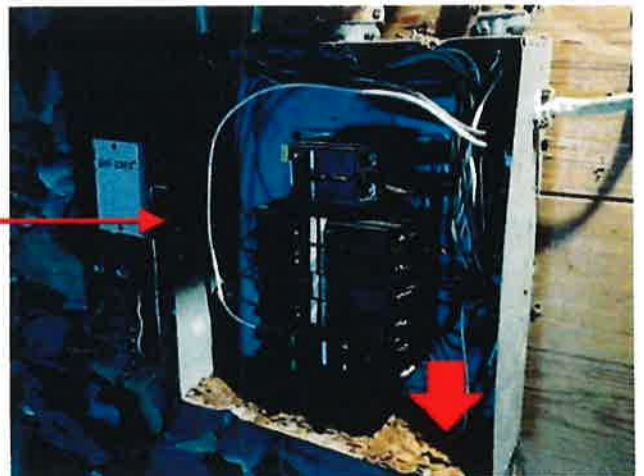
Inside of electric panel; bottom rusted.

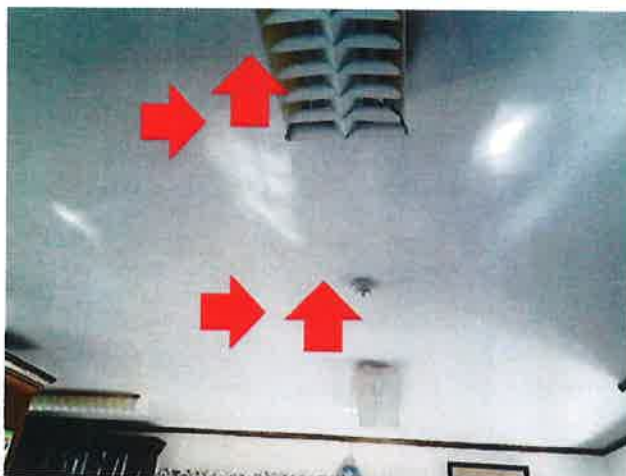
Cracked plaster ceiling.

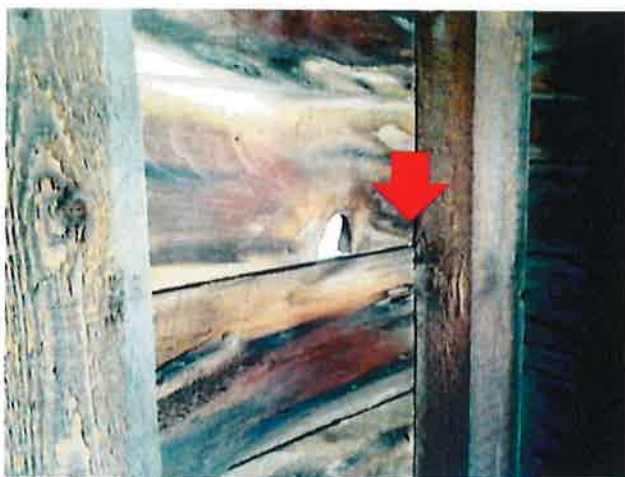
Corner of attic and another side wall; daylight seen through wall boards / air infiltration.

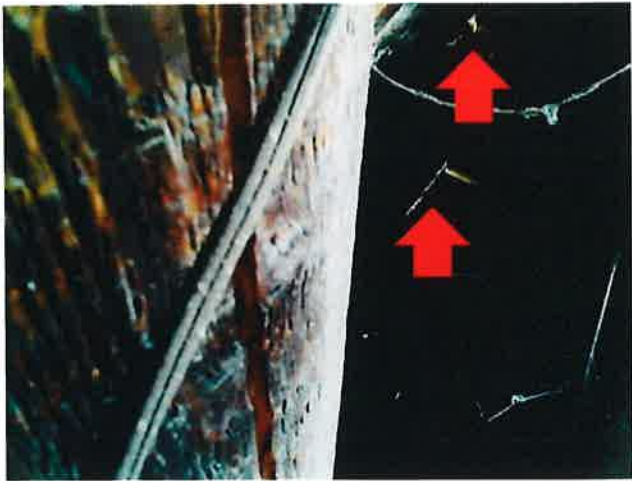
Daylight seen through side wall; air infiltration.

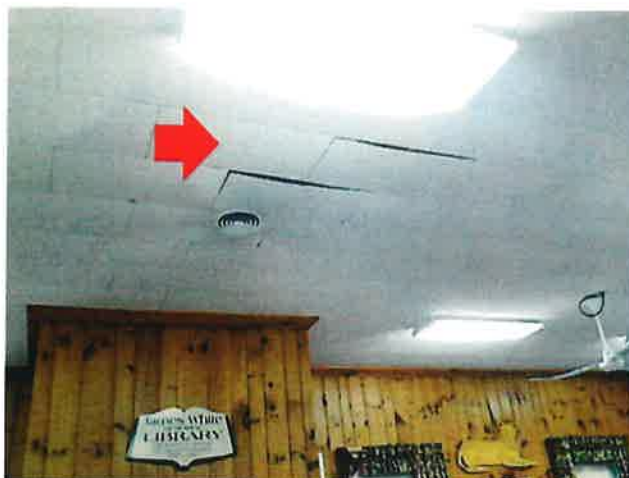
Loose / bowing ceiling tiles.

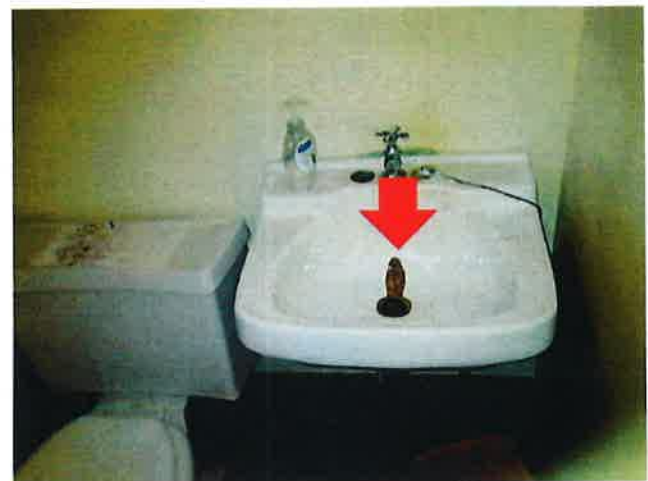
Bathroom; not ADA complaint, rusty water stains, and no hot water.
