Freetown Bandstand

Town of Freetown ADA Transition Plan

June 2023

Institute for Human Centered Design

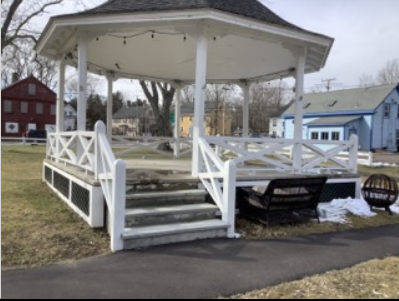
Accessibility issues include lack of an accessible route to the gazebo, bike racks, and at least one (1) bench.

ID	Location	Floor	Room	Element	Type	Photo	Issues	Current Measure	Recommendations	Quantity	Price	Cost Estimation
Approach and Entrance												
Exterior Access Route												
1	Gazebo	Ext.		Exterior Access Route

Accessible route not provided	-	Ensure an accessible route is provided to the gazebo. (Cost estimate is for a 30' long painted wood ramp.)	1	12067	\$12067
Off-Street Parking Lot or Garage												
2	Parking	Ext.		Off-Street Parking Lot or Garage	Visitor

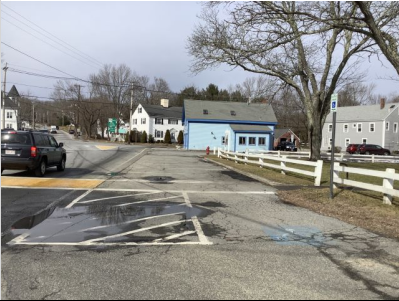
Accessibility issues at the van accessible parking space include an identification sign with the top located higher than allowed, lack of a firm, stable and slip-resistant surface due to water accumulation in the space and access aisle, and access aisle striping that is not maintained in operable working condition.

Total # of parking Total # of designated car accessible parking spaces Total # of designated van accessible spaces Sign top > 96" above finished grade (MAAB) Surface not stable, firm, and slip-resistant Not maintained in operable working condition	7 - 1 99" - -	At the van accessible parking space, ensure the top of the identification sign is located 96" max. above the ground. Repair surface to ensure water does not accumulate in the space or access aisle. Ensure that striping is maintained on access aisle.	1	Labor 1920	\$1920

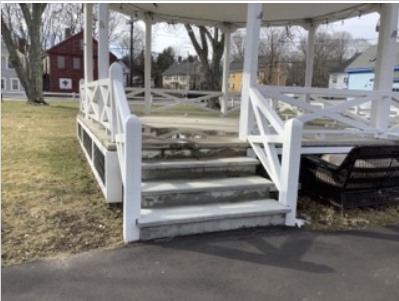
Access to Goods and Services												
Stairways												
3	Gazebo	Ext.		Stairways	Exterior

- At the stairs to the gazebo, there is a lack of handrail extensions and a lack of handrails with compliant cross sections.

Handrails do not extend 12" from stairs Handrails have noncompliant cross section	- -	Provide handrails with a 1 1/4" - 2" circular cross section. Top: Ensure handrails extend horizontally above the landing for 12" min. beginning above the first riser nosing. Bottom: Ensure that the sloped bottom extension extends one tread depth minimum beyond last riser nosing in same direction as stair flight. (Cost estimate for 10 linear ft of wood handrail.)	2	220	\$440
Benches												
4	Area With Benches	Ext.		Benches	N/A

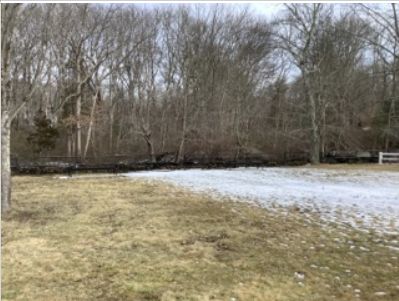
No accessible route to one bench in this area	-	Provide an accessible route to at least one bench in this area.	1	-	\$0

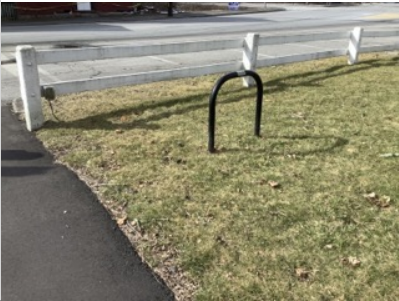
ID	Location	Floor	Room	Element	Type	Photo	Issues	Current Measure	Recommendations	Quantity	Price	Cost Estimation
Bike Racks												
5	Bike Rack	Ext.		Bike Racks	N/A

Bike rack is not connected to an accessible route	-	Ensure each bike rack is connected to an accessible route.	2	-	\$0
Best Practice												
Benches												
6	Area With Benches	Ext.		Benches	N/A
