# Hathaway Library

## Town of Freetown ADA Transition Plan

April 2023

Institute for Human Centered Design

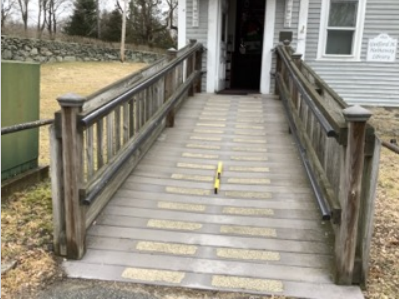
Running slope > 1:12 (8.33%) Handrails do not extend 12" past top & bottom	14.6% -	Reduce running slope to be no steeper than 1:12 (8.33%). Alter handrails to extend horizontally above and below the landing for 12" min. beyond the top and bottom of ramp runs. (Cost estimate for a new 15' long concrete ramp.)	1	17,702	\$17702
Access to Goods and Services												
Means of Egress												
2	Main Egress Door	1		Means of Egress	N/A

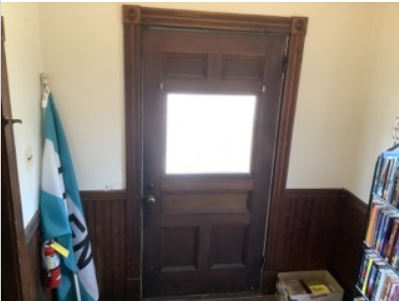
Tactile exit sign not provided	-	Ensure that a tactile exit sign with raised characters and braille is provided at the exit door. Mount the sign between 48"- 60" above the finished floor located on the latch side of the door. When or if an illuminated exit sign is provided, provide an illuminated sign with the International Symbol of Accessibility (ISA).	1	232	\$232

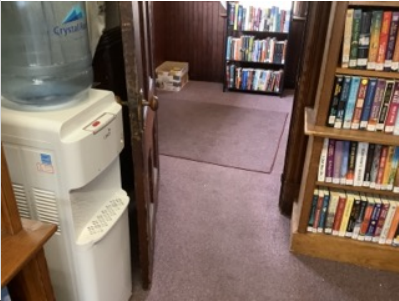
Interior Access Route												
3	Books to Main Egress			Interior Access Route	N/A

Route < 36" wide	27.5"	Relocate the water cooler to ensure that a clear width of 36" min. is maintained at the accessible route.	1	Labor	\$0
4	Children's Books	1		Interior Access Route	N/A

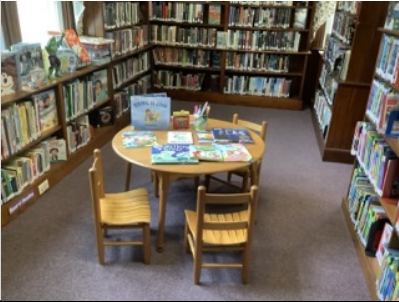
Route < 36" wide	23.7"	Relocate the table and chair to ensure that a clear width of 36" min. is maintained at the accessible route.	1	Labor	\$0

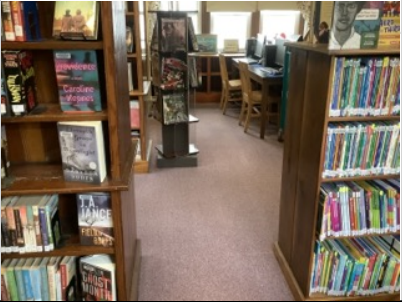
ID	Location	Floor	Room	Element	Type	Photo	Issues	Current Measure	Recommendations	Quantity	Price	Cost Estimation
5	Book Stacks	1		Interior Access Route

Route < 36" wide	31.5"	Relocate the book stacks to ensure that a clear width of 36" min. is maintained at the accessible route. Note that the route is able to narrow to 32" wide min. for a depth of 24" max.	1	Labor	\$0
Doors, Doorways, & Gates												
6	Main Egress to Books	1		Doors, Doorways, & Gates	Circulation

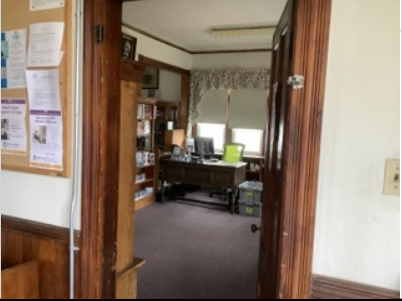
Clear width at door < 32" Hardware not compliant	29.6" -	Widen the door so that there is 32" min. clear width. Provide hardware that can be operable with one hand and not require tight grasping, pinching, or twisting of the wrist.	1	3850	\$3850
Dining or Work Surfaces												
7	Computer Work Station	1		Dining or Work Surfaces	Work Surface

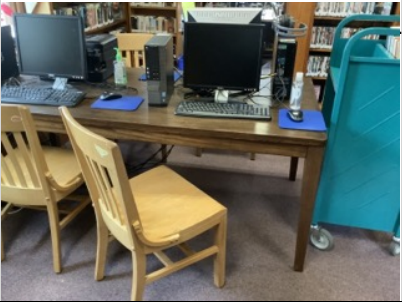
Knee or toe clearance not provided	24.7"	Provide at least one work surface with 27" min. high knee and toe clearance.	1	700	\$700
