# Old Police Station

## Town of Freetown ADA Transition Plan

May 2023

Institute for Human Centered Design

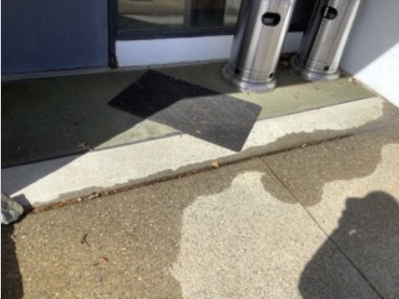
Surface openings > 1/2"	1"	Repair surface and ensure mat is secured.	1	256	\$256
2	Path Near North Side Parking Lot	Ext.		Exterior Access Route	Walkway

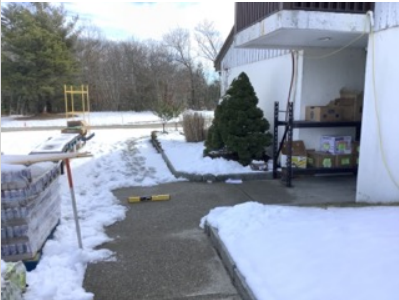
Cross slope > 1:50 (2.00%)	4%	Reduce cross slope to be no steeper than 1:50 (2.00%).	1	-	\$0
3	Near North Side Parking Lot	Ext.		Exterior Access Route	Walkway

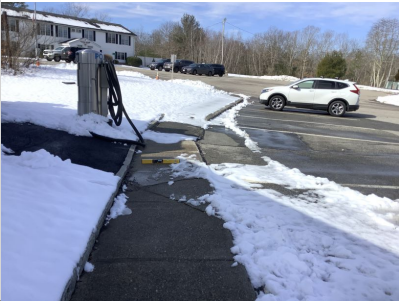
Cross slope > 1:50 (2.00%)	4.3%	Reduce cross slope to be no steeper than 1:50 (2.00%).	1	-	\$0
4	Path Near East Side Parking Lot	Ext.		Exterior Access Route	Walkway

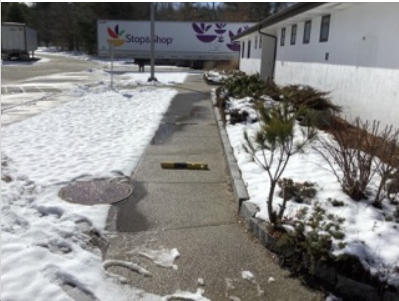
Cross slope > 1:50 (2.00%) Does not prevent accumulation of water	2.9%	Reduce cross slope to be no steeper than 1:50 (2.00%). Repair surface.	1	-	\$0
5	Path Near East Side Parking Lot	Ext.		Exterior Access Route	Walkway

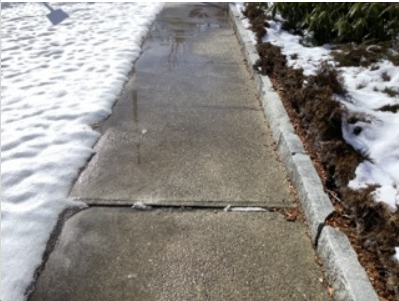
Level changes > 1/4"	.5"	Alter change in level to be 1/4" high max.	1	256	\$256

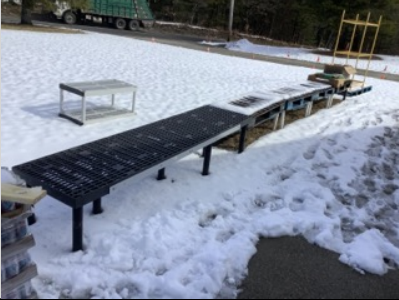
Accessible route not provided	-	Ensure an accessible route is provided food display racks.	1	-	\$0
Curb Ramp												
7	East Side Parking Lot	Ext.		Curb Ramp	N/A

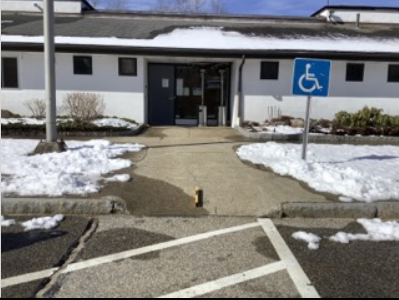
Running slope is > 1:12 (8.33%)	10.6%	Reduce running slope to be no steeper than 1:12 (8.33%).	1	2800	\$2800
8	Curb Ramp Near North Side Parking Lot	Ext.		Curb Ramp	N/A

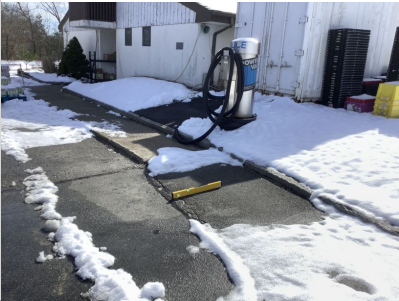
Landing not provided at top of curb ramp	-	Provide landing at top of curb ramp or reconfigure ramp.	1	2800	\$2800
Off-Street Parking Lot or Garage												
9	East Side Parking Lot	Ext.		Off-Street Parking Lot or Garage	Visitor

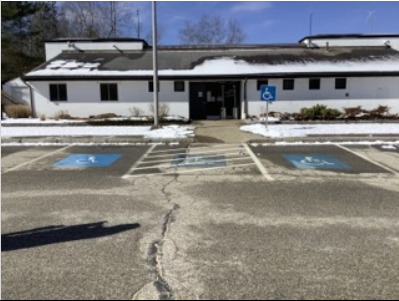
Total # of parking Total # of designated car accessible parking spaces Total # of designated van accessible spaces Running or cross slope at space > 1:50 (2.00%) Running or cross slope at access aisle > 1:50 (2.00%) Sign with the International Symbol of Acc. not provided Sign does not have the designation "Van Accessible" Sign bottom < 60" above finished grade Surface not stable, firm, and slip-resistant	15 2 0 5.5% 4.5% - - 47" -	Reduce running or cross slope at the spaces and aisle to be no steeper than 1:50 (2.00%). Provide a sign with the International Symbol of Accessibility (ISA) at each space with the bottom of the sign 60" min. above the ground and the top 96" max. above the ground. Add the designation "Van Accessible" to the sign located at the van accessible space. Repair surface.	1	1900	\$1900

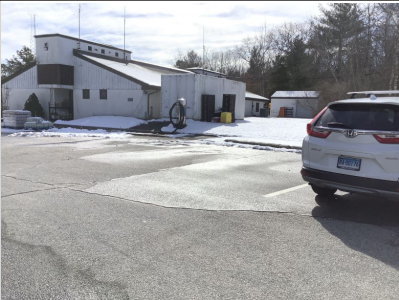
10	North Side Parking Lot	Ext.		Off-Street Parking Lot or Garage	Visitor

Total # of parking Total # of designated van accessible spaces	6 0	Provide one compliant van accessible parking space and marked access aisle that are both at least 96" wide. Provide a sign with the International Symbol of Accessibility (ISA) with bottom of the sign 60" min. above the ground and the top 96" max. above the ground. Add the designation "Van Accessible" to the sign located at the van accessible space.	1	1850	\$1850
Access to Goods and Services

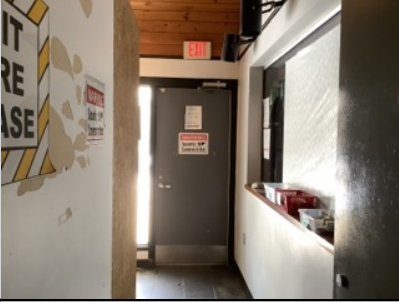
Tactile exit sign not provided Illuminated ISA symbol not provided (MAAB)	- -	Ensure that a tactile exit sign with raised characters and braille is provided at the exit door. Mount the sign between 48"- 60" above the finished floor located on the latch side of the door. When the illuminated exit sign is repaired or replaced, provide an illuminated sign with the International Symbol of Accessibility (ISA).	1	232	\$232
12	Exit to Loading Dock	1		Means of Egress	N/A

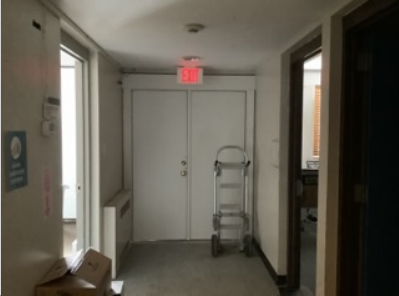
Tactile exit sign not provided Illuminated ISA symbol not provided (MAAB)	- -	Ensure that a tactile exit sign with raised characters and braille is provided at the exit door. Mount the sign between 48"- 60" above the finished floor located on the latch side of the door. When the illuminated exit sign is repaired or replaced, provide an illuminated sign with the International Symbol of Accessibility (ISA).	1	232	\$232

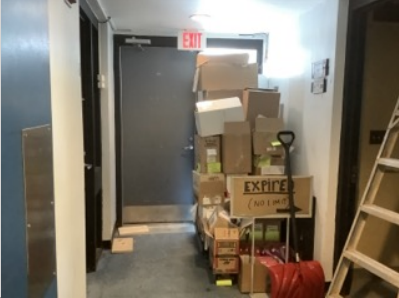
13	Exit to North Side Parking Lot	1		Means of Egress	N/A

Tactile exit sign not provided Illuminated ISA symbol not provided (MAAB)	- -	Ensure that a tactile exit sign with raised characters and braille is provided at the exit door. Mount the sign between 48"- 60" above the finished floor located on the latch side of the door. When the illuminated exit sign is repaired or replaced, provide an illuminated sign with the International Symbol of Accessibility (ISA).  Note: Ensure all items are cleared from the exit.	1	232	\$232
Doors, Doorways, & Gates												
14	Exit to Loading Dock	1		Doors, Doorways, & Gates	Emergency Egress

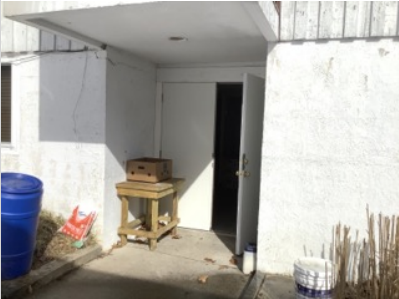
If double-leaf door, neither compliant	27"	Ensure that at least one of the active leaves is at least 32" min. wide.	1	3366	\$3366
15	Exit to Loading Dock	1		Doors, Doorways, & Gates	Emergency Egress

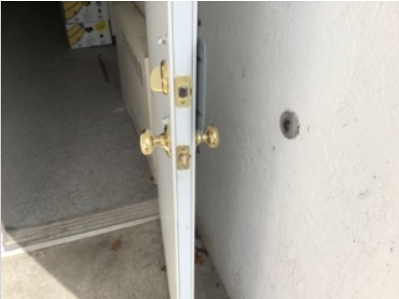
Hardware not compliant		Provide hardware that can be operable with one hand and not require tight grasping, pinching, or twisting of the wrist.	1	484	\$484

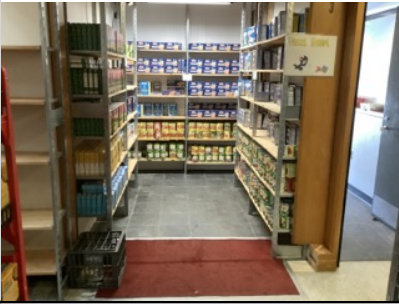
Raised characters not provided on sign Braille not provided on sign	- -	Provide text with raised characters duplicated in braille on the sign. Mount the sign between 48"-60" above the finished floor located on right side of the entrance. Ensure to provide a clear floor space of 18" min. by 18" min. at the sign.	1	232	\$232
17	Beverage and Cereals Room	1	4	Signage	Designation

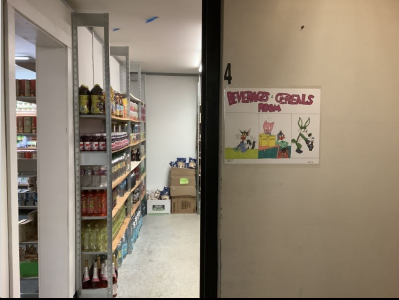
Raised characters not provided on sign Braille not provided on sign	- -	Provide text with raised characters duplicated in braille on the sign. Mount the sign between 48"-60" above the finished floor located on right side of the entrance. Ensure to provide a clear floor space of 18" min. by 18" min. at the sign.	1	232	\$232
18	Health and Beauty Room	1	5	Signage	Designation

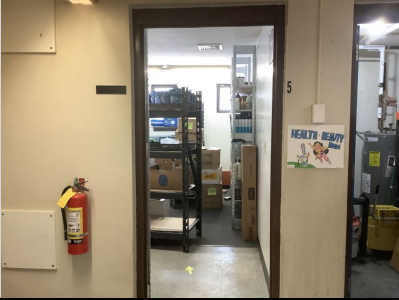
Raised characters not provided on sign Braille not provided on sign	- -	Provide text with raised characters duplicated in braille on the sign. Mount the sign between 48"-60" above the finished floor located on right side of the entrance. Ensure to provide a clear floor space of 18" min. by 18" min. at the sign.	1	232	\$232

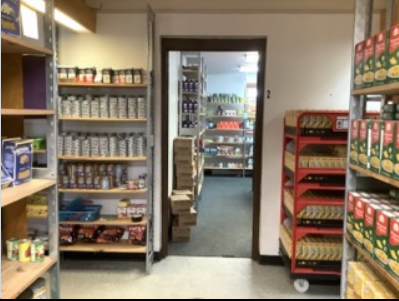
19	Room 2	1	2	Signage	Designation

Raised characters not provided on sign Braille not provided on sign Signage lacks 18" by 18" clear floor space	- - -	Provide text with raised characters duplicated in braille on the sign. Mount the sign between 48"-60" above the finished floor located on right side of the entrance. Ensure to provide a clear floor space of 18" min. by 18" min. at the sign.	1	232	\$232
Service Counter												
20	Check-In Counter	1		Service Counter	N/A

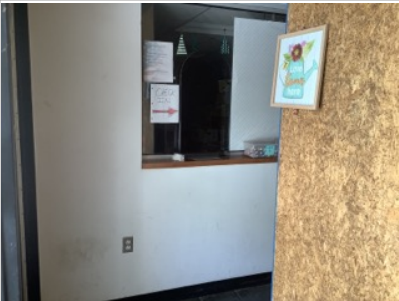
Counter > 36" high	42"	Provide a counter that is 36" max. above the ground or finished floor.	1	880	\$880
