Freetown Transfer Station

Town of Freetown ADA Transition Plan

June 2023

Institute for Human Centered Design

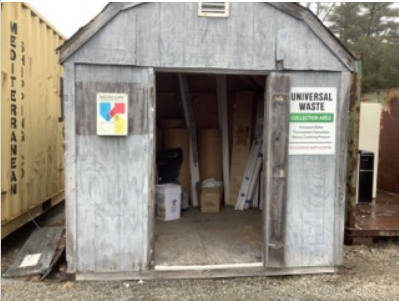
Level changes > 1/4"	7"	Ensure that staff is available to help the public dispose of items in the waste shed and other locations such as the trash dump with the 40.8" high railings.	1	-	\$0
2	Swap Shed	Ext.		Exterior Access Route

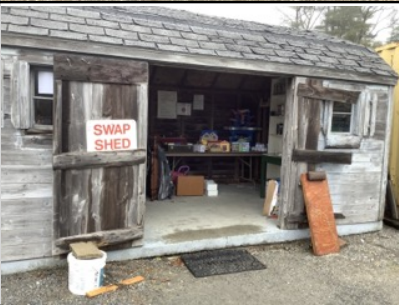
Surface is not stable, firm, and slip-resistant Accessible route not provided	- 7"	Ensure an accessible route is provided to the swap shed. IHCD recommends an asphalt concrete or stone dust route that addresses the change in level.	1	-	\$0
Off-Street Parking Lot or Garage												
3	Parking Lot	Ext.		Off-Street Parking Lot or Garage	Visitor

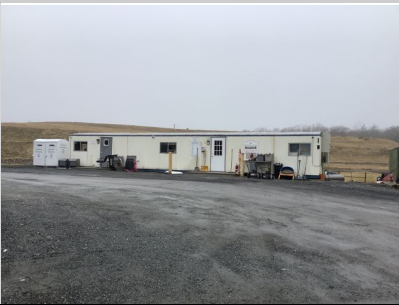
Total # of parking Total # of designated car accessible parking spaces Total # of designated van accessible spaces Van space < 132" or < 96" wide Access aisle < 96" wide at van space Access aisle does not adjoin an accessible route Sign with the International Symbol of Acc. not provided Sign does not have the designation "Van Accessible"	5 0 0 - - - - -	Provide a compliant van accessible parking space and marked access aisle, both at least 96" wide. Include an identification sign with the International Symbol of Accessibility (ISA), and the designation "Van Accessible". Ensure the bottom of the sign is located 60" min. from the ground. Ensure an accessible route is provided from the van accessible parking space to each office entrance.	1	1850 Labor	\$1850

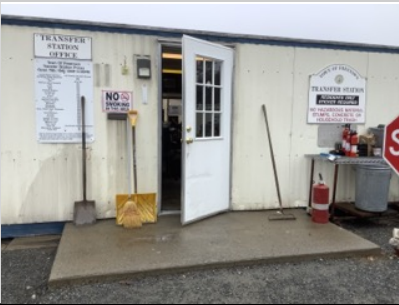
Entrance												
4	Transfer Station Office	Ext.		Entrance	Main Entrance

Entrance not on an accessible route Maneuvering clearance(s) not provided Hardware not compliant	2.5" - -	Provide an accessible route to the office entrance. (Cost estimate for a 4' x 4' concrete area.) Relocate the shovel to provide 18" min. maneuvering clearance at the pull-side of the door. Provide hardware that can be operable with one hand and not require tight grasping, pinching, or twisting of the wrist.	1	740 Labor	\$740

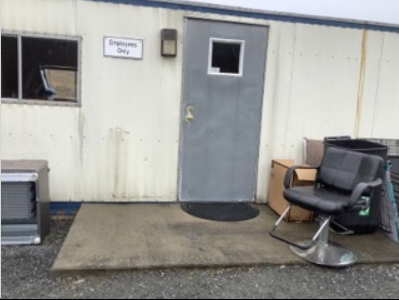
Entrance not on an accessible route Hardware not compliant	- -	Provide an accessible route to the animal control office entrance. (Cost estimate for a 4' x 4' concrete patch.) Provide hardware that can be operable with one hand and not require tight grasping, pinching, or twisting of the wrist.	1	740	\$740
Access to Goods and Services												
Means of Egress												
6	Animal Control Office, Egress Door	1		Means of Egress	N/A

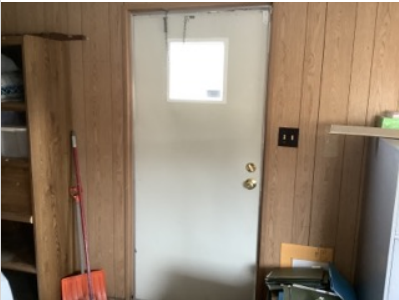
Tactile exit sign not provided Illuminated ISA symbol not provided (MAAB)	- -	Ensure that a tactile exit sign with raised characters and braille is provided at the exit door. Mount the sign between 48"- 60" above the finished floor located on the latch side of the door. After the door is made accessible, when and if an illuminated exit sign is provided, provide an illuminated sign with the International Symbol of Accessibility (ISA).	1	232	\$232

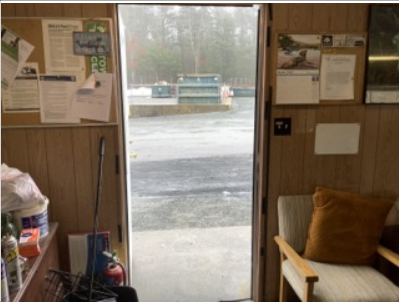
7	Transfer Station Office	1		Means of Egress	N/A

Tactile exit sign not provided Illuminated ISA symbol not provided (MAAB)	- -	Ensure that a tactile exit sign with raised characters and braille is provided at the exit door. Mount the sign between 48"- 60" above the finished floor located on the latch side of the door. After the door is made accessible, when and if an illuminated exit sign is provided, provide an illuminated sign with the International Symbol of Accessibility (ISA).	1	232	\$232
Interior Access Route												
8	Transfer Station Office	1		Interior Access Route	Interior

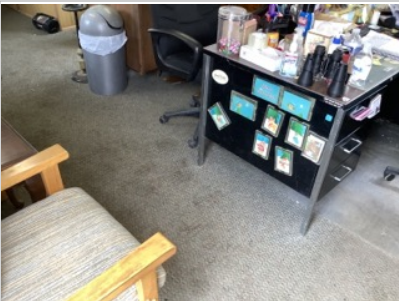
Route < 36" wide	33"	Relocate the desk to ensure that a clear width of 36" min. is maintained at the accessible route.	1	Labor	\$0

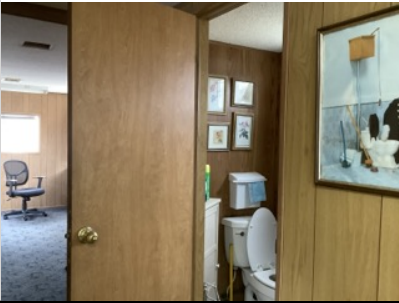
Clear width at door < 32" Hardware is not compliant	24.3" -	Widen the door so that there is 32" min. clear width. Provide hardware that can be operable with one hand and not require tight grasping, pinching, or twisting of the wrist. (See Record ID #15 for cost.)	1	-	\$0
10	Transfer Station Office	1		Doors, Doorways, & Gates	Other

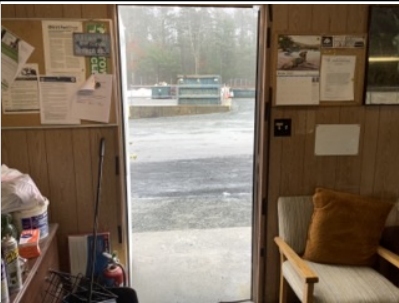
Maneuvering clearance(s) not provided	3"	Relocate the chair to provide 12" min. maneuvering clearance at the push-side of the door.	1	Labor	\$0
Stairways												
11	Trash Dump	Ext.		Stairways	N/A

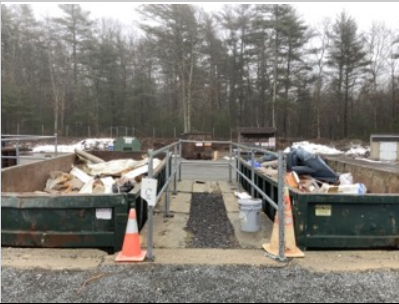
- The handrails at three (3) trash stations are higher than allowed, and also lack bottom extensions.

Handrail height < 34" or > 38" Handrails do not extend 12" from stairs	40.8" -	Alter so the handrails are 34"- 38" high above the floor. Ensure handrails extend horizontally above the ground for 12" min. beginning above the route to the trash dump. (Cost estimate provided for welding 2 extensions to each set of handrails).	3	Labor 1,600	\$4800

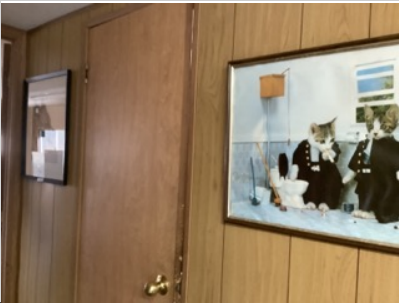
Not provided	-	Provide a designation sign, located on the latch side of the door, that includes text with raised characters duplicated in braille on the sign.	1	232	\$232
13	Animal Control Office	Ext.		Signage	Designation

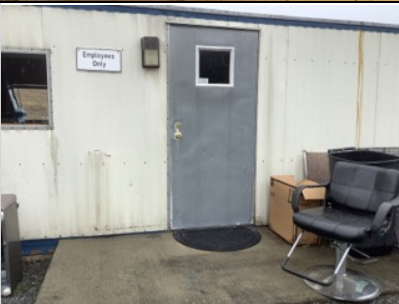
Not provided	-	Provide a designation sign, located on the latch side of the door, that includes text with raised characters duplicated in braille on the sign.	1	346	\$346

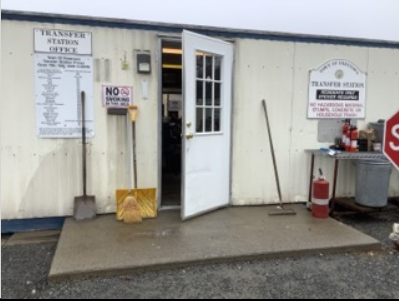
Not provided	-	Provide a designation sign, located on the latch side of the door, that includes text with raised characters duplicated in braille on the sign.	1	346	\$346
Toilet & Bathing Rooms												
Overall Access												
15	Single-User Toilet Room	1		Overall Access	Toilet Room

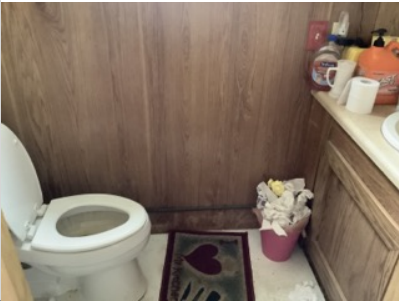
Accessibility issues include lack of a compliant single-user toilet room with an audible and visual fire alarm.

Accessible plumbing fixtures or stalls not provided Audible and visible alarm not provided	- -	Add an accessible single-user toilet room. (Cost includes a door with a compliant clear width and compliant hardware.) When fire system is updated, ensure that a visible and audible fire alarm is installed.	1	24604	\$24604
