Freetown Council on Aging/ Senior Center

Town of Freetown ADA Transition Plan

August 2023

Institute for Human Centered Design

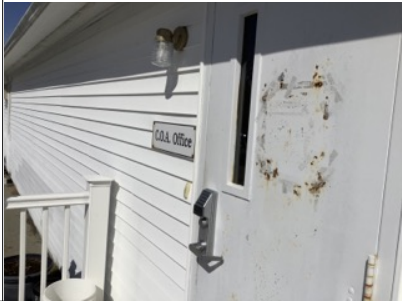
ID	Location	Floor	Room	Element	Type	Photo	Issues	Current Measure	Recommendations	Quantity	Price	Cost Estimation
Approach and Entrance												
Exterior Access Route												
1	Southwest Entrance/Exit to COA Office	Ext.		Exterior Access Route	Exterior

Obstructed by protruding objects	5"	Relocate light fixture out of the circulation path.	1	Labor	\$0
2	Pavilion Near West Side Parking Lot	Ext.		Exterior Access Route	Exterior

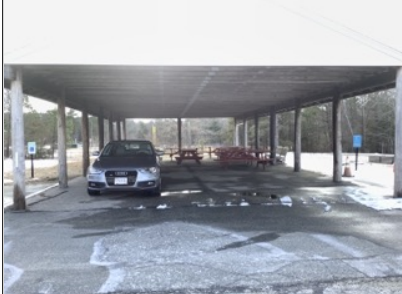
Does not prevent accumulation of water	-	Repair surface.	1	-	\$0
3	Garden Beds	Ext.		Exterior Access Route	Exterior

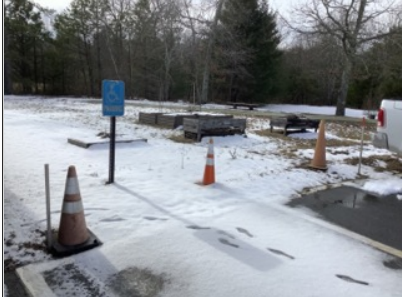
Accessible route not provided	-	Ensure an accessible route is provided to the garden beds.	1	-	\$0
4	Shuffleboard	Ext.		Exterior Access Route	Exterior

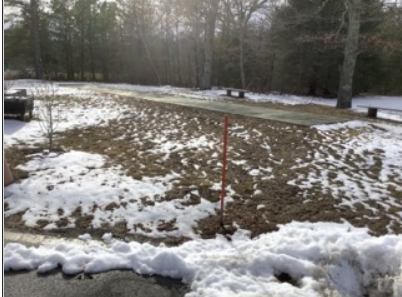
Accessible route not provided	-	Ensure an accessible route is provided to the shuffleboard court.	1	-	\$0
5	Horshoe Pit	Ext.		Exterior Access Route	Exterior

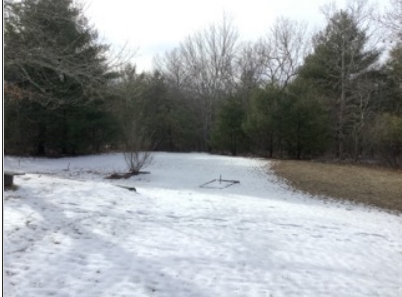
Accessible route not provided	-	Ensure an accessible route is provided to the horseshoe pit.	1	-	\$0

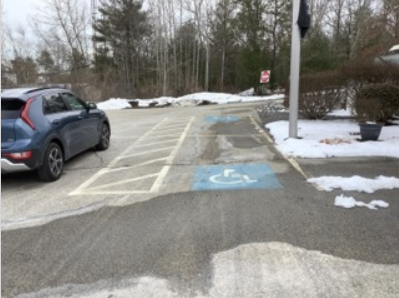
ID	Location	Floor	Room	Element	Type	Photo	Issues	Current Measure	Recommendations	Quantity	Price	Cost Estimation
Off-Street Parking Lot or Garage												
6	East Side Parking Lot	Ext.		Off-Street Parking Lot or Garage	Visitor

Total # of parking Total # of designated car accessible parking spaces Total # of designated van accessible spaces Van space < 132" or <96" wide Running or cross slope at space > 1:50 (2.00%) Access aisle < 96" wide at van space Running or cross slope at access aisle > 1:50 (2.00%) Sign with the International Symbol of Acc. not provided Sign does not have the designation "Van Accessible"	24 4 0 95" 2.6% 45" 2.6% - -	Provide a van accessible space and access aisle that is at least 96" wide each. Reduce running or cross slope to be no steeper than 1:50 (2.00%). Provide a sign with the International Symbol of Accessibility (ISA) with the bottom of the sign 60" min. above the ground. Add the designation "Van Accessible" to the sign at the van accessible space. (Cost for van accessible parking space.)	1	1850	\$1850

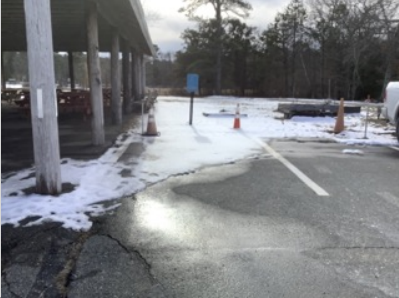
7	Northwest Space - West Side Parking Lot	Ext.		Off-Street Parking Lot or Garage	Visitor

Access aisle not provided Sign does not have the designation "Van Accessible" Surface not stable, firm, and slip-resistant	- - -	Provide a marked access aisle that is at least 96" wide. Add the designation "Van Accessible" to the sign located at the van accessible space. Ensure to clear snow from the accessible spaces.	1	800	\$800
Exterior Ramp												
8	Ramp to Northwest Side Entrance/Exit	Ext.		Exterior Ramp	N/A

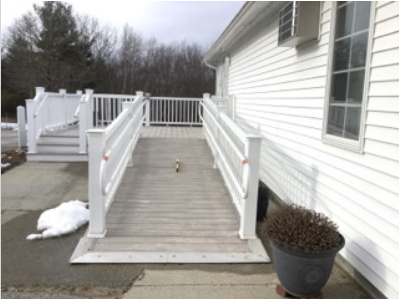
No lower handrail 18"-20" high provided Running slope > 1:12 (8.33%)	22" 9.9%	Provide a lower handrail between 18" to 20" high above the ground or finished floor. Reduce running slope to be no steeper than 1:12 (8.33%). (Cost estimate based on a new 30' painted wood ramp.)	1	12067	\$12067
9	Ramp to Northwest Side Entrance/Exit	Ext.		Exterior Ramp	N/A

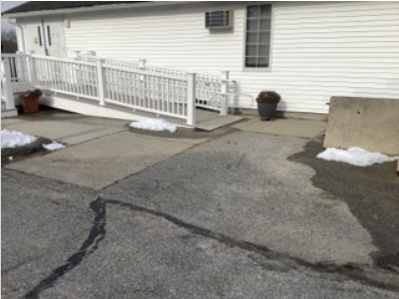
Handrails do not extend 12" past top & bottom Edge protection < 4" high	- -	Ensure that handrails extend horizontally above the landing for 12" min. beyond the top and bottom of ramp runs. Provide edge protection that prevents the passage of a 4" diameter sphere, where any portion of the sphere is within 4" of the finished floor or ground surface. (Cost included in ID #8.)	1	-	\$0

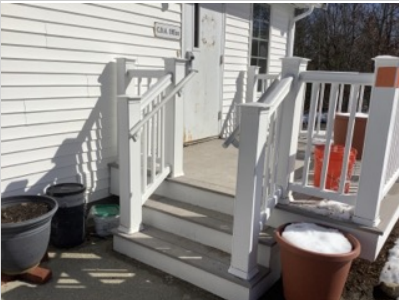
Exterior Stair												
10	Southwest Entrance/Exit to COA Office	Ext.		Exterior Stair	N/A

Handrails do not extend 12" from stair	-	Bottom: Ensure that the sloped bottom extension extends 12" plus the width of one tread beyond the bottom riser in same direction as stair flight.	1	1600	\$1600

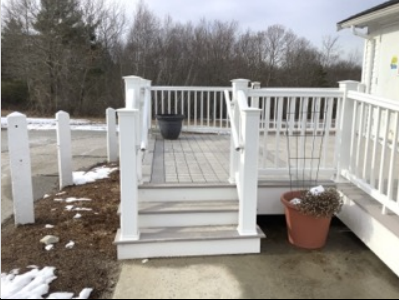
ID	Location	Floor	Room	Element	Type	Photo	Issues	Current Measure	Recommendations	Quantity	Price	Cost Estimation
11	Northwest Side Entrance/Exit	Ext.		Exterior Stair	N/A

Handrails do not extend 12" from stair	-	Bottom: Ensure that the sloped bottom extension extends 12" plus the width of one tread beyond the bottom riser in same direction as stair flight.	1	1600	\$1600
Access to Goods and Services												
Means of Egress												
12	Main Entrance/Exit	1		Means of Egress	N/A

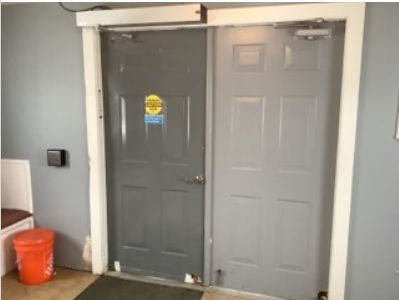
Tactile exit sign not provided	-	Ensure that a tactile exit sign with raised characters and braille is provided at the exit door. Mount the sign between 48"- 60" above the finished floor located on the right side of the double doors or the inactive leaf.	1	232	\$232
13	Southwest Entrance/Exit	2		Means of Egress	N/A

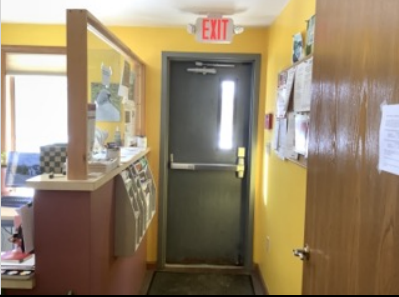
Tactile exit sign not provided	-	Ensure that a tactile exit sign with raised characters and braille is provided at the exit door. Mount the sign between 48"- 60" above the finished floor located on the latch side of the door.	1	232	\$232

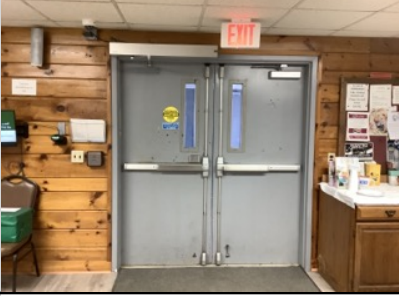
14	Main Entrance/Exit	1		Means of Egress	N/A

Tactile exit sign not provided Illuminated ISA symbol not provided (MAAB)	- -	Ensure that a tactile exit sign with raised characters and braille is provided at the exit door. Mount the sign between 48"- 60" above the finished floor located on the right side of the double doors or the inactive leaf. When the illuminated exit sign is repaired or replaced, provide an illuminated sign with the International Symbol of Accessibility (ISA).	1	232	\$232
15	Northwest Side Entrance/Exit	2		Means of Egress	N/A

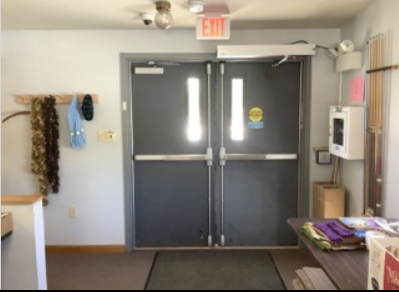
Tactile exit sign not provided Illuminated ISA symbol not provided (MAAB)	- -	Ensure that a tactile exit sign with raised characters and braille is provided at the exit door. Mount the sign between 48"- 60" above the finished floor located on the right side of the double doors or the inactive leaf. When the illuminated exit sign is repaired or replaced, provide an illuminated sign with the International Symbol of Accessibility (ISA).	1	232	\$232

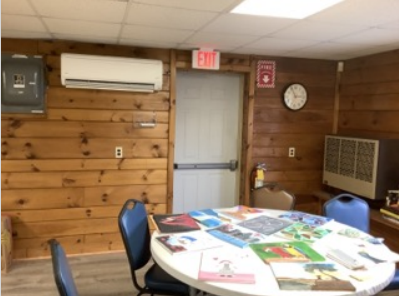
ID	Location	Floor	Room	Element	Type	Photo	Issues	Current Measure	Recommendations	Quantity	Price	Cost Estimation
16	Hall	1		Means of Egress	N/A

Tactile exit sign not provided Directional sign to accessible emergency exit not provided	- -	Ensure that a tactile exit sign with raised characters and braille is provided at the exit door. Mount the sign between 48"- 60" above the finished floor located on the latch side of the door. Provide a directional sign indicating the location of the nearest accessible emergency exit.	1	464	\$464
17	Near Director's Office	2		Means of Egress	N/A

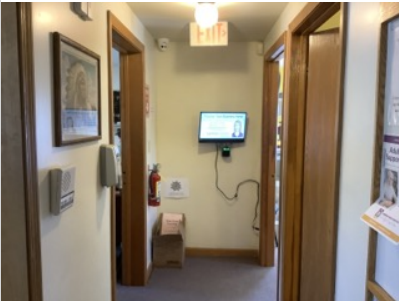
Directional sign to accessible emergency exit not provided	-	Provide a directional sign indicating the location of the nearest accessible emergency exit.	1	232	\$232
Interior Access Route												
18	Hall	1		Interior Access Route	N/A

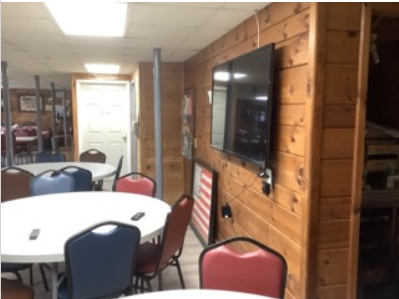
Route < 36" wide	-	Ensure that a clear width of 36" min. is maintained at the accessible route.	1	Labor	\$0

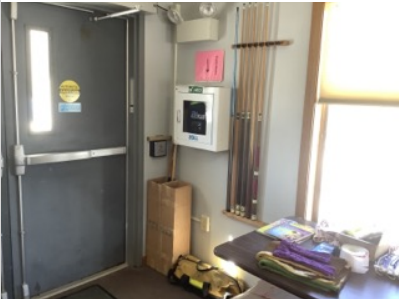
19	Northwest Side Entrance/Exit	2		Interior Access Route	292

Obstructed by protruding objects	-	Relocate defibrillator out of the circulation path.	1	Labor	\$0
20	Stair	2		Interior Access Route	N/A

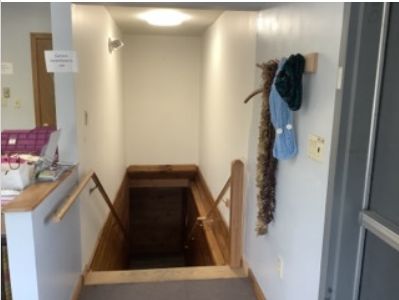
Accessible vertical route not provided	-	Provide accessible vertical access. (Cost estimate is for a limited-use/limited-application (LULA) elevator between floors.)	1	90000	\$90000

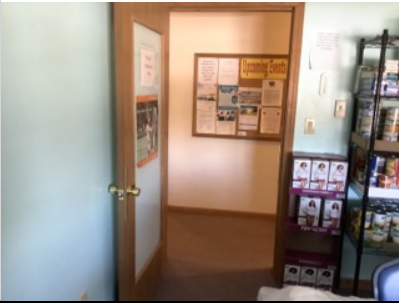
ID	Location	Floor	Room	Element	Type	Photo	Issues	Current Measure	Recommendations	Quantity	Price	Cost Estimation
Doors, Doorways, & Gates												
21	Volunteering Activity Room Near SHINE	2		Doors, Doorways, & Gates	Other

Maneuvering clearance(s) not provided Hardware not compliant	- -	Relocate items to provide 24" maneuvering clearance on the pull side of the door. Provide hardware that can be operable with one hand and not require tight grasping, pinching, or twisting of the wrist.	1	Labor 484	\$484
22	Stair to Hall	1		Doors, Doorways, & Gates	Circulation

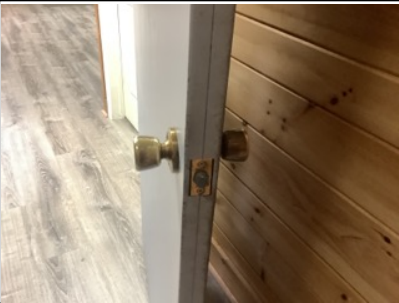
Hardware not compliant	-	Provide hardware that can be operable with one hand and not require tight grasping, pinching, or twisting of the wrist.	1	484	\$484
23	SHINE	2		Doors, Doorways, & Gates	Office

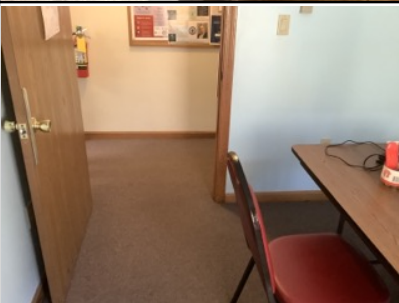
Hardware not compliant	-	Provide hardware that can be operable with one hand and not require tight grasping, pinching, or twisting of the wrist.	1	484	\$484

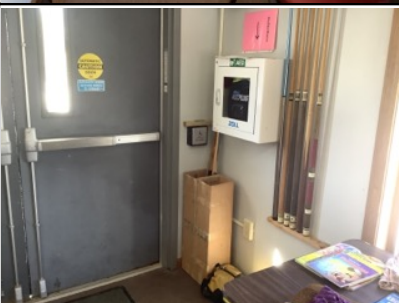
24	Northwest Side Entrance/Exit	2		Doors, Doorways, & Gates	Emergency Egress

Clear floor space at opener not provided	-	Relocate defibrillator, pool sticks and table to provide a 30" x 48" clear floor space at automatic door opener.	1	Labor	\$0
Stairways												
25	Stair	2		Stairways	Interior

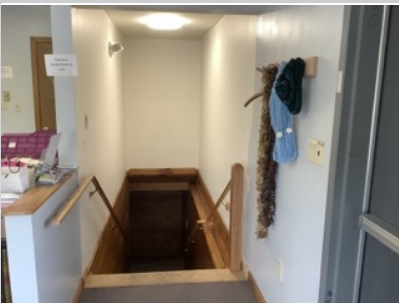
Handrails do not extend 12" from stairs Handrails not continuous where required	- -	Top: Ensure handrails extend horizontally above the landing for 12" min. beginning above the first riser nosing. Provide a continuous handrail on the right side of the stair. (Cost for replacing a 30' wood handrail.)	1	1320	\$1320

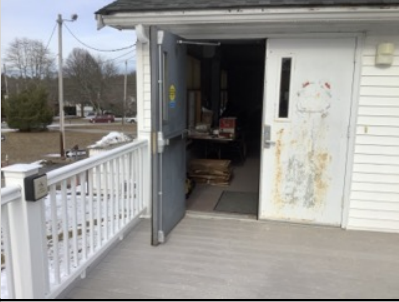
ID	Location	Floor	Room	Element	Type	Photo	Issues	Current Measure	Recommendations	Quantity	Price	Cost Estimation
Signage												
26	Northwest Side Entrance/Exit	Ext.		Signage	Designation

Signage is not provided	-	Locate compliant signage with raised characters and braille alongside the door on the latch side.	1	346	\$346
27	Southwest Entrance/Exit to COA Office	Ext.		Signage	Designation

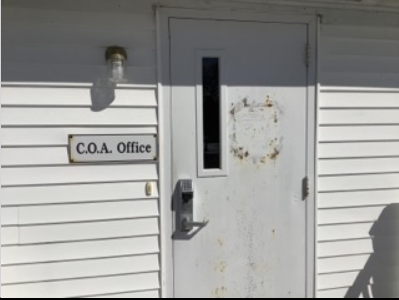
Raised characters not provided on sign Braille not provided on sign	- -	Provide text with raised characters duplicated in braille on the sign.	1	346	\$346
28	All Gender Toilet Room Near Stair (Accessible)	1		Signage	Designation

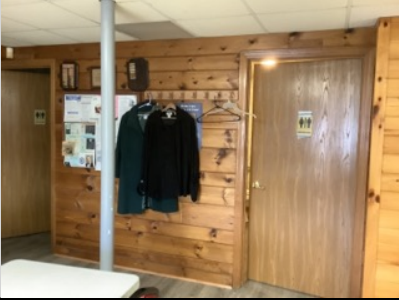
Raised characters not provided on sign Braille not provided on sign Sign not located on the latch side of the door International Symbol of Acc. not compliant	- - - -	Provide text with raised characters duplicated in braille on the sign. Locate the sign at permanent rooms alongside the door on the latch side. Provide a sign with the required International Symbol of Accessibility (ISA).	1	232	\$232

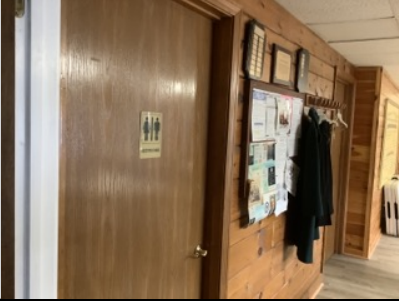
29	All Gender Toilet Room (Inaccessible)	1		Signage	Designation

Raised characters not provided on sign Braille not provided on sign Sign not located on the latch side of the door Directional sign to access. toilet not provided	- - - -	Provide text with raised characters duplicated in braille on the sign. Locate the sign at permanent rooms alongside the door on the latch side. Install a sign indicating the location of the nearest accessible toilet room.	1	232	\$232
30	SHINE	2		Signage	Designation

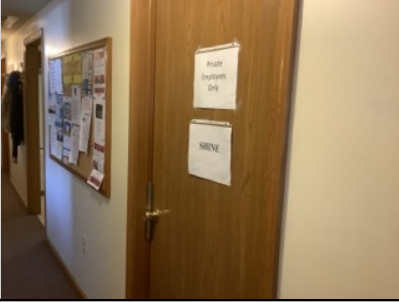
Raised characters not provided on sign Braille not provided on sign Sign not located on the latch side of the door	- - -	Provide text with raised characters duplicated in braille on the sign. Locate the sign at permanent rooms alongside the door on the latch side.	1	232	\$232

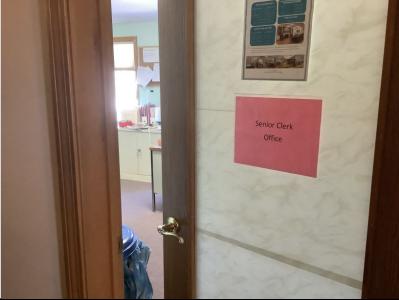
ID	Location	Floor	Room	Element	Type	Photo	Issues	Current Measure	Recommendations	Quantity	Price	Cost Estimation
31	Senior Clerk Office	2		Signage	Designation

Raised characters not provided on sign Braille not provided on sign Sign not located on the latch side of the door	- - -	Provide text with raised characters duplicated in braille on the sign. Locate the sign at permanent rooms alongside the door on the latch side.	1	232	\$232
32	All Gender Toilet Rooms	2		Signage	Designation

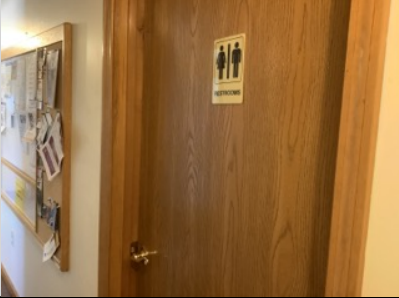
Raised characters not provided on sign Braille not provided on sign Sign not located on the latch side of the door International Symbol of Acc. not provided	- - - -	Provide text with raised characters duplicated in braille on the sign. Locate the sign at permanent rooms alongside the door on the latch side. Replace the sign with a sign containing the International Symbol of Accessibility (ISA).	2	232	\$464

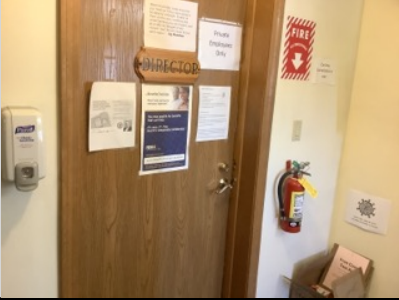
33	Director's Office	2		Signage	Designation

Raised characters not provided on sign Braille not provided on sign Sign not located on the latch side of the door	- - -	Provide text with raised characters duplicated in braille on the sign. Locate the sign at permanent rooms alongside the door on the latch side.	1	232	\$232
34	Main Entrance/Exit	Ext.		Signage	Designation

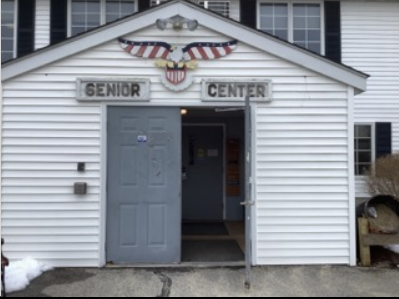
Raised characters not provided on sign Braille not provided on sign Sign not located on the latch side of the door	- - -	Provide text with raised characters duplicated in braille on the sign. Locate the sign at permanent rooms alongside the door on the latch side.	1	346	\$346
Service Counter												
35	COA Office at Southwest Entrance/Exit	2		Service Counter	N/A

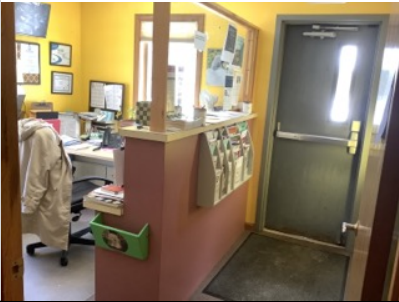
Counter > 36" high	47"	Provide a counter that is 36" max. above the finished floor.	1	880	\$880

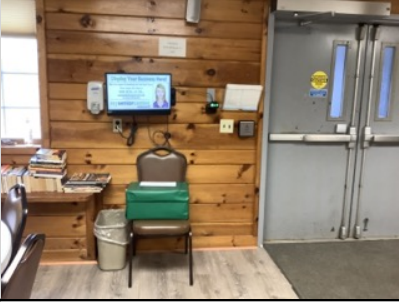
ID	Location	Floor	Room	Element	Type	Photo	Issues	Current Measure	Recommendations	Quantity	Price	Cost Estimation
Operable Parts / Reach Range												
36	Sign In Screen Near Main Entrance/Exit	1		Operable Parts / Reach Range	Equipment

Clear floor space is not provided Reach < 15" or > 48"(forward/side approach)	- 60"	Provide a 30" min. by 48" min. clear floor space at the sign in screen and relocate so that controls are between 15"- 48" above the finished floor.	1	Labor	\$0
37	Main Entrance/Exit	1		Operable Parts / Reach Range	Other

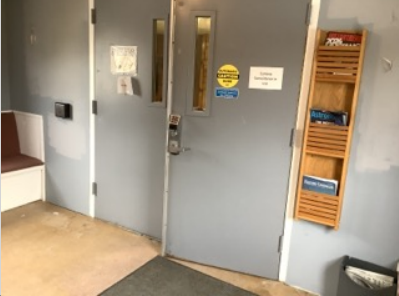
Reach < 15" or > 48"(forward/side approach)	66"	Relocate magazine rack so that magazines are between 15"- 48" above the finished floor.	1	Labor	\$0
38	Sign In Screen Near Director's Office	2		Operable Parts / Reach Range	Equipment

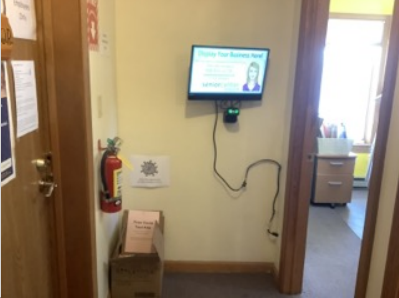
Reach < 15" or > 48"(forward/side approach)	60"	Relocate screen so that controls are between 15"- 48" above the finished floor.	1	Labor	\$0

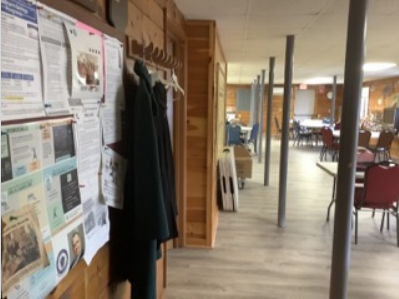
39	Hall	1		Operable Parts / Reach Range	Clothes Rod/Hooks

Side reach > 54"	69"	Provide a coat hook 48" above the finished floor max.	1	150	\$150
40	Corridor Near the Offices	2		Operable Parts / Reach Range	Clothes Rod/Hooks

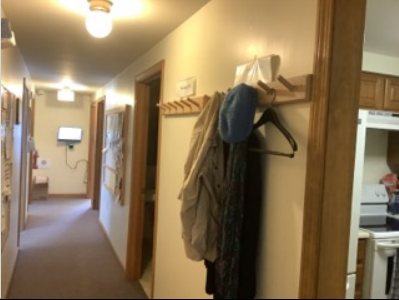
Side reach > 54"	68"	Provide a coat hook 48" above the finished floor max.	1	150	\$150

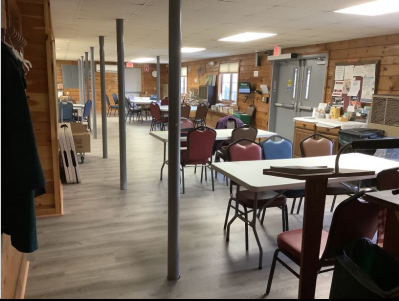
ID	Location	Floor	Room	Element	Type	Photo	Issues	Current Measure	Recommendations	Quantity	Price	Cost Estimation
Assembly Area												
41	Hall for Night Bingo and Events	1		Assembly Area	N/A

Assistive listening devices not provided	-	If audible communication is integral to the use of the space, provide an assistive listening system.	1	1214	\$1214
Picnic Tables												
42	Pavilion Near West Side Parking Lot	Ext.		Picnic Tables	N/A

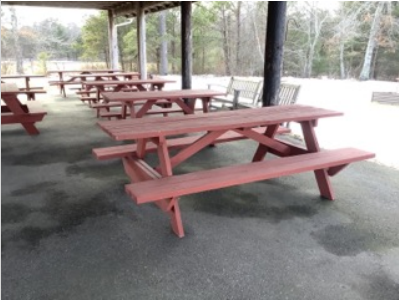
Knee clearance less than 19" deep	13"	Provide at least one picnic table with knee clearance that is 19" deep min.	1	1400	\$1400
43	Pavilion Near West Side Parking Lot	Ext.		Picnic Tables	N/A

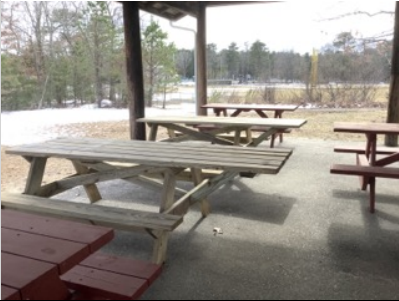
Knee clearance less than 19" deep	-	Provide at least one picnic table with knee clearance that is 19" deep min. clear beyond the angled support.	1	1400	\$1400
Exterior Benches												
44	Bench Near Pavillion	Ext.		Exterior Benches	N/A

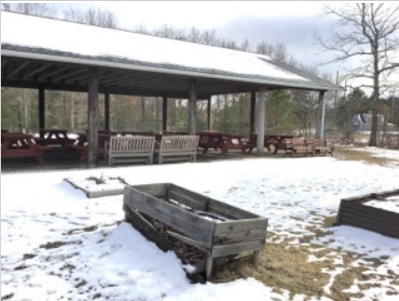
No accessible route to one bench in area	-	Provide an accessible route to one bench in this area.	1	-	\$0

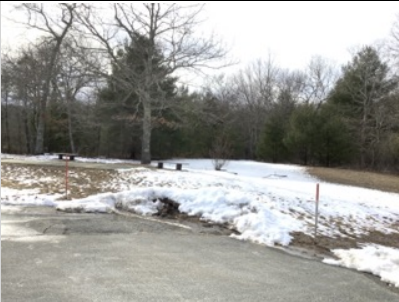
45	Bench Near Shuffleboard	Ext.		Exterior Benches	N/A

No accessible route to one bench in area	-	Provide an accessible route to one bench in this area.	1	-	\$0

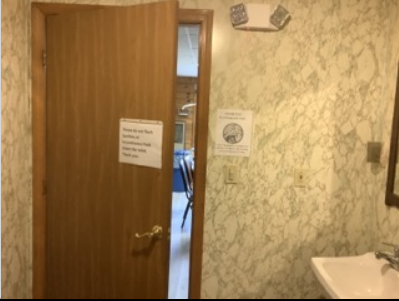
ID	Location	Floor	Room	Element	Type	Photo	Issues	Current Measure	Recommendations	Quantity	Price	Cost Estimation
Toilet & Bathing Rooms												
Overall Access												
46	All Gender Toilet Room Near Stair	1		Overall Access	Toilet Room

Audible and visible alarm not provided	-	When fire system is updated, ensure that a visible and audible fire alarm is installed.	1	-	\$0
Lavatory												
47	All Gender Toilet Room Near Stair	1		Lavatory	N/A

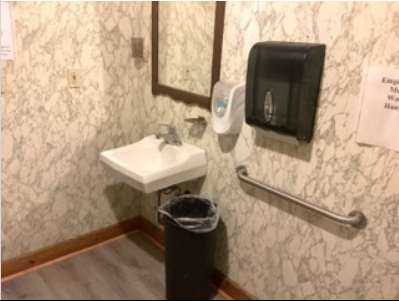
Toe or knee clearances not provided Plumbing underneath is exposed Mirror above lavatory w/reflective surface > 40"	24" - 45"	Provide at least one lavatory with knee and toe clearance positioned for a forward approach. Insulate or otherwise configure pipes to prevent contact at lavatory. Lower mirror so that the bottom surface is at 40" max. above the finished floor.	1	2034	\$2034
48	All Gender Toilet Rooms	2		Lavatory	N/A

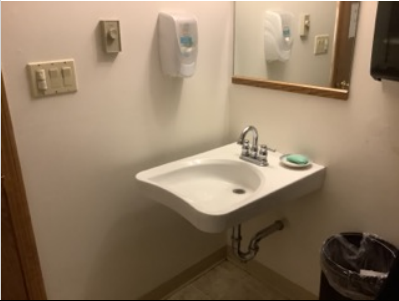
Plumbing underneath is exposed Mirror above lavatory w/reflective surface > 40"	- 45"	Insulate or otherwise configure pipes to prevent contact at lavatory. Lower mirror so that the bottom surface is at 40" max. above the finished floor.	2	348	\$696

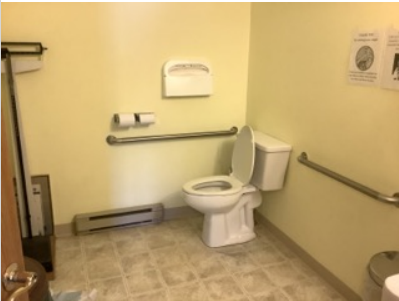
Single-User Toilet												
49	All Gender Toilet Room 2	2		Single-User Toilet	N/A

Flush control not on open side Clearance at toilet < 72" clear depth (MAAB) Hook located > 54" high	- - 60"	Relocate the flush control to the open side. Relocate cleaning supplies to ensure that there is 72" deep min. clear floor space at the toilet. Locate the coat hook no higher than 48" above the finished floor and ensure a 30" min. by 48" min. clear floor space is provided at the coat hook.	1	524	\$524

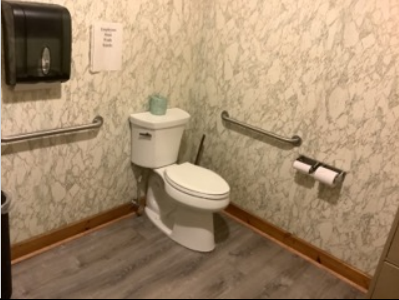
ID	Location	Floor	Room	Element	Type	Photo	Issues	Current Measure	Recommendations	Quantity	Price	Cost Estimation
50	All Gender Toilet Room Near Stair	1		Single-User Toilet	N/A

Side grab bar < 54" from back wall Side or rear grab bar < 33" or > 36" high Rear grab bar < 42" long (MAAB) Item mounted over grab bar (MAAB)	- 31" 25" -	Provide a side wall grab bar that is 42" long min. located 12" max. from the rear wall. Mount grab bars 33"- 36" above the finished floor. Provide a rear wall grab bar that is 42" long min. and extends from the toilet 12" min. on one side and 24" min. on the other side (open side). Relocate paper towel dispenser so that it is not mounted over the grab bar.	1	2052	\$2052
51	All Gender Toilet Room	2		Single-User Toilet	N/A

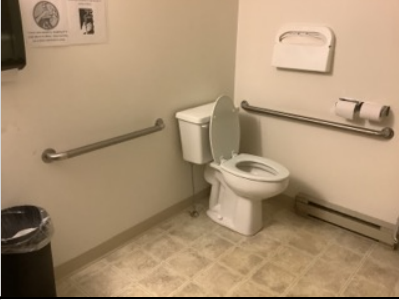
Side grab bar < 54" from back wall Side or rear grab bar < 33" or > 36" high Rear grab bar < 42" long (MAAB)	47" 31" 32"	Relocate side wall grab bar 12" from the rear wall. Mount grab bars 33"- 36" above the finished floor. Provide a rear wall grab bar that is 42" long min. and extends from the toilet 12" min. on one side and 24" min. on the other side (open side).	2	1294	\$2588

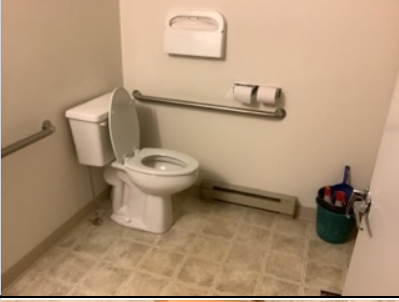
52	All Gender Toilet Room	2		Single-User Toilet	N/A

Clearance at toilet < 72" clear depth (MAAB) Toilet paper dispenser is not compliant Toilet cover dispenser is not compliant	65" - -	Relocate cabinets to ensure that there is 72" deep min. clear floor space at the toilet. Relocate toilet paper so that it is 24" min. high, located under the grab bar, and between 7" and 9" from the front of the toilet. Relocate toilet cover dispenser so the operable parts are no higher than 48" on the side of the toilet. Ensure that no dispensers are mounted over the grab bar that can obstruct the grab bar use.	2	512	\$1024
53	All Gender Toilet Room Near Stair	1		Single-User Toilet	N/A

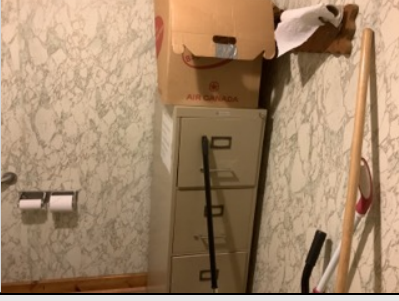
Clearance at toilet < 72" clear depth (MAAB) Hook located > 48" high (2010 ADA)	66" 64"	Relocate cabinet and other items to ensure that there is 72" deep min. clear floor space at the toilet. Locate the coat hook no higher than 48" above the finished floor and ensure a 30" min. by 48" min. clear floor space is provided at the coat hook.	1	150	\$150

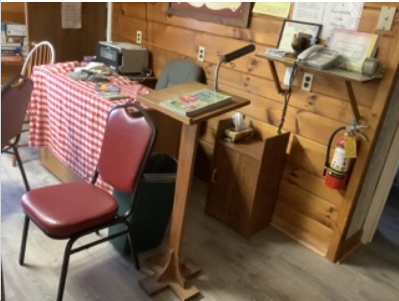
Best Practice												
54	Hall	1

-	Recommend providing an adjustable height lectern with knee and toe clearance.	1	-	\$0

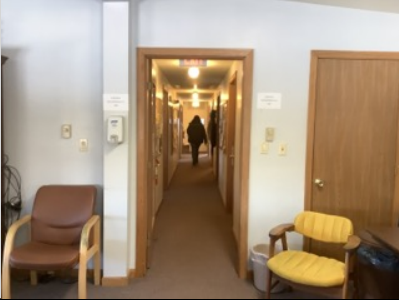
ID	Location	Floor	Room	Element	Type	Photo	Issues	Current Measure	Recommendations	Quantity	Price	Cost Estimation
55	To Offices From Northwest Side Entrance/Exit	2

-	Recommend providing a directional sign to the offices and toilet rooms.	1	-	\$0
56	Stair	2

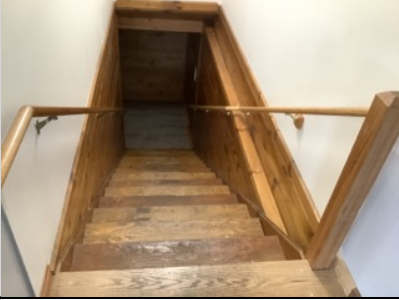
-	Recommend providing visual contrast strips at the edge of each stair tread at exterior and interior stairs. Note: Applies to all exterior and interior stairs.	-	-	\$0
57	Southwest Space - West Side Parking Lot	Ext.

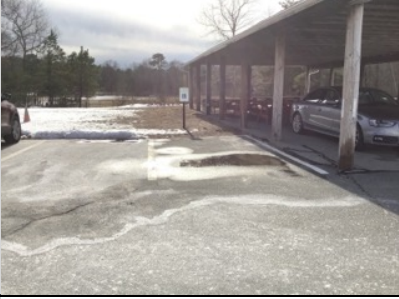
-	There are more accessible parking spaces than required, which is good practice for a Council on Aging/Senior Center. At this additional accessible parking space we recommend the following: provide a marked access aisle that is at least 60" wide. Locate sign with the bottom of the sign 60" min. above the ground. Repair the surface.	1	-	\$0
58	Garden Beds	Ext.

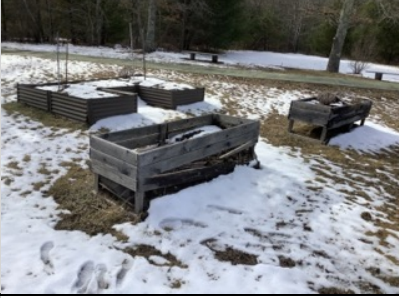
-	Consider providing raised garden beds with the top surface between 28" and 34" above the ground and 27" min. high knee and toe clearance for wheelchair users.	1	-	\$0

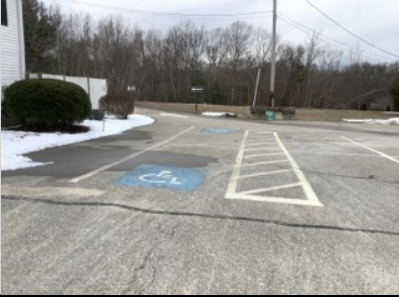
59	East Side Parking Lot	Ext.

-	There are more accessible parking spaces than required. At the additional accessible parking spaces that are provided beyond code requirements, we recommend:reducing running or cross slope to be no steeper than 1:50 (2.00%) at the access aisles and the spaces, and providing 60" wide access aisles and signs with the International Symbol of Accessibility (ISA) mounted at 60" min. above the ground.	3	-	\$0
