# K.R. Rezendes Baseball Complex

## Town of Freetown ADA Transition Plan

August 2023

Institute for Human Centered Design

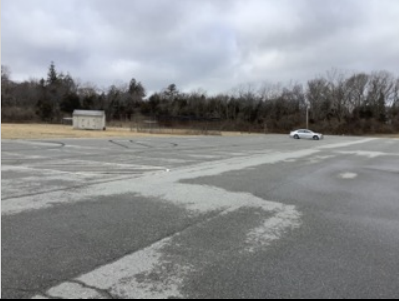
ID	Location	Floor	Room	Element	Type	Photo	Issues	Current Measure	Recommendations	Quantity	Price	Cost Estimation
Approach and Entrance												
Off-Street Parking Lot or Garage												
1	Parking Lot	Ext.		Off-Street Parking Lot or Garage	Visitor

Total # of parking Total # of designated car accessible parking spaces Total # of designated van accessible spaces Access aisle not provided Sign with the International Symbol of Acc. not provided Sign does not have the designation "Van Accessible"	95 0 0 - - -	Provide 3 car accessible spaces, each 96" wide min. with 60" wide min. access aisles. Provide 1 van accessible parking space & marked access aisle, each t 96" min. wide. Provide a sign with the International Symbol of Accessibility (ISA) with the bottom of the sign 60" min. above the ground and the top 96" max. above the ground at each space. Add the designation "Van Accessible" to the van accessible space.	4	1850	\$7400

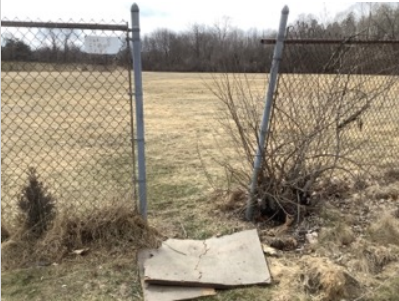
Access to Goods and Services												
Doors, Doorways, & Gates												
2	Southwest Baseball Field	Ext.		Doors, Doorways, & Gates	Other

Surface not stable, firm, and slip-resistant	-	Remove cardboard from the gateway.	1	Labor	\$0
3	Men's and Women's Single-User Toilet Rooms	Ext.		Doors, Doorways, & Gates	Toilet Room

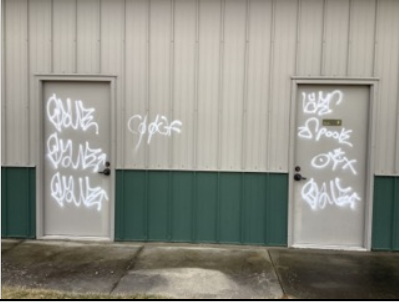
Threshold > 1/2" high	1.25"	Alter the threshold to be 1/2" high max.	2	150	\$300
Signage												
4	Men's Toilet Room	Ext.		Signage	Designation

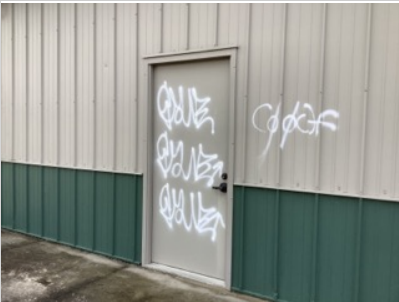
Not provided	-	Provide a designation sign, located on the latch side of the door, that includes text with raised characters duplicated in braille on the sign.	1	232 Labor	\$232

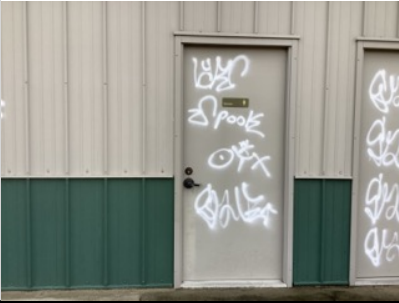
ID	Location	Floor	Room	Element	Type	Photo	Issues	Current Measure	Recommendations	Quantity	Price	Cost Estimation
5	Women's Single-User Toilet Room	Ext.		Signage	Designation

Raised characters not provided Braille not provided Sign not located on the latch side of the door	- - -	Provide a designation sign, located on the latch side of the door, that includes text with raised characters duplicated in braille on the sign.	1	232 Labor	\$232
Service Counter												
6	Concession Stand	Ext.		Service Counter	N/A

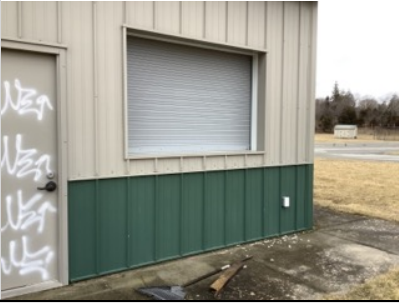
Counter > 36" high	45"	Provide a counter that is 36" max. above the ground.	3	880	\$2640
Toilet & Bathing Rooms												
Overall Access												
7	Men's Single-User Toilet Room	Ext.		Overall Access	Toilet Room

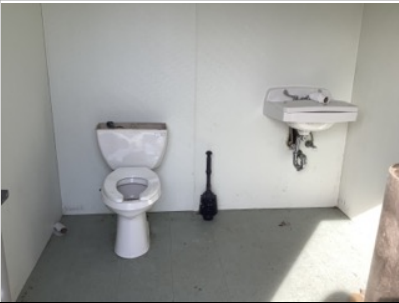
Audible and visible alarm not provided	-	When fire system is updated, ensure that a visible and audible fire alarm is installed.	1	-	\$0
8	Women's Single-User Toilet Room	Ext.		Overall Access	Toilet Room

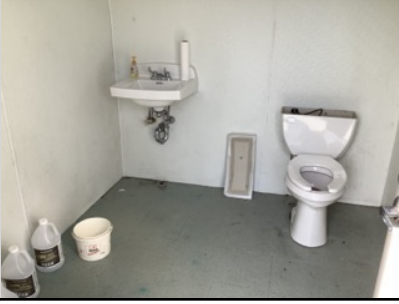
Audible and visible alarm not provided	-	When fire system is updated, ensure that a visible and audible fire alarm is installed.	1	-	\$0

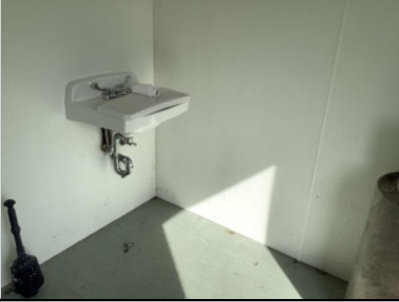
ID	Location	Floor	Room	Element	Type	Photo	Issues	Current Measure	Recommendations	Quantity	Price	Cost Estimation
Lavatory												
9	Men's Single-User Toilet Room	Ext.		Lavatory	N/A

Exposed plumbing underneath	-	Insulate or otherwise configure pipes to prevent contact for at the lavatory.	1	92	\$92
10	Women's Single-User Toilet Room	Ext.		Lavatory	N/A

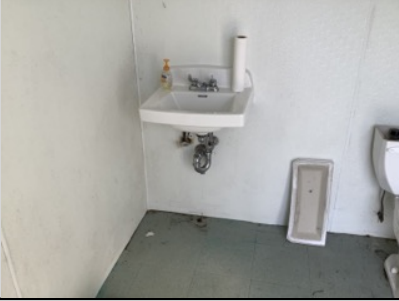
Exposed plumbing underneath	-	Insulate or otherwise configure pipes to prevent contact for at the lavatory.	1	92	\$92
Single-User Toilet												
11	Men's Single-User Toilet Room	Ext.		Single-User Toilet	N/A

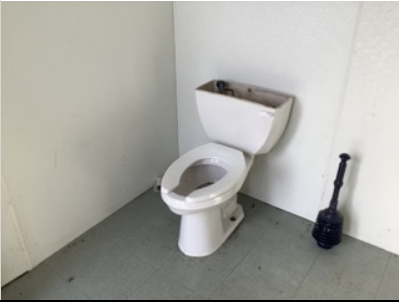
. Centerline < or > 18" (MAAB) . Grab bar not provided	23" -	Relocate toilet so that the centerline is 18" from the side wall. Provide one side wall grab bar that is 42" long min. located 12" max. from the rear wall and one rear wall grab bar that is 42" long min. and extends from the toilet 12" min. on one side and 24" min. on the other side (open side). Mount both grab bars 33"- 36" above the finished floor.	1	4624	\$4624

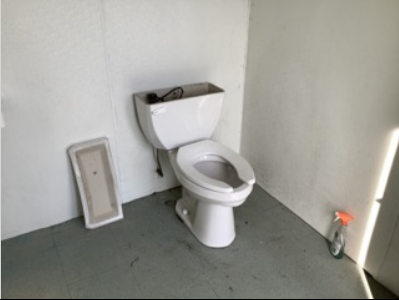
12	Women's Single-User Toilet Room	Ext.		Single-User Toilet	N/A

. Centerline < or > 18" (MAAB) . Grab bar not provided Clearance at toilet < 60" clear width	21.5" - 57"	Relocate toilet so that the centerline is 18" from the side wall. Provide one side wall grab bar that is 42" long min. located 12" max. from the rear wall and one rear wall grab bar that is 42" long min. and extends from the toilet 12" min. on one side and 24" min. on the open side. Mount both grab bars 33"- 36" above the finished floor. Renovate the toilet room to ensure that there is 60" wide min. clear floor space at the toilet.	1	24604	\$24604
Play and Sport Areas

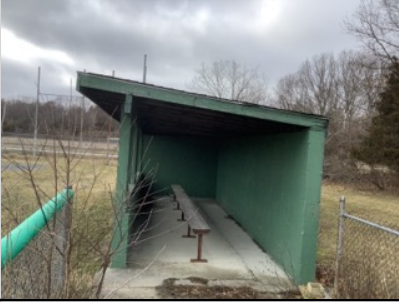
ID	Location	Floor	Room	Element	Type	Photo	Issues	Current Measure	Recommendations	Quantity	Price	Cost Estimation
Field												
13	Northeast Baseball Field, First and Third Base Team Seating	Ext.		Field	Baseball

Accessible spaces are not provided at team seating Not connected to an accessible-route	- -	Provide a 30" x 48" stable, firm and slip resistant clear floor space at team seating. Provide an accessible route to the baseball field team seating.	2	-	\$0
14	Northwest Baseball Field, First and Third Base Team Seating	Ext.		Field	Baseball

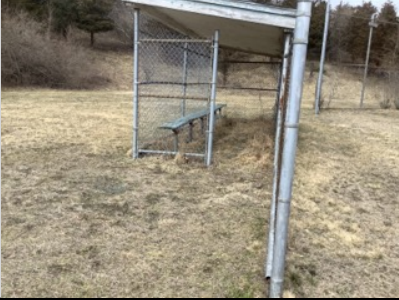
Accessible spaces are not provided at team seating Not connected to an accessible-route	- -	Provide a 30" x 48" stable, firm and slip resistant clear floor space at team seating. Provide an accessible route to the baseball field team seating.	2	-	\$0
15	Southeast Baseball Field, First and Third Base Team Seating	Ext.		Field	Baseball

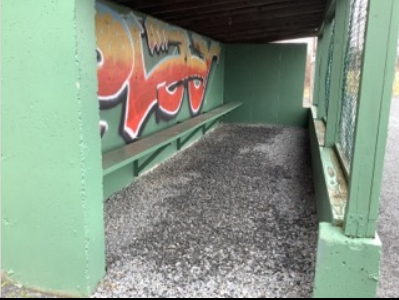
Accessible spaces are not provided at team seating Not connected to an accessible-route	- -	Provide a 30" x 48" stable, firm and slip resistant clear floor space at team seating. Provide an accessible route to the baseball field team seating.	2	-	\$0

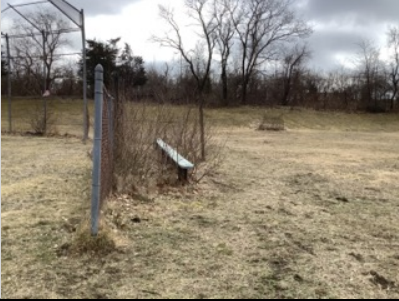
16	Southwest Baseball Field, First and Third Base Team Seating	Ext.		Field	Baseball

Accessible spaces are not provided at team seating Not connected to an accessible-route	- -	Provide a 30" x 48" stable, firm and slip resistant clear floor space at team seating. Provide an accessible route to the baseball field team seating.	2	-	\$0
17	Northeast Baseball Field, Sidelines Seating	Ext.		Field	Baseball	 	Accessible spaces not provided at sidelines seating Not connected to an accessible-route	- -	Provide a 36" x 60" stable, firm and slip resistant clear floor space at sidelines seating. Provide an accessible route to the baseball field sidelines seating.	2	-	\$0

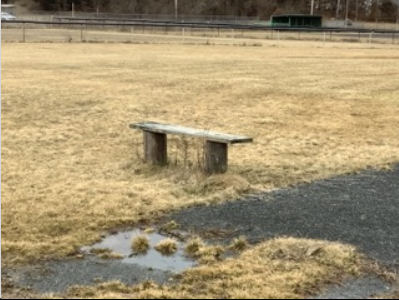
ID	Location	Floor	Room	Element	Type	Photo	Issues	Current Measure	Recommendations	Quantity	Price	Cost Estimation
18	Southeast Baseball Field, Sidelines Seating	Ext.		Field	Baseball

Accessible spaces not provided at sidelines seating Not connected to an accessible-route	- -	Provide a 36" x 60" stable, firm and slip resistant clear floor space at sidelines seating. Provide an accessible route to the baseball field sidelines seating.	1	-	\$0
19	Multi-Purpose Fields	Ext.		Field	Soccer

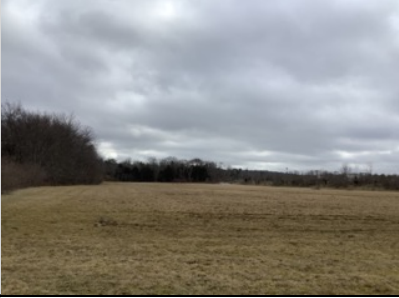
Not connected to an accessible-route No accessible route to all areas of sport activity	- -	Provide a stable, firm and slip resistant accessible route to the multi-purpose fields. Install an accessible route between all areas of sports activity.	2	-	\$0
20	Northeast Field	Ext.		Field	Baseball

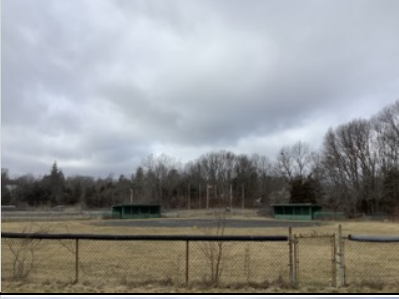
Not connected to an accessible-route No accessible route to all areas of sport activity	- -	Provide a stable, firm and slip resistant accessible route to the baseball field. Install an accessible route between all areas of sports activity.	1	-	\$0

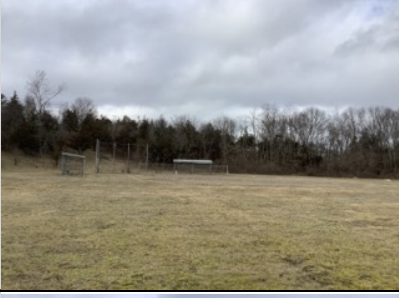
21	Northwest Baseball Field	Ext.		Field	Baseball

Not connected to an accessible-route No accessible route to all areas of sport activity	- -	Provide a stable, firm and slip resistant accessible route to the baseball field. Install an accessible route between all areas of sports activity.	1	-	\$0
22	Southeast Baseball Field	Ext.		Field	Baseball

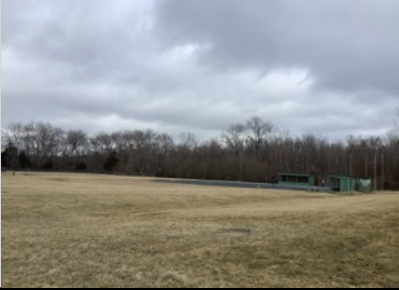
Not connected to an accessible-route No accessible route to all areas of sport activity	- -	Provide a stable, firm and slip resistant accessible route to the baseball field. Install an accessible route between all areas of sports activity.	1	-	\$0

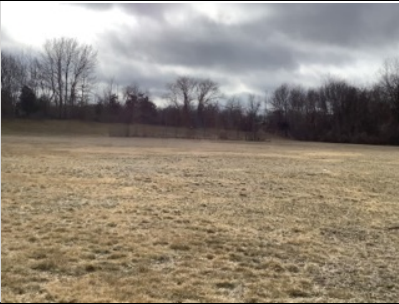
ID	Location	Floor	Room	Element	Type	Photo	Issues	Current Measure	Recommendations	Quantity	Price	Cost Estimation
23	Southwest Baseball Field	Ext.		Field	Baseball

Not connected to an accessible-route No accessible route to all areas of sport activity	- -	Provide a stable, firm and slip resistant accessible route to the baseball field. Install an accessible route between all areas of sports activity.	1	-	\$0
24	Batting Cages Near Northwest Baseball Field	Ext.		Field	Baseball

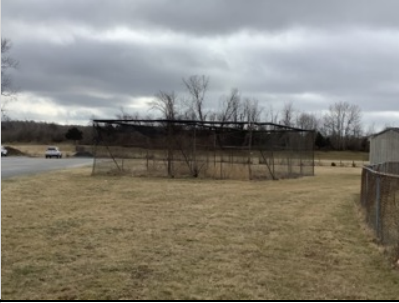
Practice areas are not on an accessible route No accessible route to all areas of sport activity	- -	Provide a stable, firm and slip resistant accessible route to batting cage practice areas. Install an accessible route between all areas of sports activity.	1	-	\$0
25	Northeast Baseball Field	Ext.		Field	Baseball

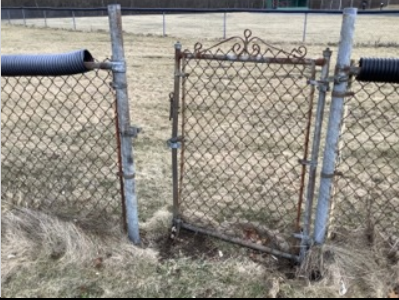
Accessibility issues include lack of an accessible route to the edge of sport activity (four (4) baseball fields, batting cages, two (2) multi-purpose fields), lack of at least a 30” by 48” stable, firm and slip-resistant area adjacent to the team seating area benches, and lack of a 36” by 60” stable, firm and slip-resistant area adjacent to two (2) sideline seating areas. Additionally, the gate at the southwest baseball field lacks a stable, firm and slip-resistant surface due to cardboard, and the gate at the northeast baseball field is not maintained in operable working condition due to the ground condition.

Field not maintained in operable working condition	-	Ensure the ground surface at the gate is maintained in operable working condition, to ensure the gate has ease of maneuverability and can open to 90 degrees.	1	Labor	\$0
