Freetown Police Station

Town of Freetown ADA Transition Plan

August 2023

Institute for Human Centered Design

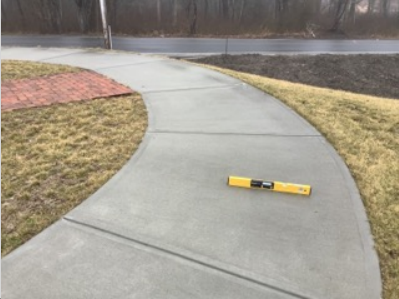
Cross slope > 1:50 (2.00%)	3%	Reduce cross slope to be no steeper than 1:50 (2.00%).	1	-	\$0
2	Parking Lot to Flag Pole	Ext.		Exterior Access Route	Walkway

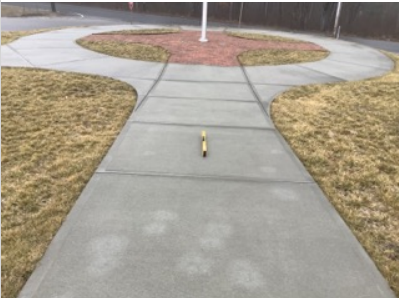
Running slope > 1:20 (5.00%)	6%	Reduce running slope to be no steeper than 1:20 (5.00%).	1	-	\$0
3	Route to Freetown Memorial Park	Ext.		Exterior Access Route	Exterior

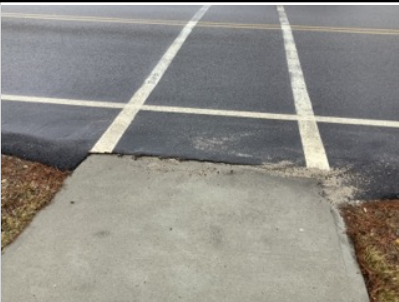
Route not maintained in operable working condition	-	Ensure the route is maintained in operable working condition by clearing the dirt and repairing the transition from the accessible route to the pedestrian street crossing.	1	Labor	\$0
Off-Street Parking Lot or Garage												
4	Parking Lot	Ext.		Off-Street Parking Lot or Garage	Visitor

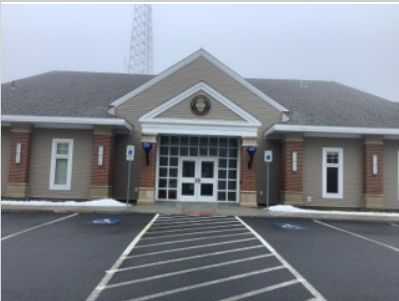
Total # of parking Total # of designated car accessible parking spaces Total # of designated van accessible spaces Sign top > 96" above finished grade	52 3 1 98"-99"	Locate sign with the top of the sign 96" above the ground at the accessible parking space.	2	Labor	\$0

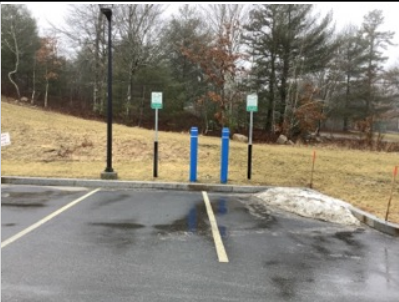
5	Electric Vehicle Parking	Ext.		Off-Street Parking Lot or Garage	Visitor

Vehicle charging station not on accessible route	-	Provide an accessible route to the electric vehicle charging station controls.	1	Labor	\$0

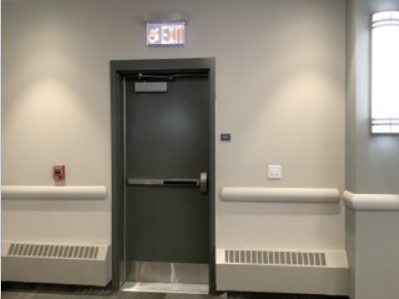
Illuminated ISA symbol not compliant (MAAB)	-	Provide an illuminated sign with the International Symbol of Accessibility (ISA) that is shown in 521 CMR: 41.1.3 and 2010 ADA: 703.7.2.1.	1	200	\$200
7	Main Egress Door	1		Means of Egress	N/A

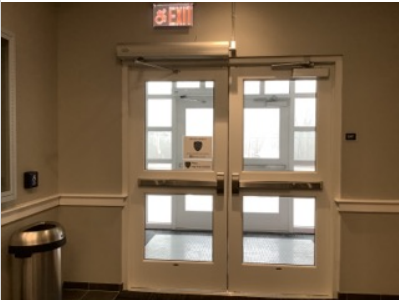
Illuminated ISA symbol not compliant (MAAB)	-	Provide an illuminated sign with the International Symbol of Accessibility (ISA) that is shown in 521 CMR: 41.1.3 and 2010 ADA: 703.7.2.1.	1	200	\$200
8	Main Egress Door	1		Means of Egress

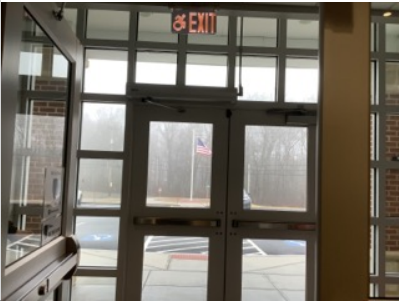
Illuminated ISA symbol not compliant (MAAB)		Provide an illuminated sign with the International Symbol of Accessibility (ISA) that is shown in 521 CMR: 41.1.3 and 2010 ADA: 703.7.2.1.	1	200	\$200

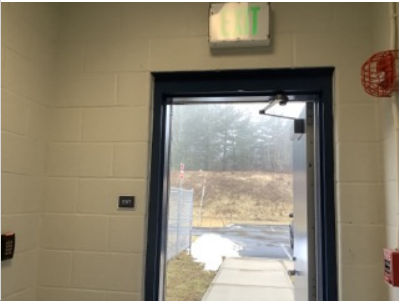
9	Egress Door, Mantrap Room	1	A162	Means of Egress	N/A

Illuminated ISA symbol not provided (MAAB)	-	Provide an illuminated sign with the International Symbol of Accessibility (ISA).	1	200	\$200
Interior Access Route												
10	Conference Room	1	A127	Interior Access Route	N/A

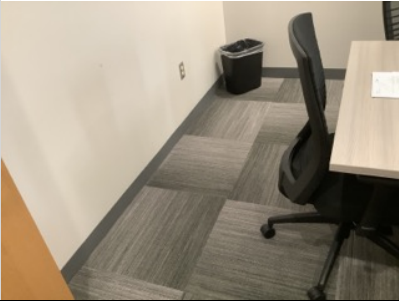
Route < 36" wide	34.5"	Ensure that a clear width of 36" min. is maintained at the accessible route.	1	Labor	\$0

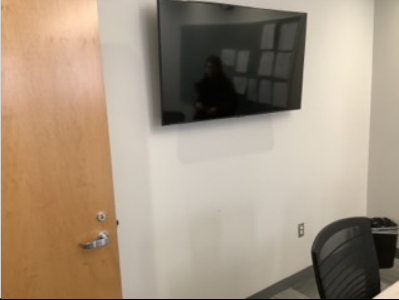
Obstructed by protruding objects	5"	Provide a cane-detectable barrier underneath the television.	1	306	\$306
Doors, Doorways, & Gates												
12	Public Interview Room	1	A119	Doors, Doorways, & Gates	Office

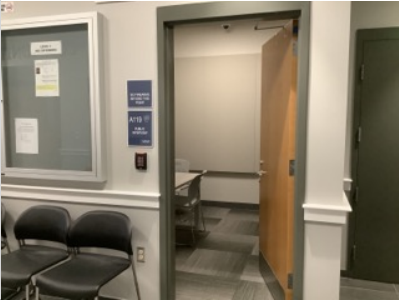
Maneuvering clearance(s) not provided Door requires > 5 lbs. of force to open	7" 10 lbs	Relocate the chair to provide maneuvering clearance at the push-side of the door. Adjust closers so doors do not require more than 5 pounds of force to open.	1	Labor	\$0
13	Community Room/Emergency Operations Center	1	A112	Doors, Doorways, & Gates	Meeting Room

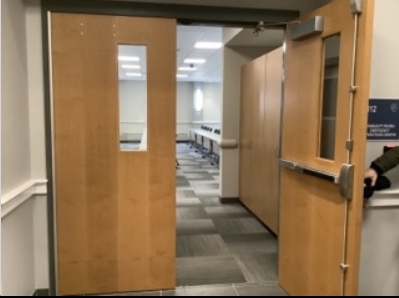
Door requires > 5 lbs. of force to open	10 lbs	Adjust closers so doors do not require more than 5 pounds of force to open.	1	Labor	\$0
14	Kitchenette	1	A113	Doors, Doorways, & Gates	Other

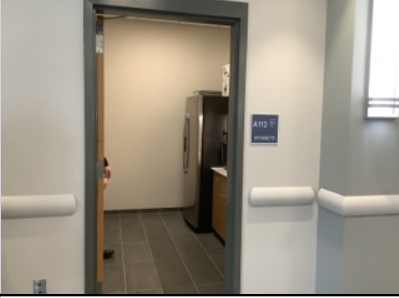
Door requires > 5 lbs. of force to open	13 lbs	Adjust closers so doors do not require more than 5 pounds of force to open.	1	Labor	\$0

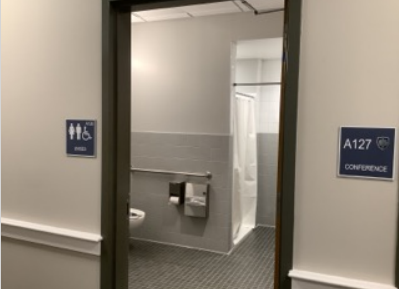
15	Single-User Toilet Room	1	A126	Doors, Doorways, & Gates	Toilet Room

Door requires > 5 lbs. of force to open	10 lbs	Adjust closers so doors do not require more than 5 pounds of force to open.	1	Labor	\$0

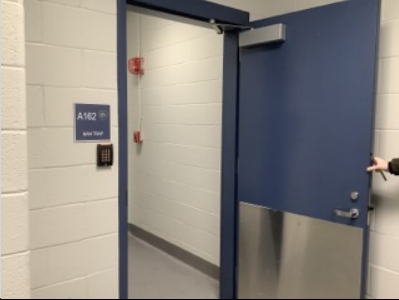
Door requires > 5 lbs. of force to open	8 lbs	Adjust closers so doors do not require more than 5 pounds of force to open.	1	Labor	\$0
17	Egress Door From the Mantrap	1	A162	Doors, Doorways, & Gates	Emergency Egress

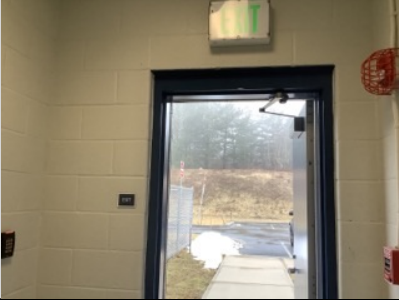
Door requires > 5 lbs. of force to open	11 lbs	Adjust closers so doors do not require more than 5 pounds of force to open.	1	Labor	\$0
18	Men's and Women's Single-User Toilet Room	1	A141, A142	Doors, Doorways, & Gates	Toilet Room

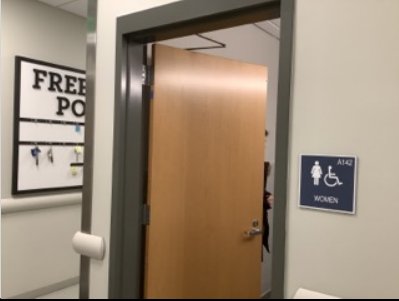
Door requires > 5 lbs. of force to open	10 lbs	Adjust closers so doors do not require more than 5 pounds of force to open.	2	Labor	\$0
19	Men's Single-User Toilet Room	1	A141	Doors, Doorways, & Gates	Toilet Room

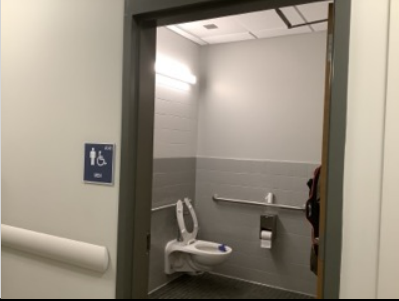
Door requires > 5 lbs. of force to open	9 lbs	Adjust closers so doors do not require more than 5 pounds of force to open.	1	Labor	\$0

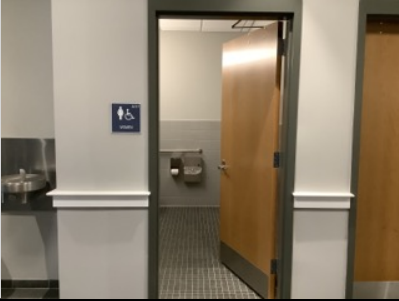
20	Women's Single-User Toilet Room	1	A117	Doors, Doorways, & Gates	Toilet Room

Door requires > 5 lbs. of force to open	10 lbs	Adjust closers so doors do not require more than 5 pounds of force to open.	1	Labor	\$0

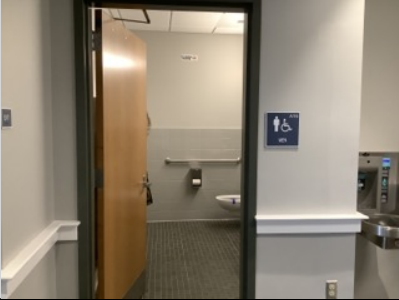
. Door requires > 5 lbs. of force to open	10 lbs	Adjust closers so doors do not require more than 5 pounds of force to open.	1	Labor	\$0
22	Main Egress	1		Doors, Doorways, & Gates	Emergency Egress

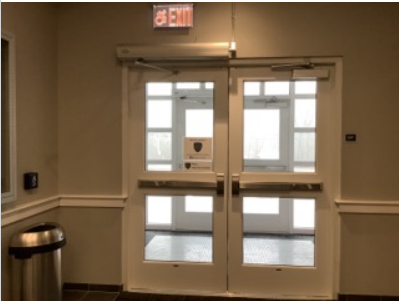
. Door requires > 5 lbs. of force to open Automatic door opener not operable Clear floor space at opener not provided	14 lbs - -	Adjust closers so doors do not require more than 5 pounds of force to open. Repair or replace the door opener. Relocate the trash can to provide a 30" x 48" clear floor space at automatic door opener.	1	Labor	\$0
Signage												
23	Administration	1		Signage	Designation

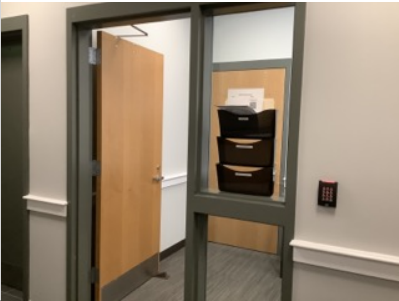
Signage is not provided	-	Provide a designation sign, located on the latch side of the door, that includes text with raised characters duplicated in braille on the sign.	1	232	\$232

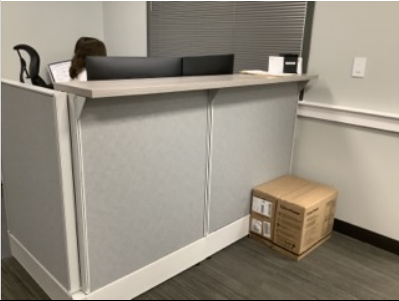
Service Counter												
24	Administration	1		Service Counter	N/A

Counter > 36" high	43.5"	Provide a counter that is 36" max. above the ground or finished floor.	1	880	\$880
Assembly Area												
25	Community Room/Emergency Operations Center	1	A112	Assembly Area	N/A

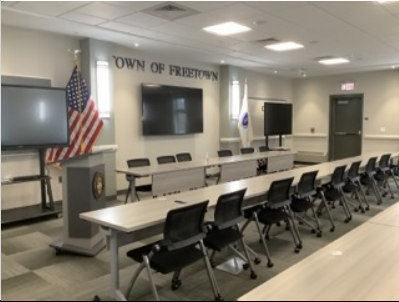
Accessibility issues include lack of an assistive listening system in the Community Room/Emergency Operations Center.

Assistive listening devices not provided	-	If audible communication is integral to the use of the space, provide an assistive listening system.	1	1214	\$1214

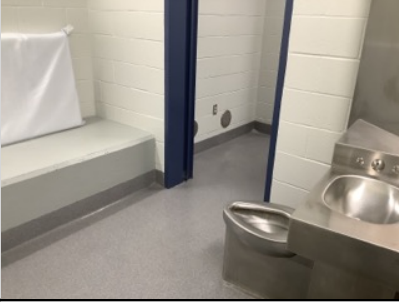
Mobility cell lacks clear floor space alongside bed Mobility cell lacks access to accessible toilet/lavatory	- -	The Town can achieve program access by making arrangements to transfer men, women and juveniles who need a mobility accessible holding cell to another Town or County holding cell that is accessible.	1	-	\$0
27	Sallyport - Eyewash Station and Emergency Shower	1	A175	Detention Facilities	N/A

***Note:** The Town can achieve program access by making arrangements to transfer men, women and juveniles who need a

mobility accessible holding cell to another Town or County holding cell that is accessible.

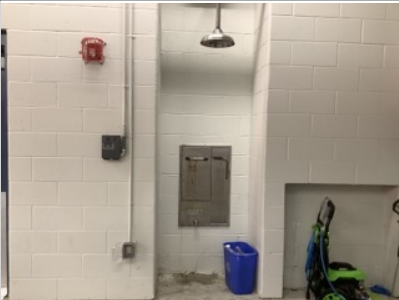
Lack of clear floor space at emergency shower	-	Relocate the trash can to provide a 30" by 48" clear floor space positioned for a forward approach at the emergency shower.	1	Labor	\$0
Toilet & Bathing Rooms												
Single-User Toilet												
28	Single-User Toilet Room	1	A126	Single-User Toilet	N/A

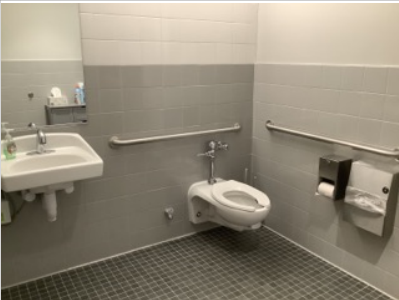
Accessibility issues at the single-user toilet room include lack of the minimum required clearance provided at the toilet.

Clearance at toilet < 60" clear width	57"	Relocate the lavatory to ensure that there is 60" wide min. clear floor space at the toilet.	1	3094	\$3094

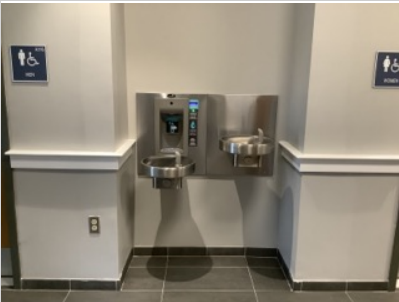
Additional Access												
Drinking Fountains												
29	By Men's and Women's Single-User Toilet Room	1		Drinking Fountains	Hi-Lo

Clear floor space not provided	-	Relocate the seated user drinking fountain to ensure that a 30" min. by 48" min. clear floor space positioned for a forward approach is centered at the drinking fountain.	1	2028	\$2028

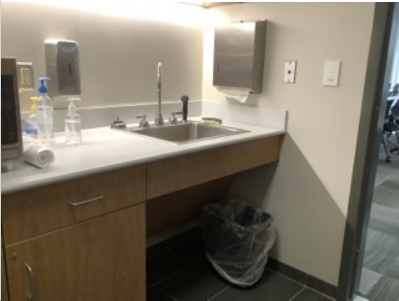
Clear floor space not provided at sink	-	Relocate the trash can to provide a 30" by 48" clear floor space positioned for a forward approach at the sink.	1	Labor	\$0
Best Practice												
31	Community Room/Emergency Operations Center	1	A112

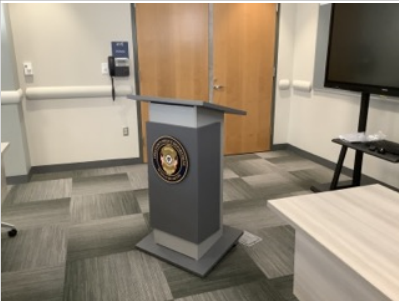
Recommend providing an adjustable height podium with knee and toe clearance.	1	-	\$0
Parking Lot												
32	Parking Lot	Ext.		Parking Lot	Visitor

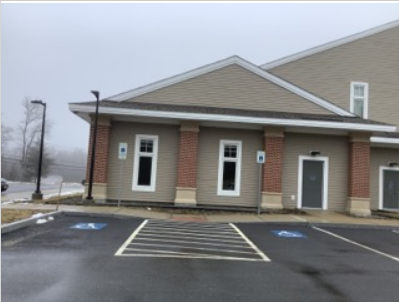
Recommend that both of the car and van accessible parking spaces on the west side of the building are relocated close to the main entrance to the police station.	1	-	\$0
33	Electric Vehicle Parking Spaces	Ext.		Parking Lot	Visitor

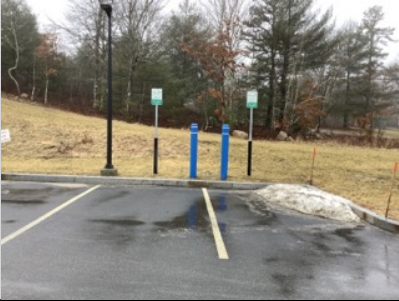
The ADA Standards do not include specific provisions for electric vehicle (EV) charging stations. However, it is advisable to address access to EV charging stations so that they are usable by people with disabilities. See https://www.access-board.gov/tad/ev/ for design recommendations.	1	-	\$0
