Freetown Highway Department

Town of Freetown ADA Transition Plan

June 2023

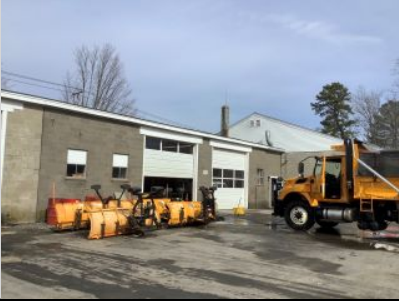
ID	Location	Floor	Room	Element	Type	Photo	Issues	Current Measure	Recommendations	Quantity	Price	Cost Estimation
Approach and Entrance												
Off-Street Parking Lot or Garage												
1	Parking Lot	Ext.		Off-Street Parking Lot or Garage	Visitor

Total # of parking Total # of designated car accessible parking spaces Total # of designated van accessible spaces Van space < 132" or <96" wide Access aisle < 96" wide at van space Access aisle does not adjoin an accessible route Sign with the International Symbol of Acc. not provided Sign does not have the designation "Van Accessible"	4 0 0 - - - - -	Provide a compliant van accessible parking space and marked access aisle, both at least 96" wide. Include an identification sign with the International Symbol of Accessibility (ISA), and the designation "Van Accessible". Ensure the bottom of the sign is located 60" min. from the ground. Ensure an accessible route is provided from the van accessible parking space to the office entrance.	1	1850	\$1850

- Provide a van accessible parking space: \$1,850
- Renovate door: \$2,232
- Renovate toilet room: \$8,246
- Miscellaneous corrective actions (designation signs, relocate protruding object): \$1,066

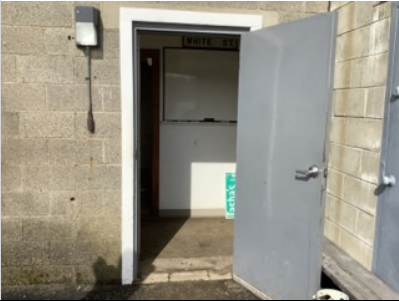
Entrance												
2	Main Entrance	Ext.		Entrance	Main Entrance

Accessibility issues include the door to the main entrance lacks the minimum required clear width.

Clear width at door is < 32"	31"	Install offset hinges to ensure that the door has a clear width of 32 inches.	1	2232	\$2232
Access to Goods and Services												
Interior Access Route												
3	By Office	1		Interior Access Route	N/A

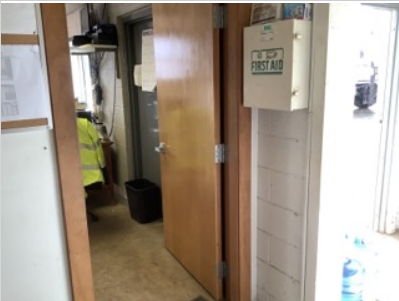
- The first aid kit outside of the office acts as a protruding object within the accessible route.

Obstructed by protruding objects	8"	Relocate first aid kit out of the circulation path.	1	256	\$256
Signage												
4	Office	1		Signage	Designation

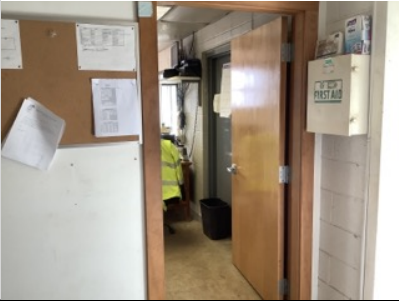
Signage is not provided	-	Provide a designation sign, located on the latch side of the door, that includes text with raised characters duplicated in braille on the sign.	1	232	\$232

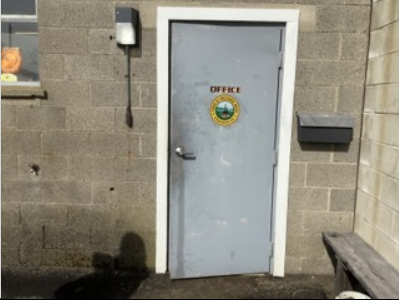
ID	Location	Floor	Room	Element	Type	Photo	Issues	Current Measure	Recommendations	Quantity	Price	Cost Estimation
5	Main Entrance	Ext.		Signage	Designation

Signage is not provided	-	Provide a designation sign, located on the latch side of the door, that includes text with raised characters duplicated in braille on the sign.	1	346	\$346
6	Single-User Toilet Room	1		Signage	Designation

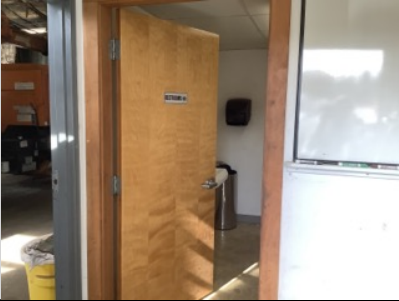
Raised characters not provided on sign Braille not provided on sign Sign not located on the latch side of the door	- - -	Provide a designation sign, located on the latch side of the door, that includes text with raised characters duplicated in braille on the sign.	1	232 Labor	\$232
Toilet & Bathing Rooms												
Overall Access												
7	Single-User Toilet Room	1		Overall Access	Toilet Room

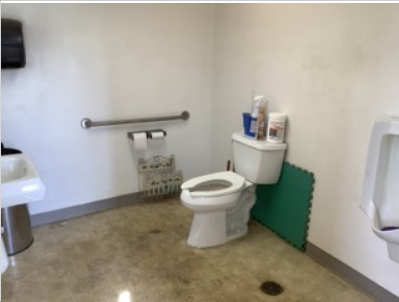
Audible and visible alarm not provided	- -	When fire system is updated, ensure that a visible and audible fire alarm is installed.	1	-	\$0

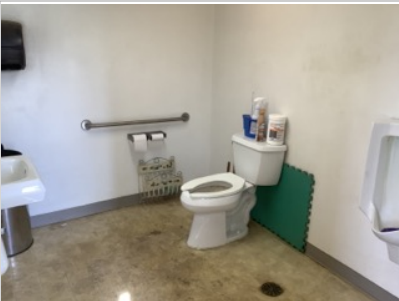
Single-User Toilet												
8	Single-User Toilet Room	1		Single-User Toilet	N/A

Flush control not on open side Centerline < or > 18" (MAAB) Grab bar not provided Side grab bar < 54" from back wall Side or rear grab bar < 33" or > 36" high	- 35.5" - 47.25 32"	Relocate the flush control to the open side Relocate toilet so that the centerline is 18" from the side wall. Provide a rear wall grab bar that is 42" long min. and extends from the toilet 12" min. on one side and 24" min. on the other side (open side) and provide a side wall grab bar that is 42" long min. located 12" max. from the rear wall. Mount both grab bars 33"- 36" above the finished floor.	1	4998	\$4998

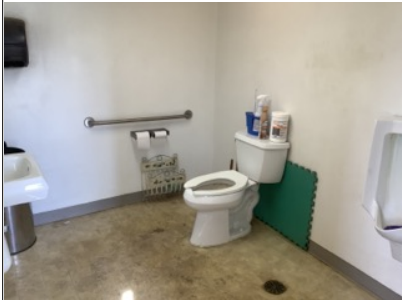
ID	Location	Floor	Room	Element	Type	Photo	Issues	Current Measure	Recommendations	Quantity	Price	Cost Estimation
Urinal												
9	Single-User Toilet Room	1		Urinal	N/A

Rim > 17" high	- -	Provide at least one urinal with the rim no higher than 17" above the finished floor.	1	3248	\$3248
Dispensers												
10	Single-User Toilet Room	1		Dispensers	Paper Towel Dispenser

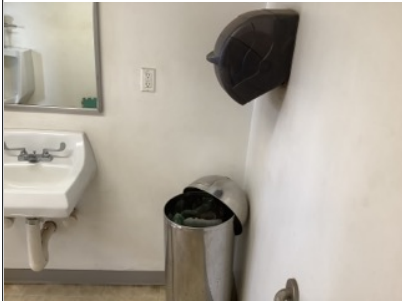
Dispenser acts as a protruding object	9.5"	Relocate dispenser out of the circulation path or relocate the trash can underneath the dispenser to act as a cane-detectable barrier.	1	Labor	\$0
