# Freetown Fire Station Number 3

## Town of Freetown ADA Transition Plan

April 2023

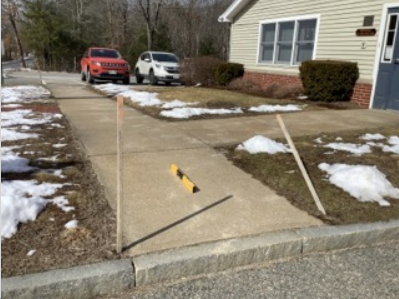
ID	Location	Floor	Room	Element	Type	Photo	Issues	Current Measure	Recommendations	Quantity	Price	Cost Estimation
Approach and Entrance												
Exterior Access Route												
1	Truck Bays to Main Entrance	Ext.		Exterior Access Route	Walkway

Running slope > 1:20 (5.00%) Accessible route not provided	5.8% -	Reduce running slope to be no steeper than 1:20 (5.00%). Ensure an accessible route is provided from the truck bays to the main entrance. (Cost estimate provided for a standard concrete curb ramp.)	1	2800	\$2800
Off-Street Parking Lot or Garage												
2	Parking Lot	Ext.		Off-Street Parking Lot or Garage	Visitor

Accessibility issues include an excessive running slope at the walkway and lack of an accessible route to the fire truck bays.

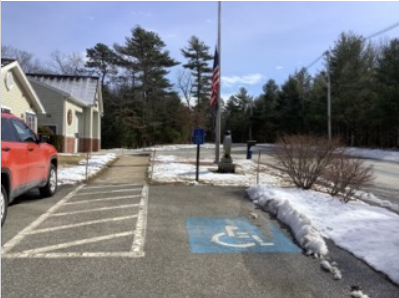
Total # of parking Total # of designated car accessible parking spaces Total # of designated van accessible spaces Access aisle < 96" wide at van space Sign does not have the designation "Van Accessible" Sign bottom < 60" above finished grade	5 1 - 61" - 41.5"	Restripe the access aisle to provide a marked access aisle that is at least 96" wide. Ensure the van accessible space is at least 96" wide min. Add the designation "Van Accessible" to the sign located at the van accessible space. Locate sign with the bottom of the sign 60" above the ground.	1	800 Labor	\$800

Accessibility issues include lack of a compliant van accessible parking space. The easiest way to address this would be to enlarge the access aisle to be 96” min. while ensuring that the van accessible parking space is no less than 96” min. Additionally, the space is lacking a sign with the designation “Van Accessible” and the existing sign is located lower than allowed.

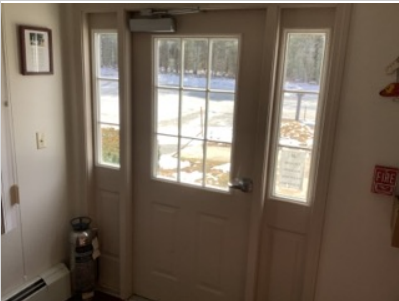
Access to Goods and Services												
Means of Egress												
3	Main Entrance	1		Means of Egress	N/A

Tactile exit sign not provided	-	Ensure that a tactile exit sign with raised characters and braille is provided at the exit door. Mount the sign between 48"- 60" above the finished floor located on the latch side of the door.  When or if an illuminated exit sign is provided, provide an illuminated sign with the International Symbol of Accessibility (ISA).	1	232	\$232
Interior Access Route												
4	Lobby	1		Interior Access Route	N/A

Accessibility issues include lack of a tactile sign (with braille and raised characters) at the emergency egress and lack of a compliant designation sign (with braille and raised characters) at the main entrance on the latch side of the door.

**Note:** When or if an illuminated exit sign is provided, provide an illuminated sign with the International Symbol of Accessibility (ISA).

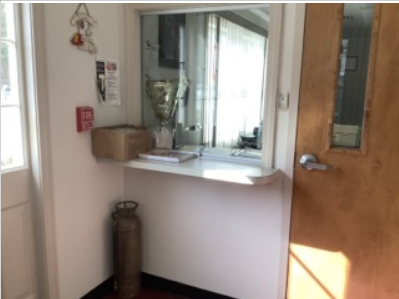
Obstructed by protruding objects	5"	Provide a cane-detectable barrier underneath the counter on the open side.	1	306	\$306

- The service counter in the lobby is located higher than allowed and acts as a protruding object.

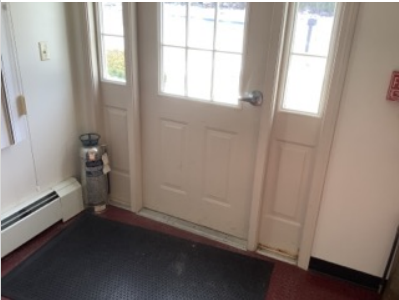
ID	Location	Floor	Room	Element	Type	Photo	Issues	Current Measure	Recommendations	Quantity	Price	Cost Estimation
Doors, Doorways, & Gates												
5	Main Entrance	1		Doors, Doorways, & Gates	Circulation

Mat not securely attached	-	Secure the mat at the egress door.	1	Labor	\$0
Signage												
6	Main Entrance	Ext.		Signage	Designation

- Secure one (1) mat at the main egress door.

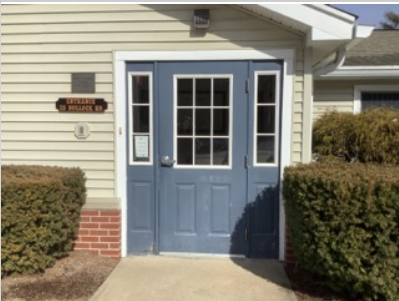
Raised characters not provided on sign Braille not provided on sign	- -	Provide a designation sign, located on the latch side of the door, that includes text with raised characters duplicated in braille on the sign.	1	232	\$232
Service Counter												
7	Lobby	1		Service Counter	N/A

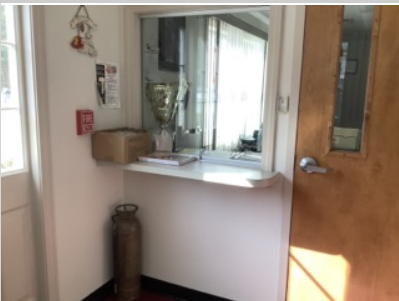
Counter > 36" high	38"	Provide a counter that is 36" max. above the finished floor.	1	880	\$880
