# Freetown Service Memorial Park

## Town of Freetown ADA Transition Plan

August 2023

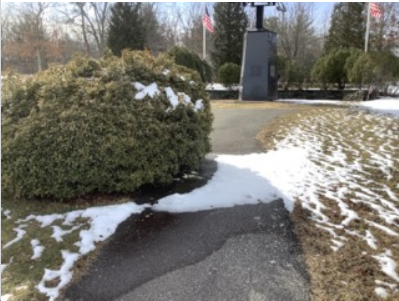
Exterior route < 48" wide	33"	Trim the bushes to ensure that a clear width of 48" min. is maintained at the accessible route.	1	Labor	\$0
2	Route to Memorial	Ext.		Exterior Access Route	Walkway

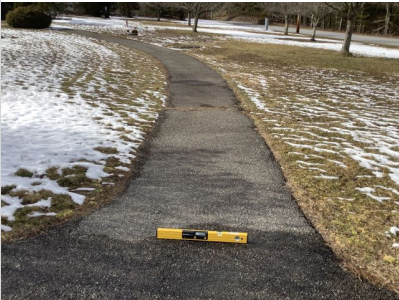
Surface openings > 1/2" Cross slope > 1:50 (2.00%)	7" 3.3%	Repair the surface.. Reduce the cross slope to be no steeper than 1:50 (2.00%).	1	3162	\$3162
3	Route to Helicopter Memorial	Ext.		Exterior Access Route	Walkway

- Renovate van accessible parking space: \$800
- Renovate the curb ramp leading to the police station: \$3,900
- Renovate a route to the helicopter memorial: \$3,162

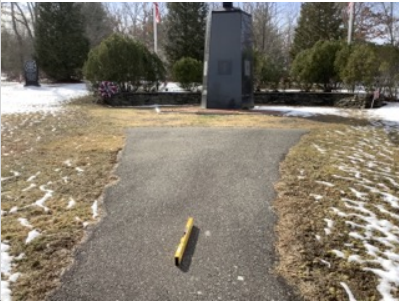
Running slope > 1:20 (5.00%)	6.6%	Reduce the running slope to be no steeper than 1:20 (5.00%).	1	-	\$0
4	Bench Memorial Area Near Memorial Drive	Ext.		Exterior Access Route	Exterior

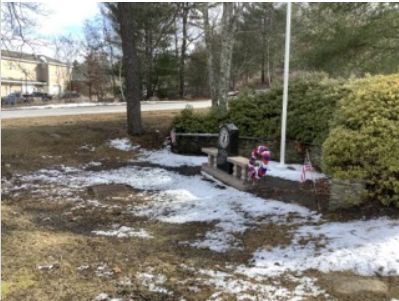
Accessible route not provided	-	Ensure an accessible route is provided to the benches and memorial.	1	-	\$0

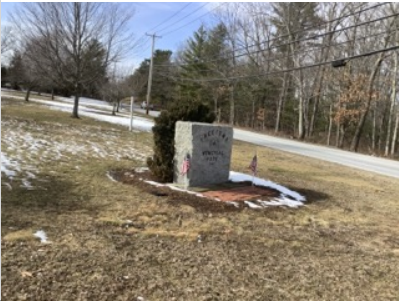
5	Memorial Near Intersection of Chace Road and Memorial Drive	Ext.		Exterior Access Route	Exterior

Accessible route not provided	-	Ensure an accessible route is provided to the memorial near Chace Road.	1	-	\$0

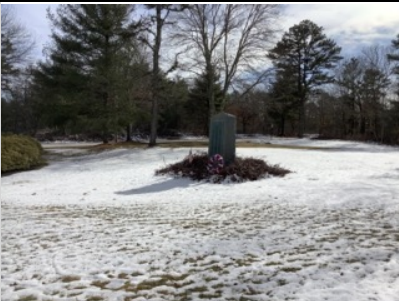
Accessible route not provided	-	Ensure an accessible route is provided to the memorial.	1	-	\$0
7	Memorial Near Parking Lot	Ext.		Exterior Access Route	Exterior

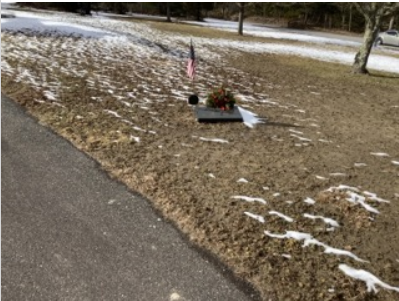
Accessible route not provided	-	Ensure an accessible route is provided to the memorial.	1	-	\$0
8	Memorials	Ext.		Exterior Access Route	Exterior

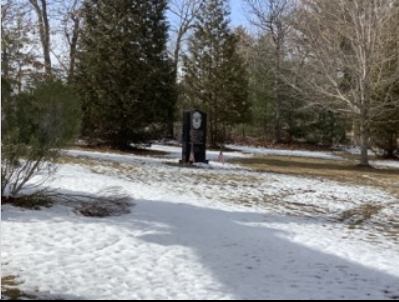
Accessible route not provided	-	Ensure an accessible route is provided to the memorial.	2	-	\$0
Curb Ramp												
9	Route to Police Station	Ext.		Curb Ramp	Parallel

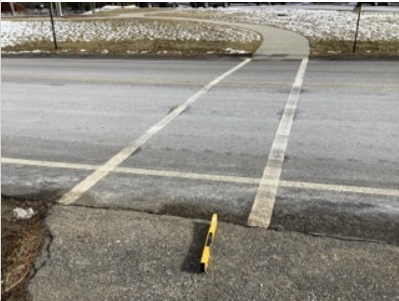
Running slope is > 1:12 (8.33%)	11.8%	Reduce running slope to be no steeper than 1:12 (8.33%).	1	3900	\$3900
Off-Street Parking Lot or Garage												
10	Parking Lot	Ext.		Off-Street Parking Lot or Garage	Visitor

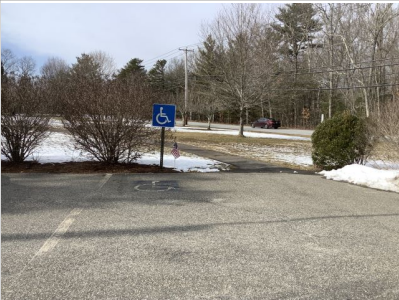
Accessibility issues at the van accessible parking space include lack of a marked access aisle, lack of the designation “Van Accessible”, and the identification sign with the International Symbol of Accessibility (ISA) is mounted lower than the minimum height allowed.

Total # of parking Total # of designated car accessible parking spaces Total # of designated van accessible spaces Access aisle not provided Sign does not have the designation "Van Accessible" Sign bottom < 60" above finished grade	5 - 1 - - 45.5"	At the van accessible parking space provide a marked access aisle that is at least 96" wide. Add the designation "Van Accessible" to the sign located at the van accessible space. Locate sign with the bottom of the sign 60" above the ground.	1	800 Labor	\$800

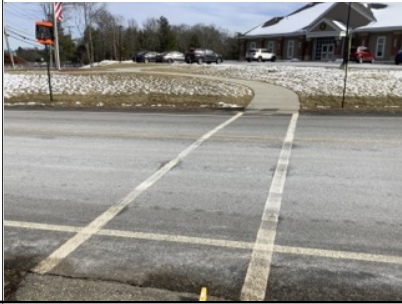
Recommend striping the pedestrian walkway to the police station along Memorial Drive.	1	-	\$0

- Recommend striping the pedestrian walkway to the police station along Memorial Drive.
