February 21, 2023
Town of Freetown
Debbie Pettey, Town Administrator

Review Of Council on Aging Building:

ACG recently visited the site of the current “Town Hall Building”. Not much has changed since our initial survey of 2014. The building is a typical 1830 wood frame construction placed on a rubble stone foundation. The lot is small and has limited parking.

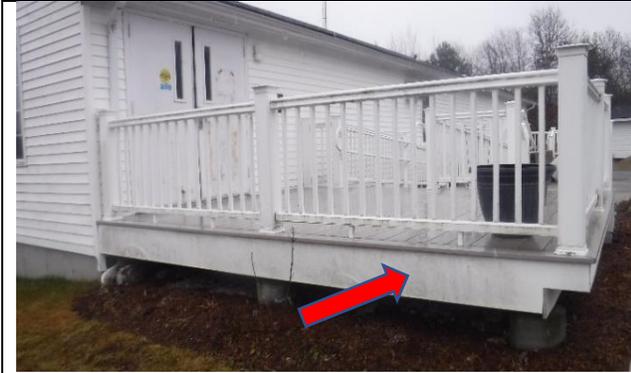
- Front gutter is sagging on rotted fascia boards
- Rake edges, wood trim paint peeling and wood decay
- Decks are in newer condition some mildew
- Recreation Room deck railings at bottom of ramp missing 2 end caps

Recreation Room deck mold, mildew

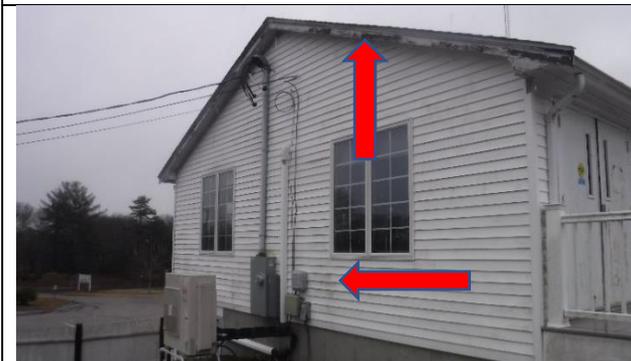
Rake edge peeling paint, rotted wood, siding mold

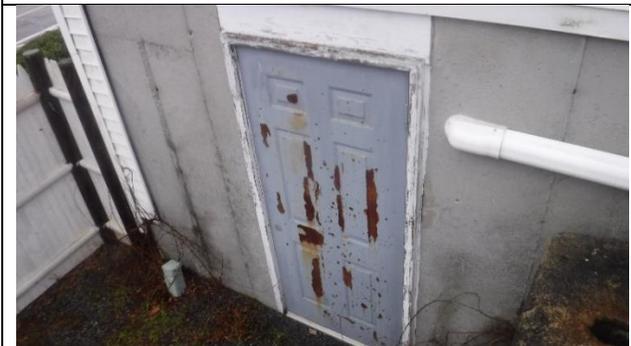
- Reception door opens when windy door open alert goes off all day
- Metal doors are significantly rusted

Rusted door

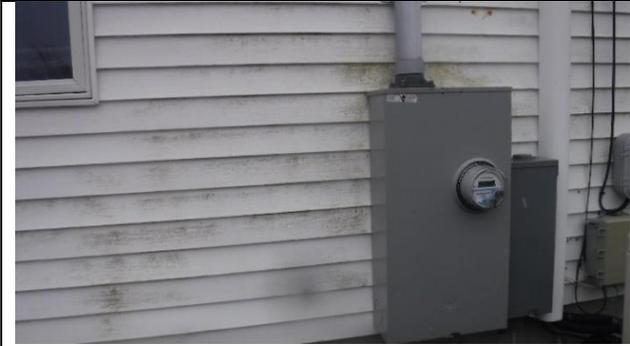
- Septic system occasionally gets pumped out
- Front double doors corroded at bottom, duct taped in 2 places
- Front of building loose vinyl siding gap,
- Areas of mold mildew on siding all sides,

Mold, mildew on siding

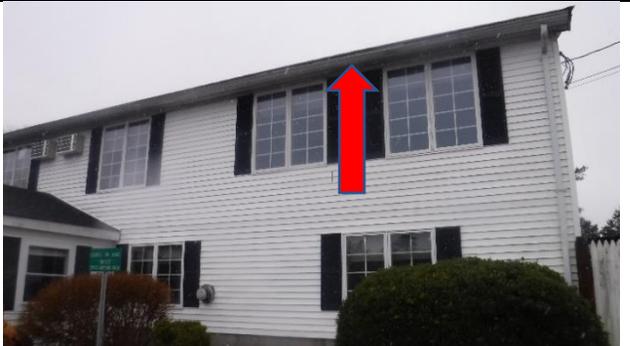
Gutter sagging

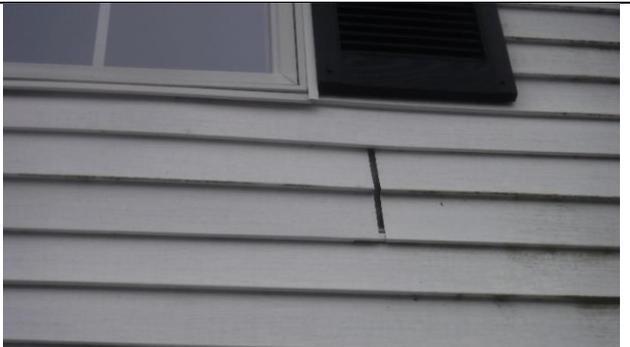
Gap in vinyl siding close up

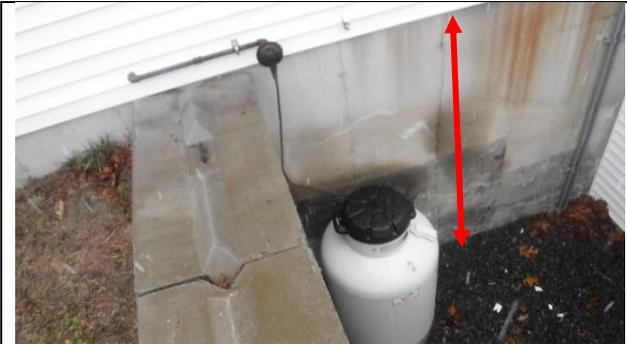
Propane tank against building and 9 foot drop

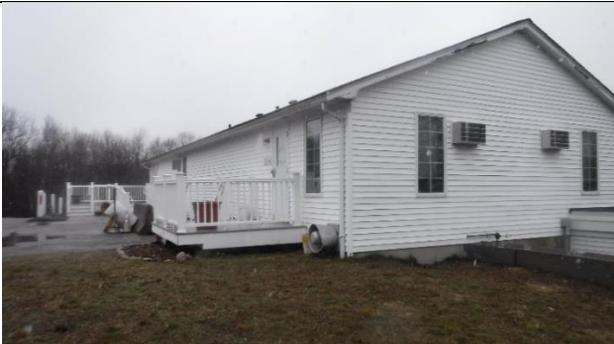
North side rake edge rotted, mold, mildew

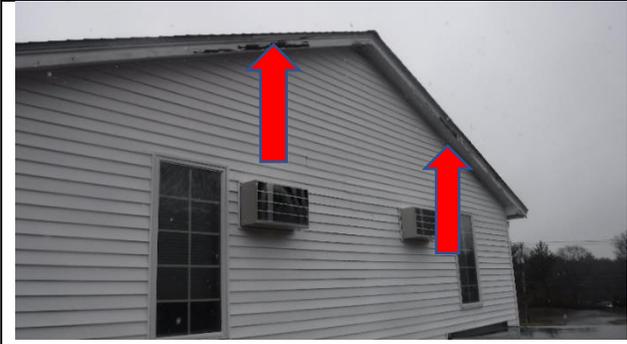
Rake edge peeling paint, rot, close up

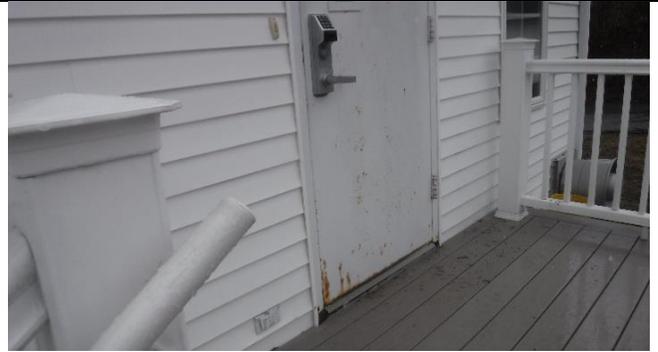
Reception entrance door opens and closes by wind

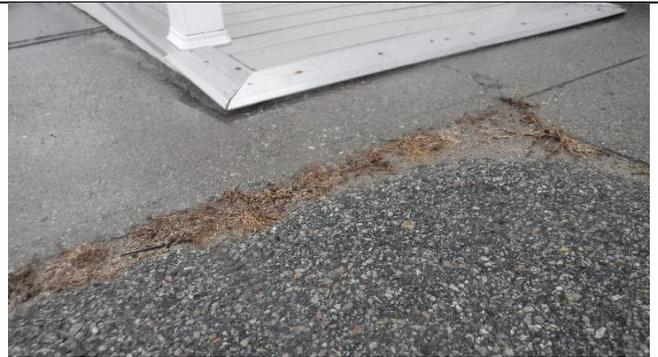
Raised metal, trip hazard

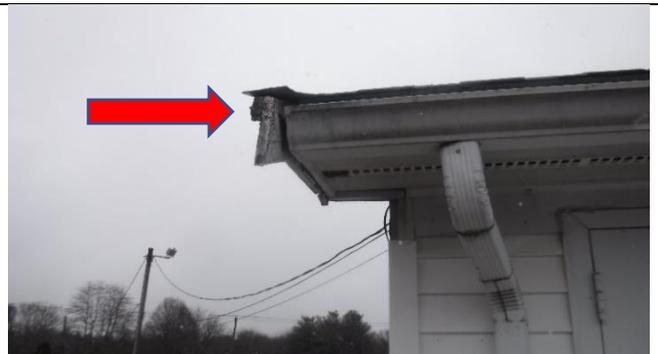
Northwest corner rake edge decay

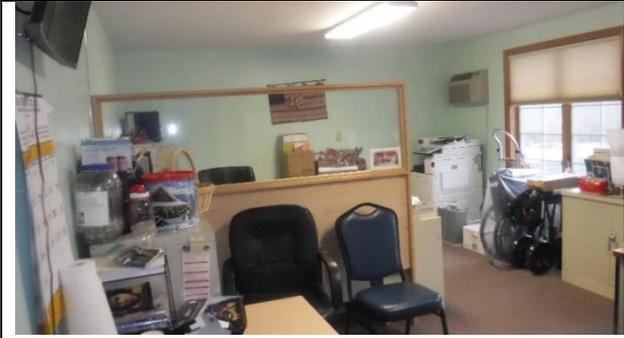
Senior clerks office lack of space

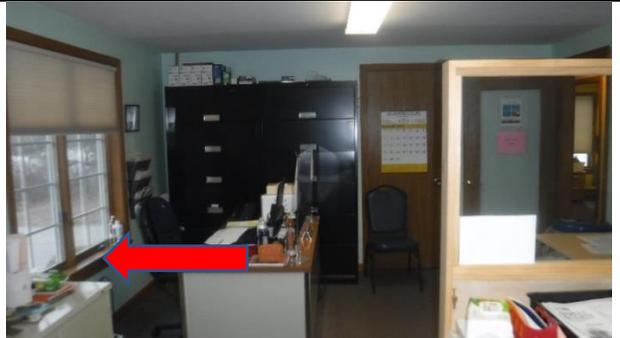
- Senior Clerk Office windows don't open – hardware worn out, stripped
- Interior stairs to lower level are unfinished
- Lower bathrooms and both kitchens wooden wall base need sanitary vinyl wall base

Senior Clerks Office window handle stripped

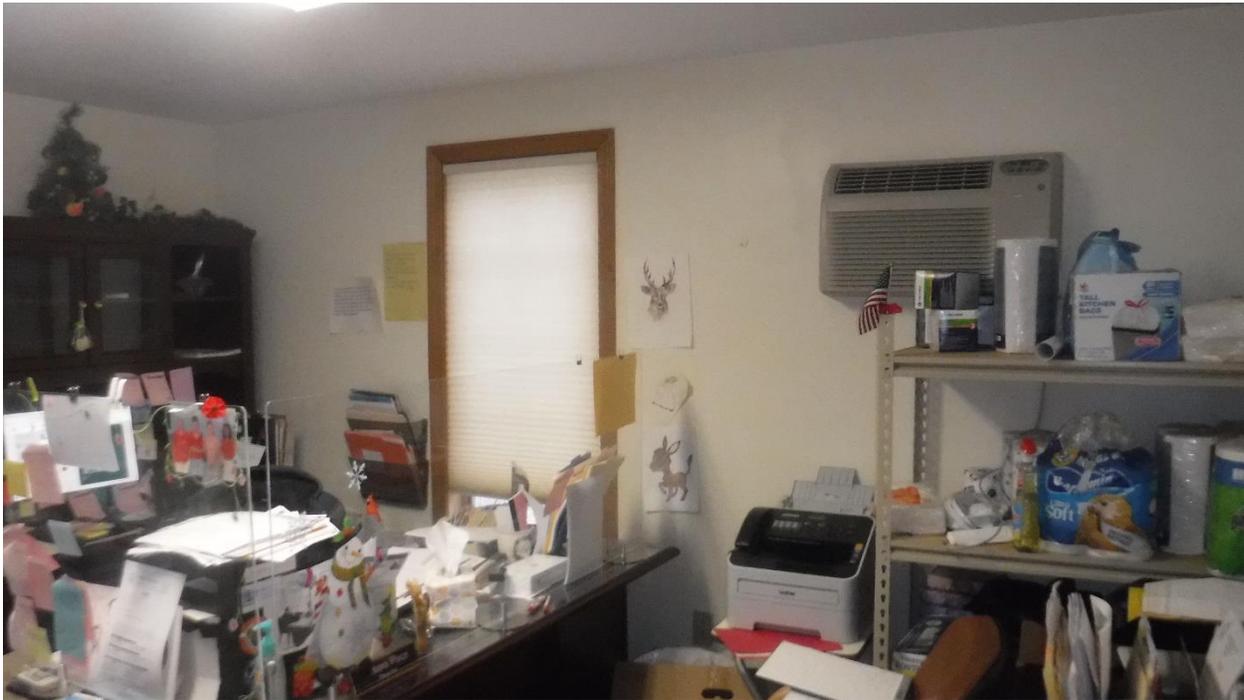
Directors Office lack of space

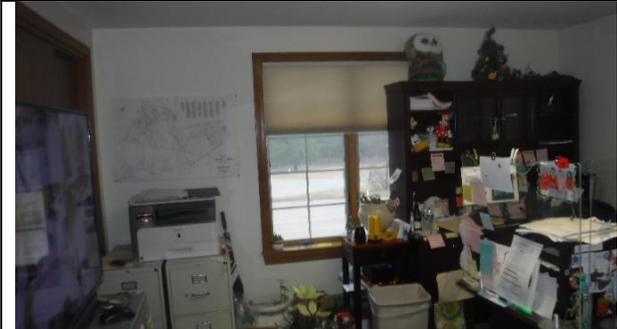
Directors Office lack of workspace

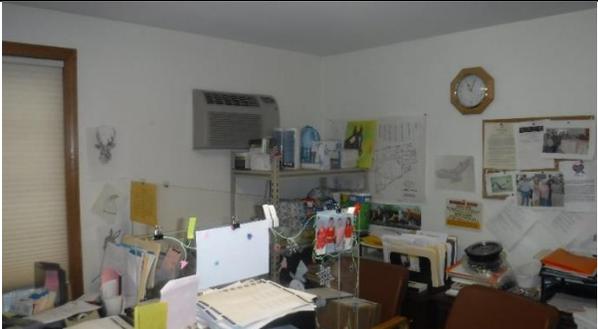
Directors Office no privacy for food stamp clients

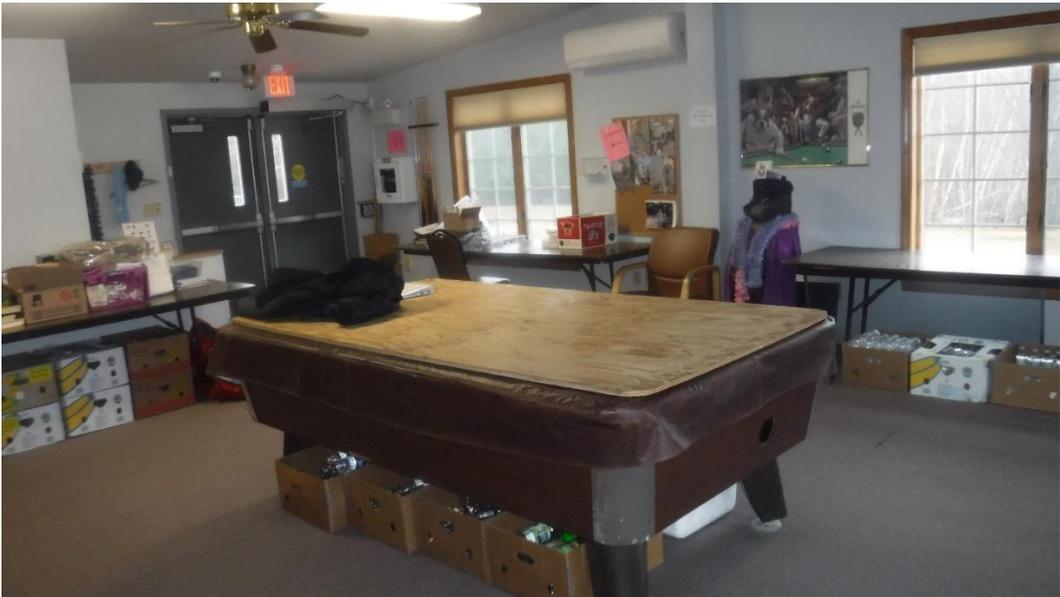
Recreation Room storage under tables and pool table

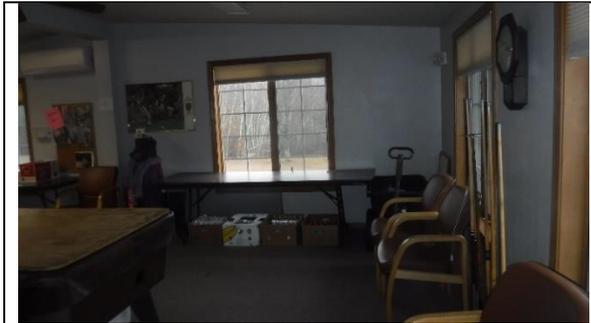
Small Recreation Room storage under tables

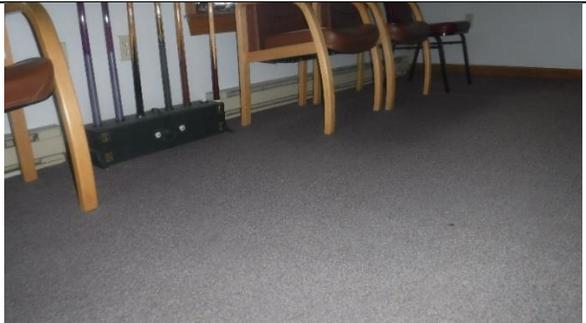
- a) Space: Inadequate working, meeting (privacy) and storage space.
- b) Heating/Cooling Systems: The building is not adequately climate controlled. Electric heaters and individual air conditioners are currently in place. A central air unit would work better.

Base board electric heat

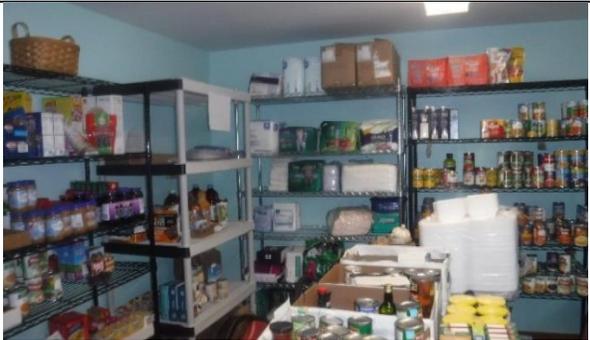
Makeshift shelving

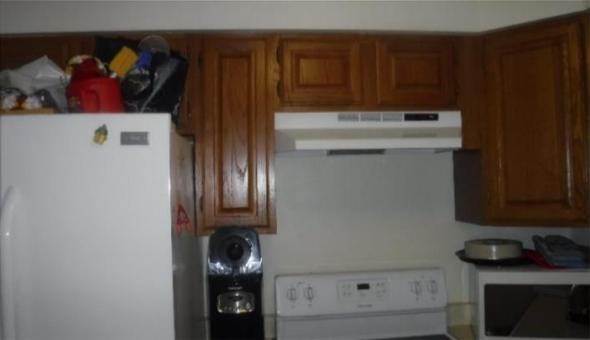
Kitchen lack of storage

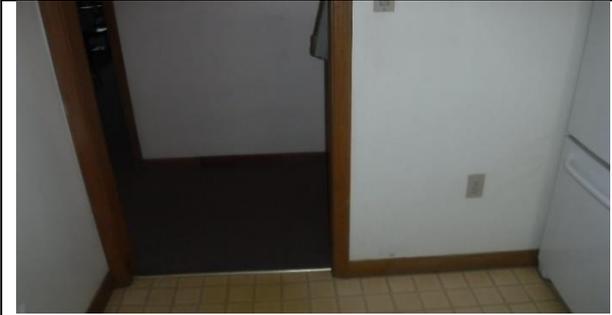
Kitchen wooden wall base

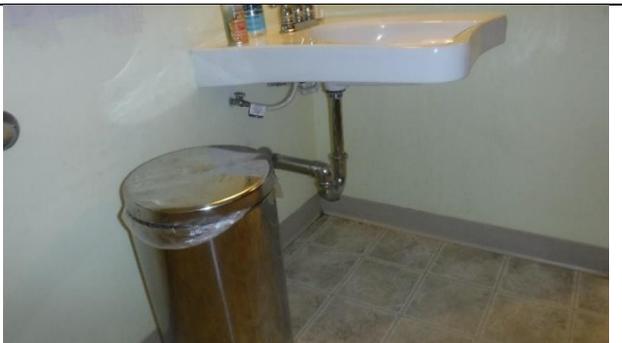
- Bathroom sinks all non ADA compliant
- Acoustical ceiling some tiles stained grid sagging in areas
- Lower kitchen partially covered wall receptacle
- Kitchen too small

ADA non-compliant sink

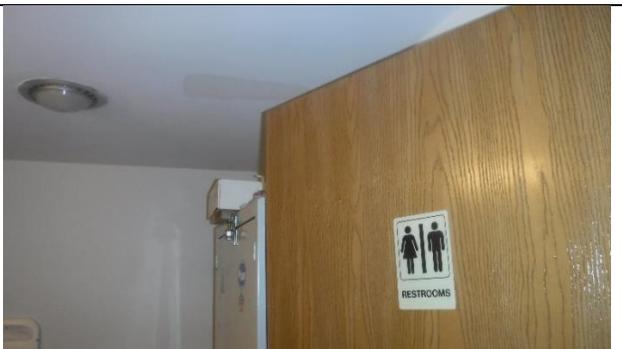
Rest room 2 stain on ceiling

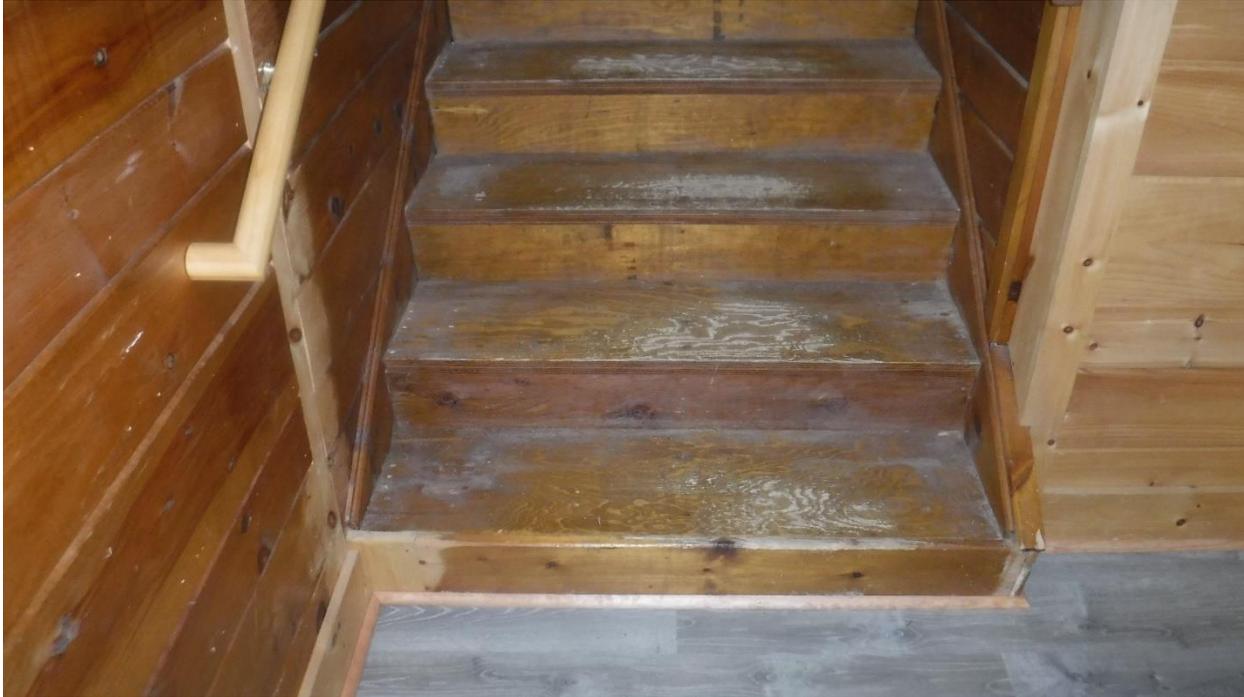
Landing, unfinished wood stairs

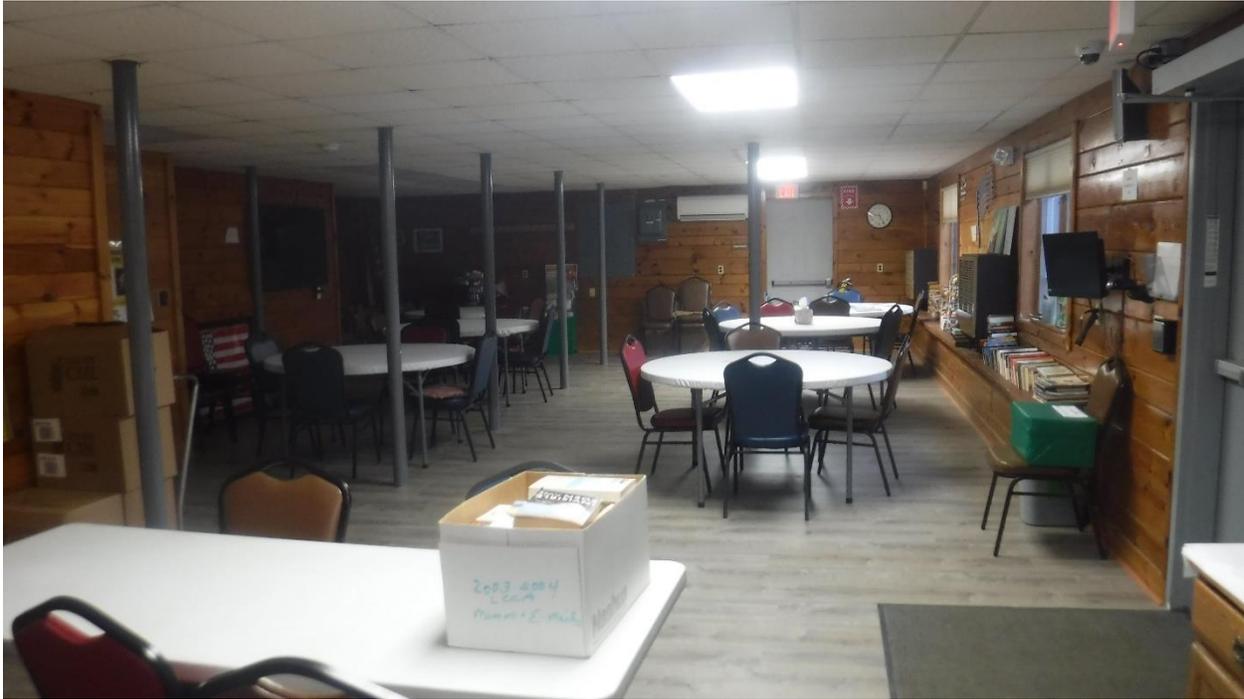
Small 1st Floor activity area lally columns restrict use of space

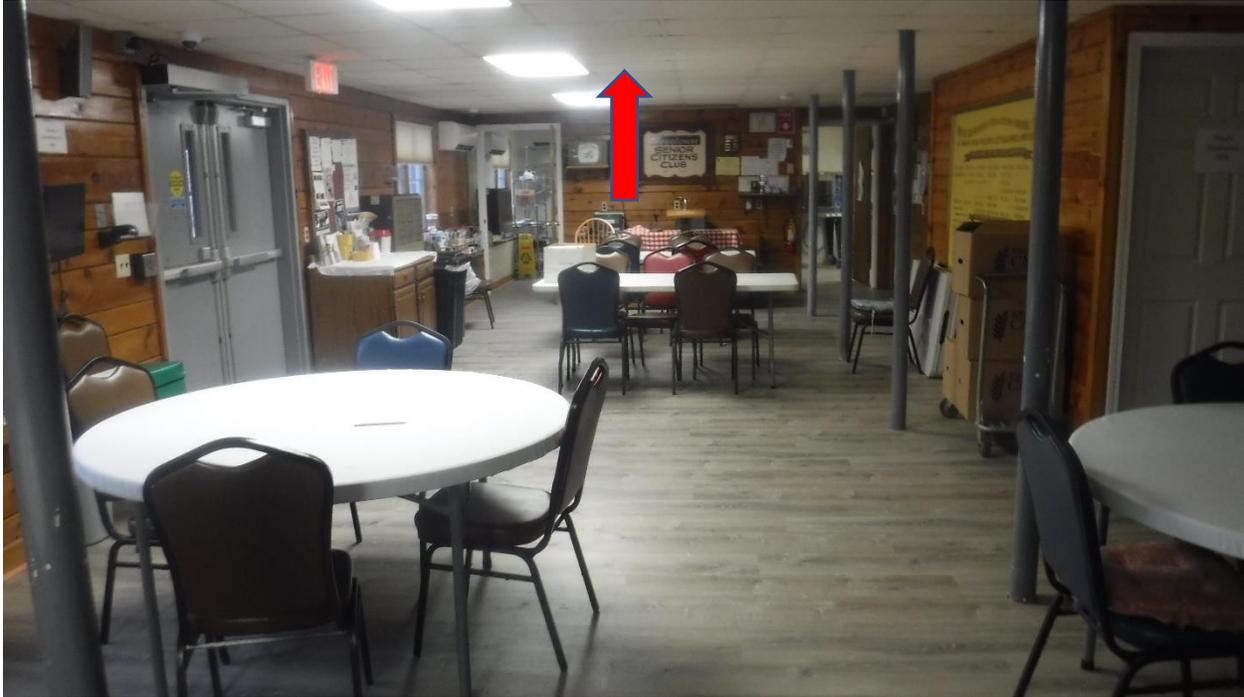
1st Floor small activity area ceiling grid sagging in some areas

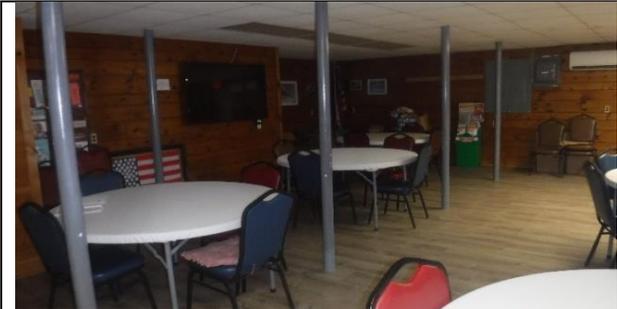
Lally columns no pole padding

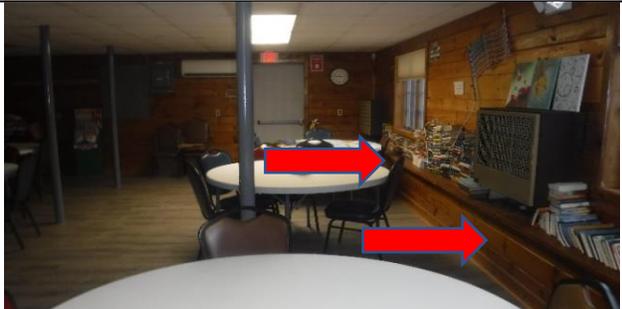
Lack of storage space

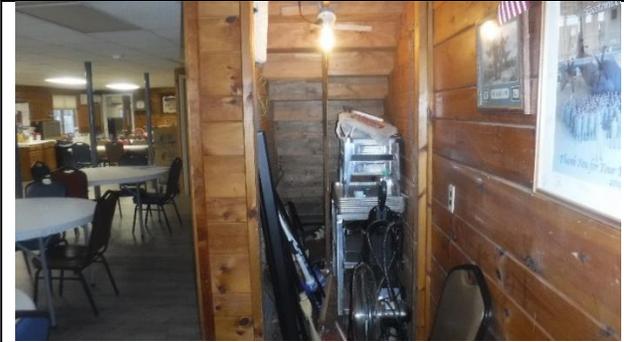
Under stairs insufficient storage

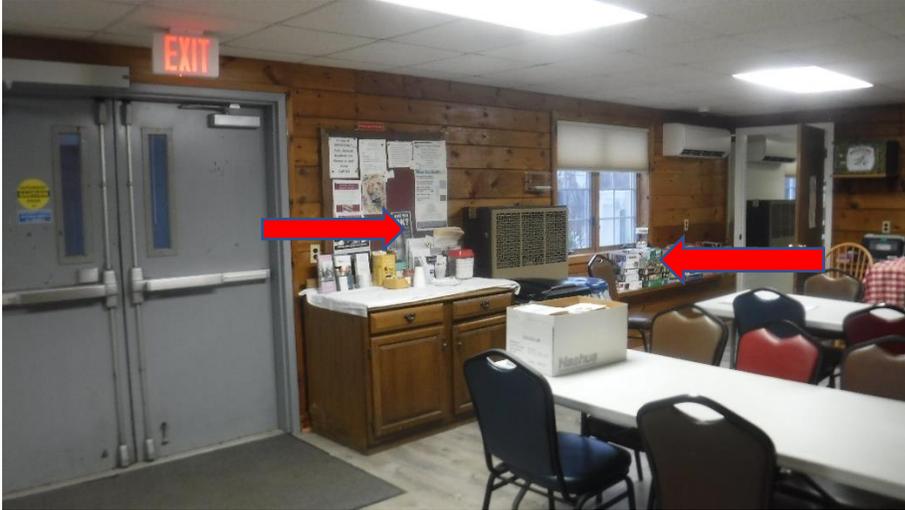
Books, puzzles, games stored below window no shelves. Old unused heaters

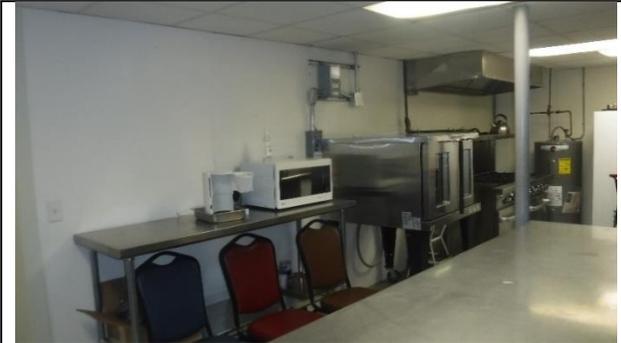
Oven not properly vented

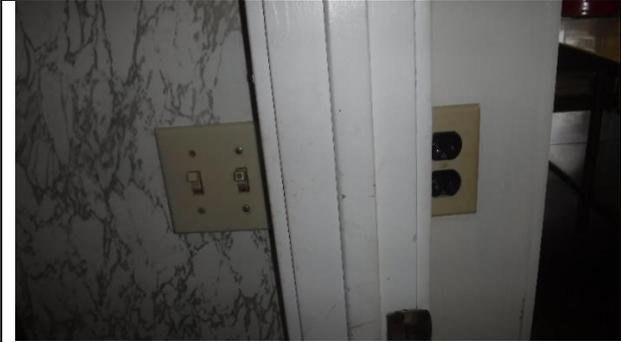
Partially covered receptacle

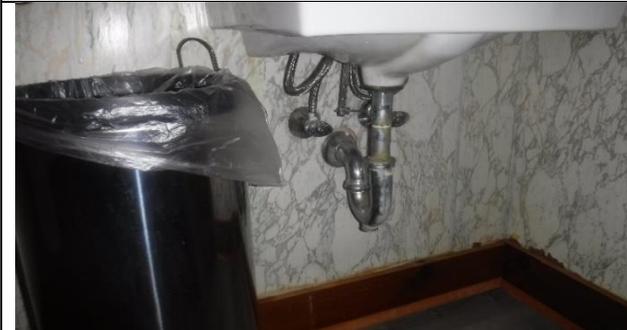
1st Floor rest room 1 ADA non-compliant sink

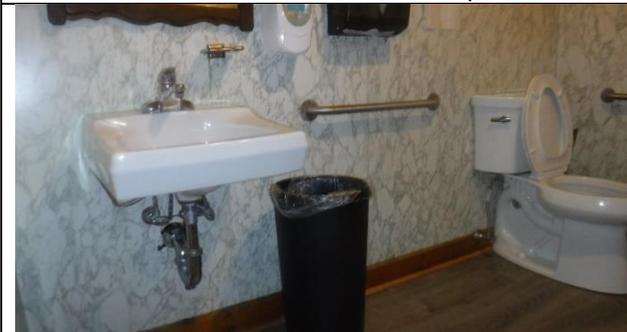
1st Floor rest room 2 sink ADA non-compliant

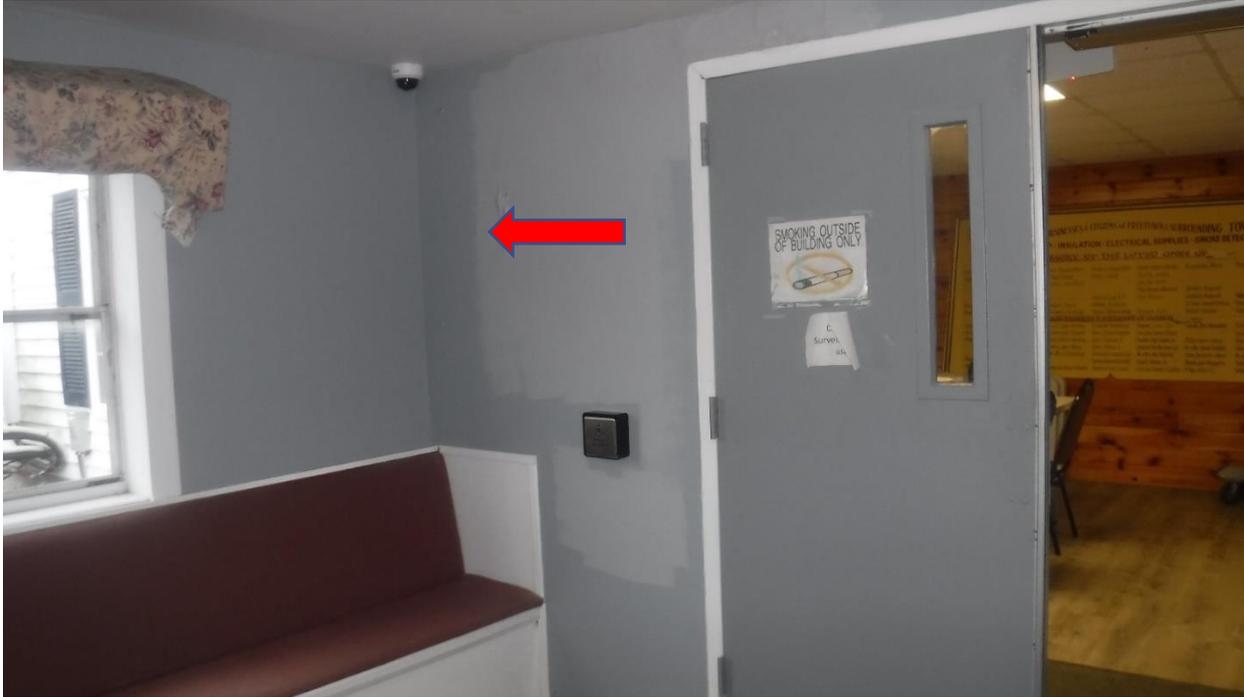
Vestibule peeling paint, drywall in disrepair

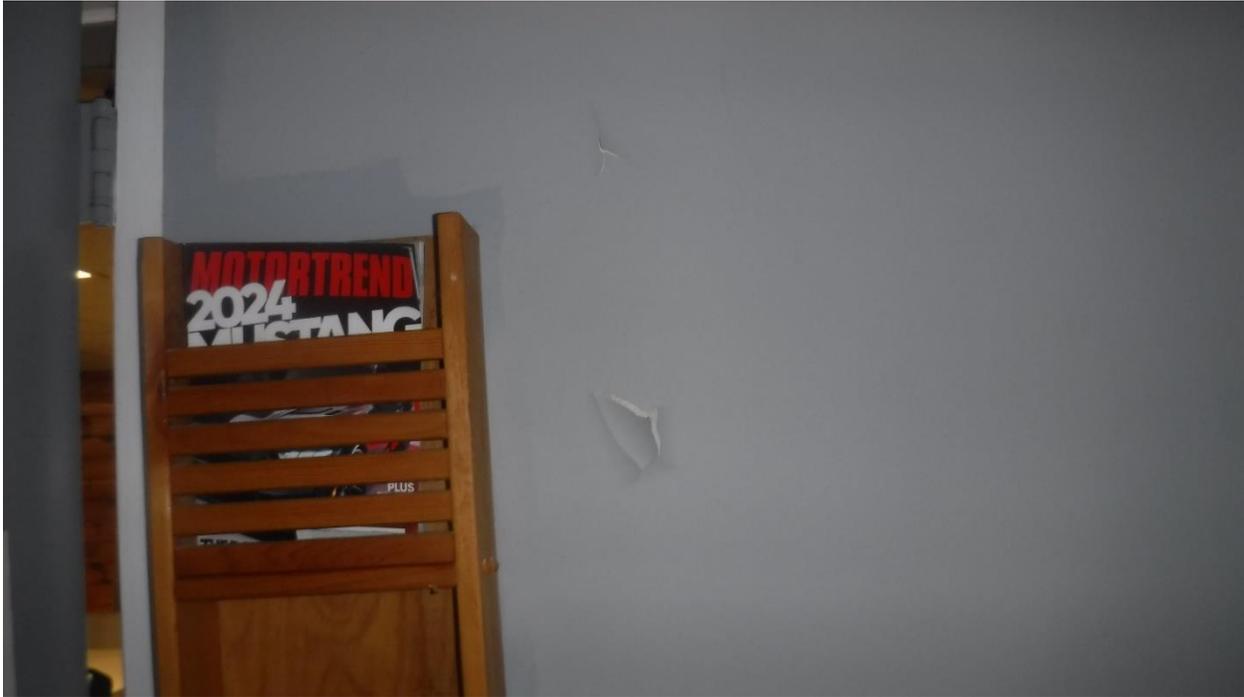
Vestibule close up view paint peeling

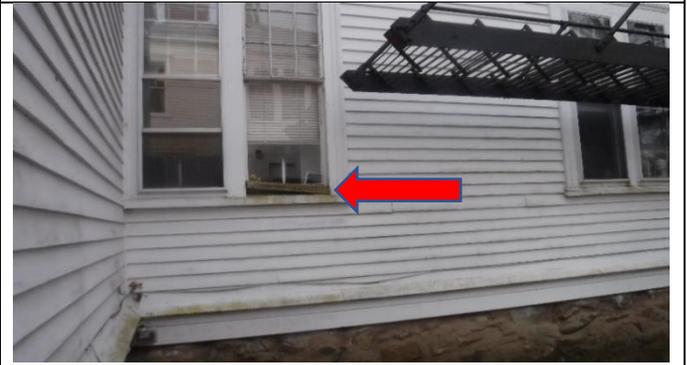
Old windows in disrepair

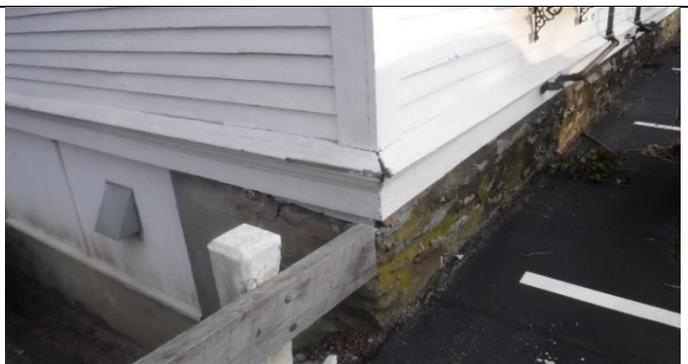
Mitered corner wood decaying

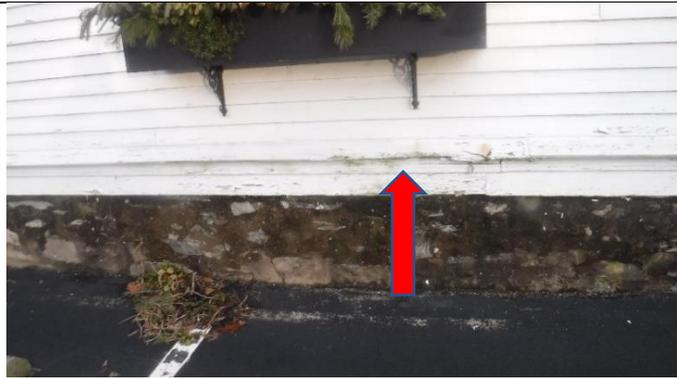
Damaged wood trim

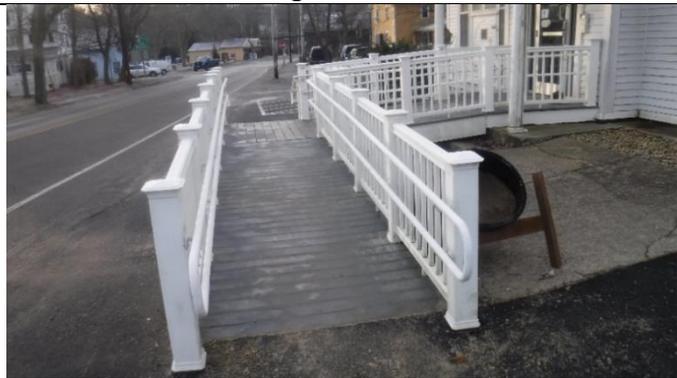
Front Entrance handicap ramp needs antiskid paint

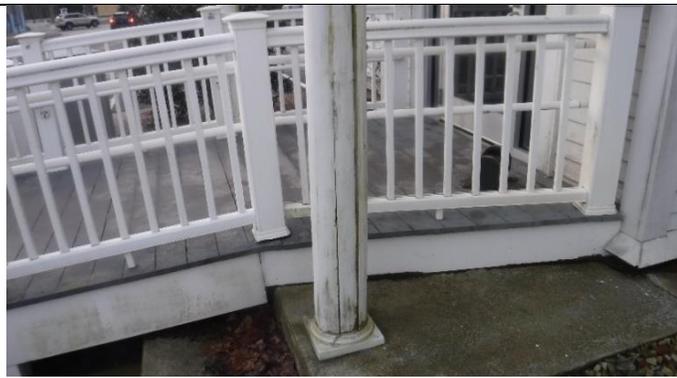
- Building not centrally located
- Numerous building code violations
- Front entrance wooden columns splitting separating
- Wood siding and trim paint peeling some areas in disrepair

Front Entrance wooden columns separating

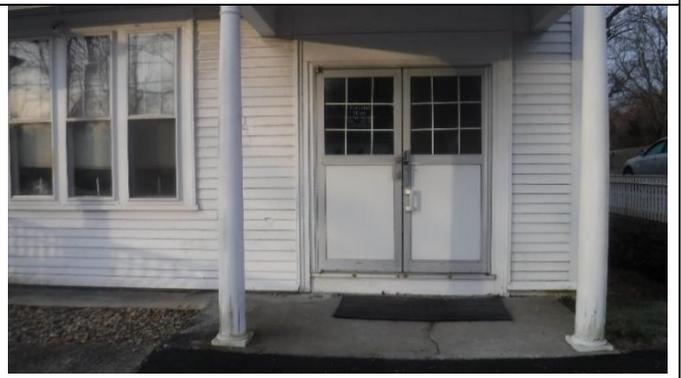
- a) ADA: No elevator to second floor, no ADA bathrooms, lack of clear space and appropriate service counter heights.
- b) Fire Code: Lack of sprinkler system, pull stations and horn strobes.
- c) Building Code: Suspected asbestos containing materials, flooring, wall coverings and pipe insulation. Condition of fire escape, deteriorating concrete supports, corroding steel and overall secureness of the fire escape is still questionable.
- d) 3rd Floor no emergency exit
- e) 3rd Floor staircase no handrails
- f) Stairs to basement no handrails
- g) 3rd Floor unguarded glass window at floor level
- h) Insufficient number of parking spaces.
- i) The building envelope is not up to code standards for air tightness and thermal performance.

ADA non-compliant front stairs to second floor

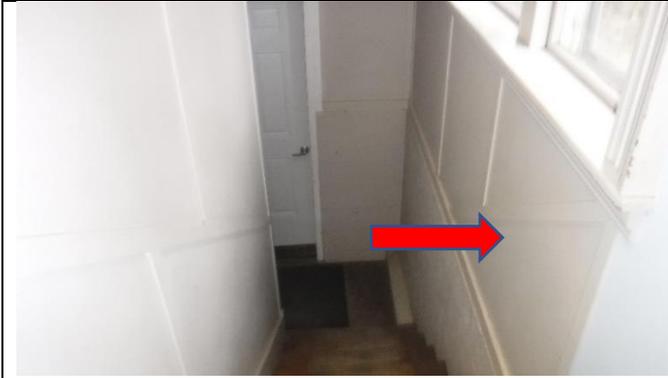
- HVAC system inadequate
- Narrow staircase to basement no railings
- Damp basement partial exposed soils floor area approximately 600 sf
- Evidence of rodents in basement

Narrow staircase to basement, no railings, suspect ACM panels

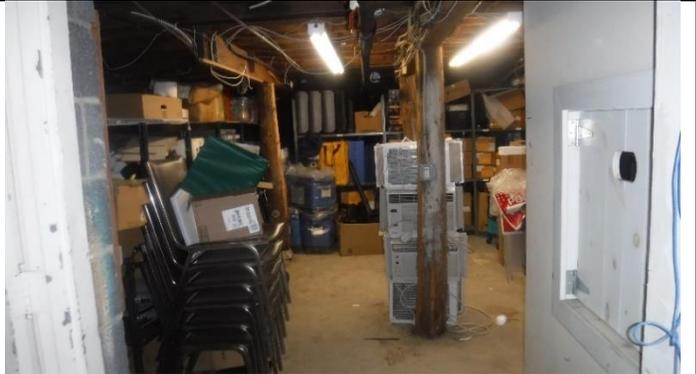
Damp basement, lack of storage space

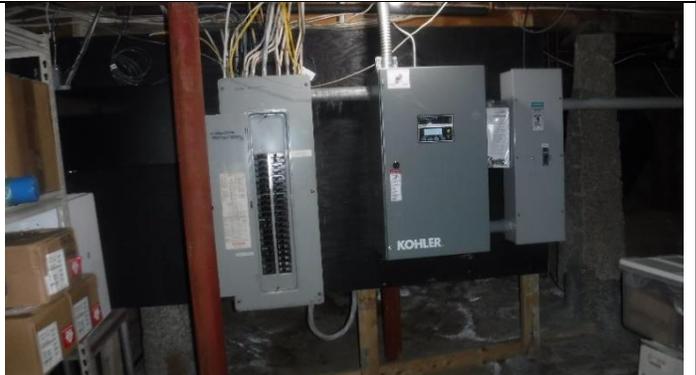
Circuit breaker and generator panels

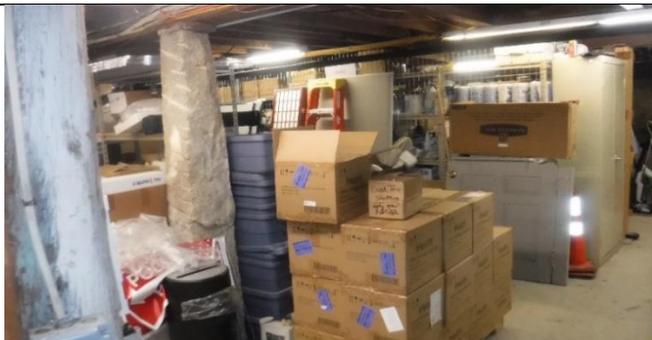
Unsecured storage in damp basement

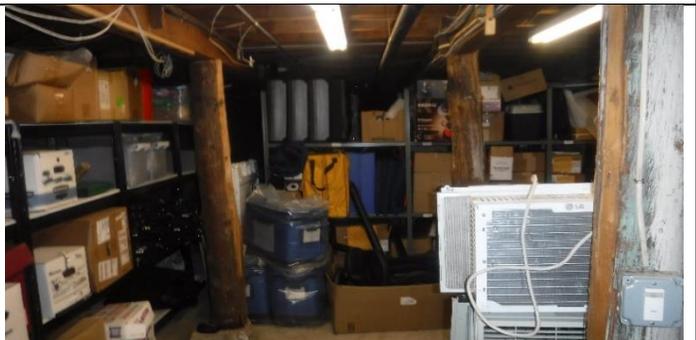
Damp basement lack of storage space

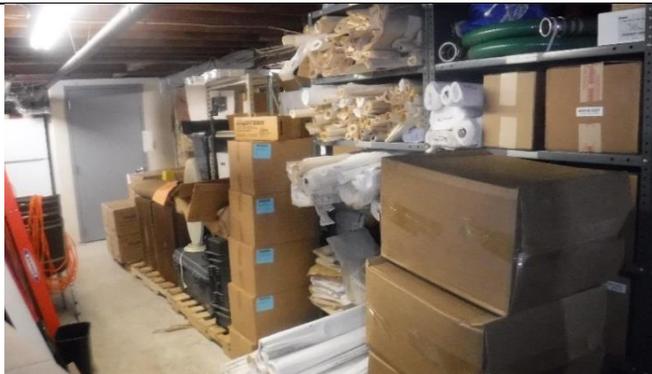
Blue print storage insufficient damp storage space

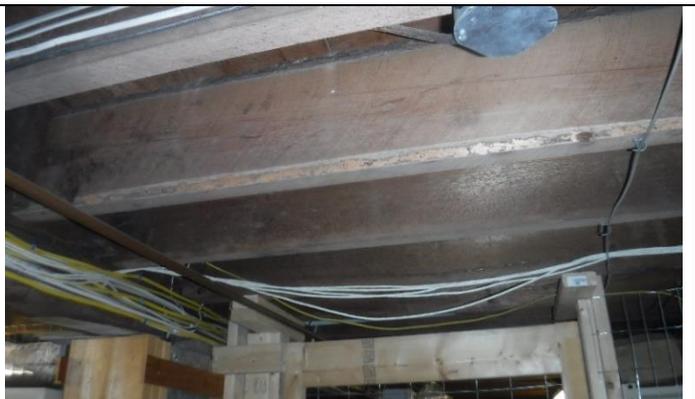
Floor joist with evidence of powder post beetles

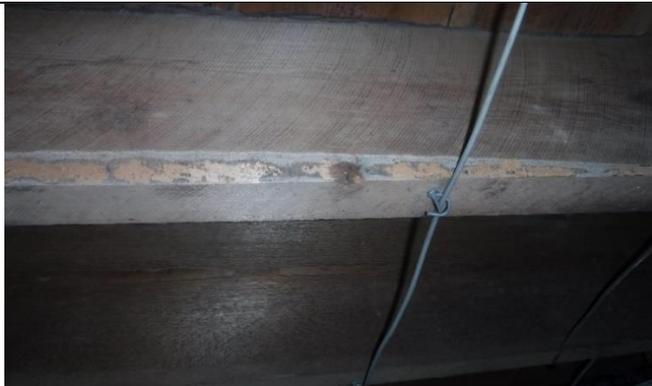
Evidence of powder post beetles close up view

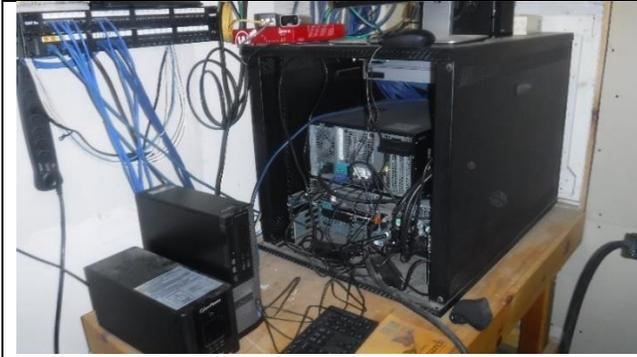
Computer on wooden table no rack

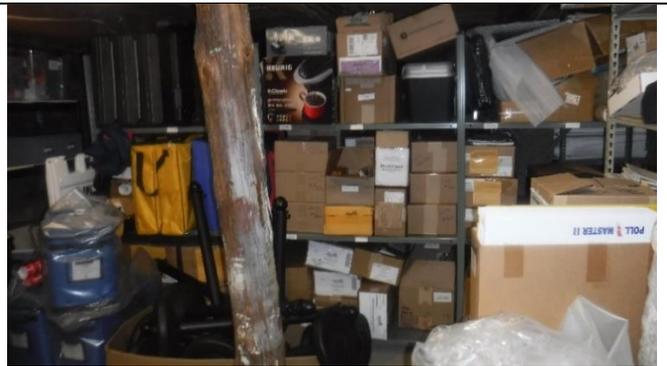
Election items stored in unsecure damp basement

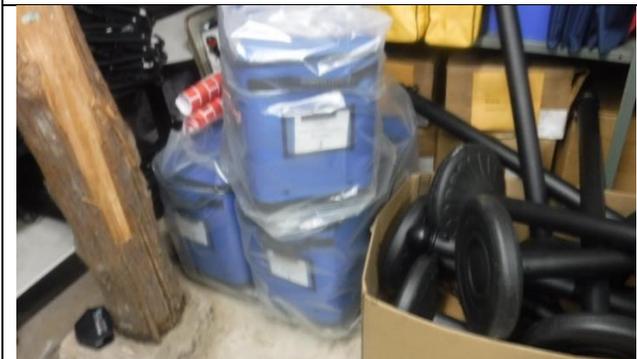
Ballot containers in plastic bags for dampness protection

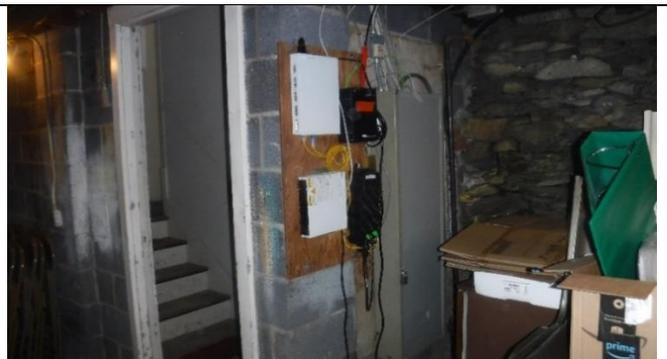
- Telephone equipment on wall not secure
- Plaster ceiling above acoustical ceiling grid plaster intermittent falling through lower ceiling tiles
- Acoustical ceiling on second floor sagging, leaking

Telephone equipment on wall

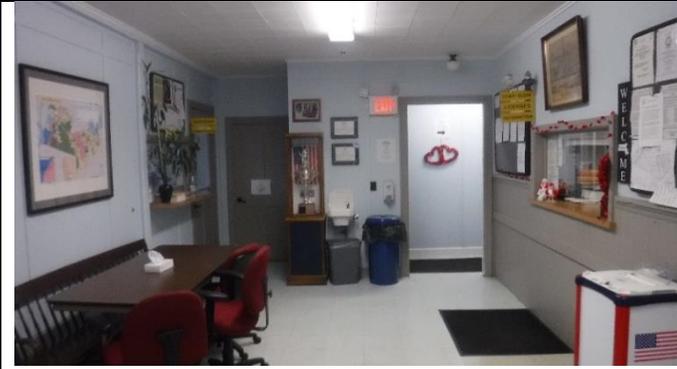
- Difficult to hear through transactions through plexiglass
- Bathrooms not handicap accessible, ADA non compliant
- Multiple air conditioner units in windows

First Floor lobby no handicap counter heights

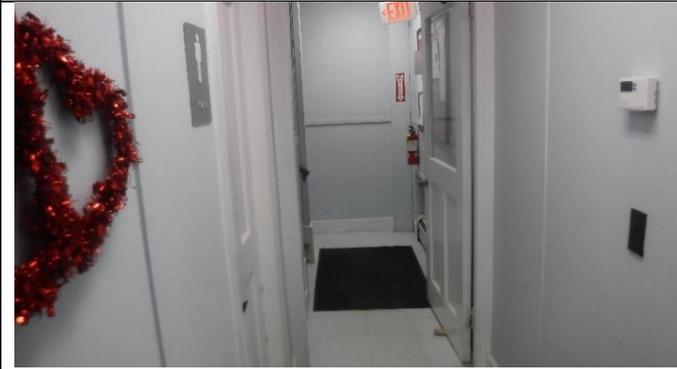
Narrow hallway and Mens room

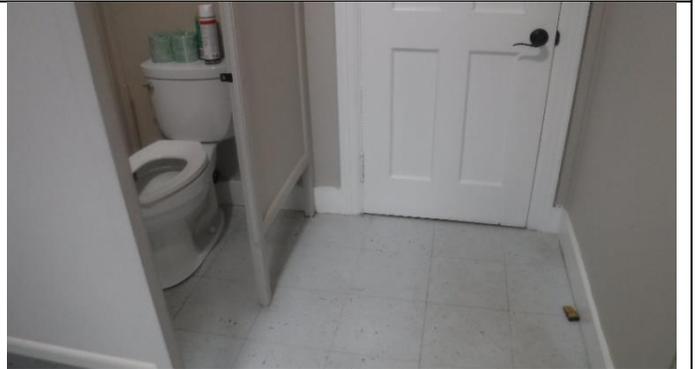
Mens Room small doorway and toilet stall

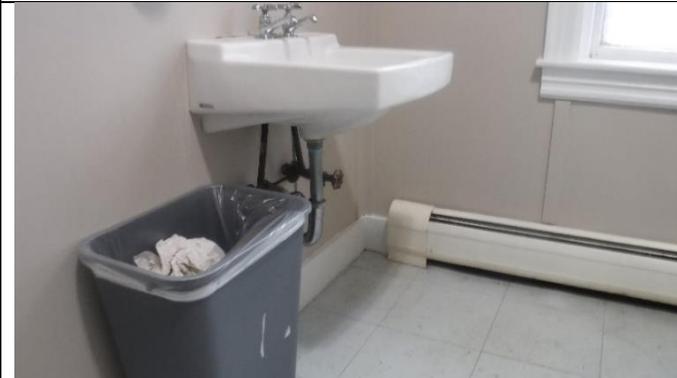
Mens Room ADA Non-compliant sink

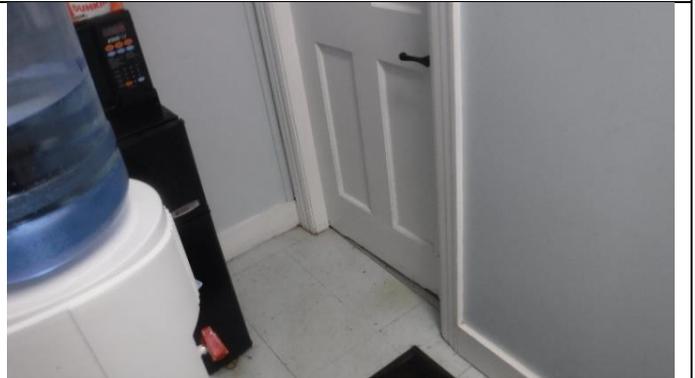
Narrow Ladies Room entrance

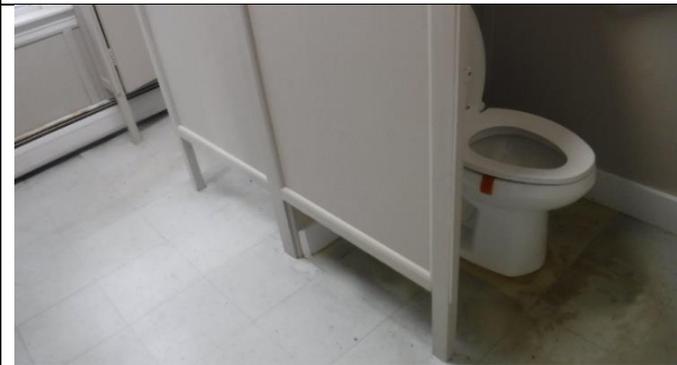
ADA non-compliant Ladies Room

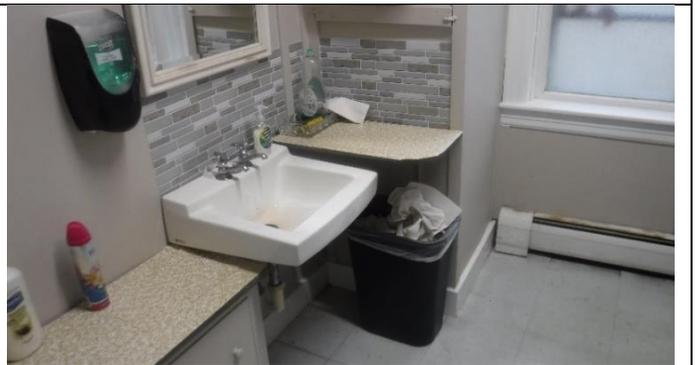
Ladies Room ADA non-compliant sink

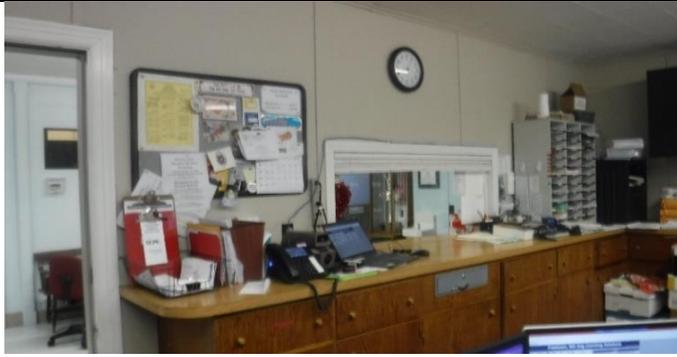
Town Clerk, Licenses Office lack of workspace, storage

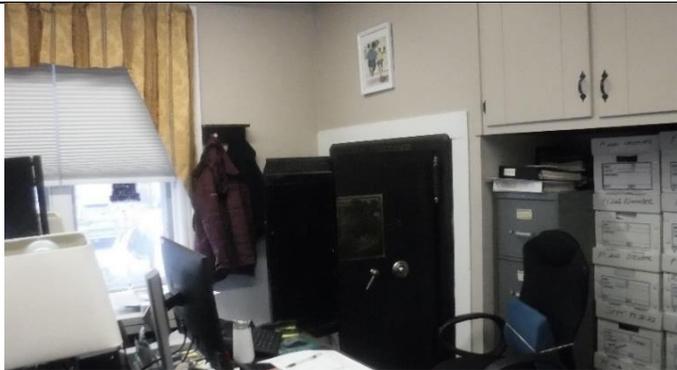
Tax Collector Office of work and storage space

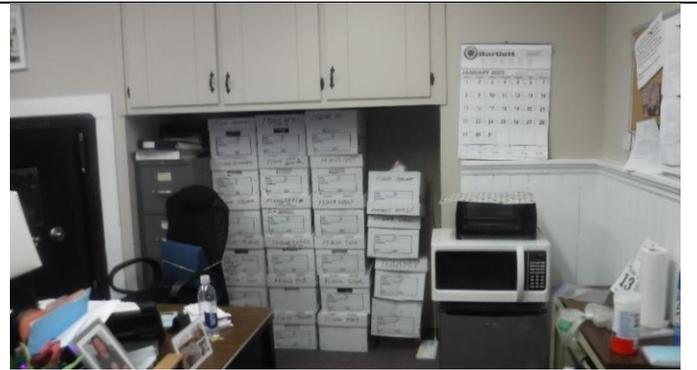
Tax Collector no employee break room

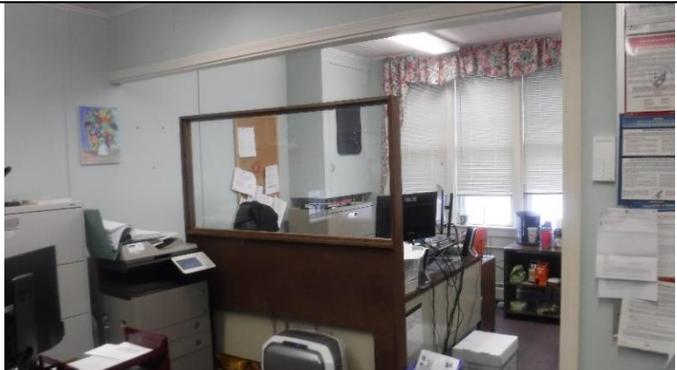
Treasurer lack of privacy, work and storage space

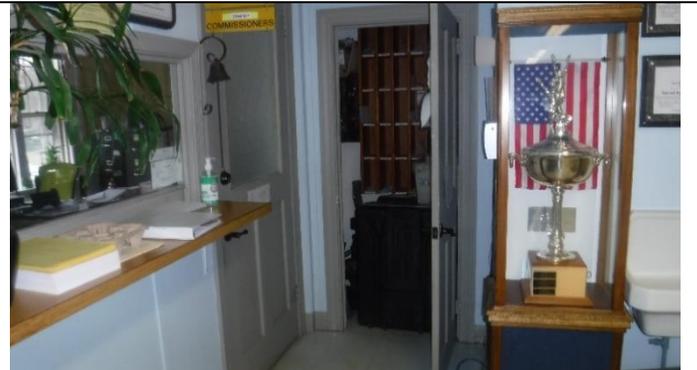
Mail closet with election equipment unsecured storage

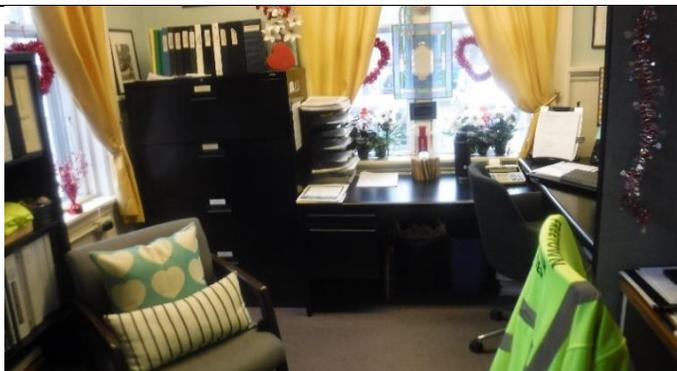
Water Commission Office insufficient workspace

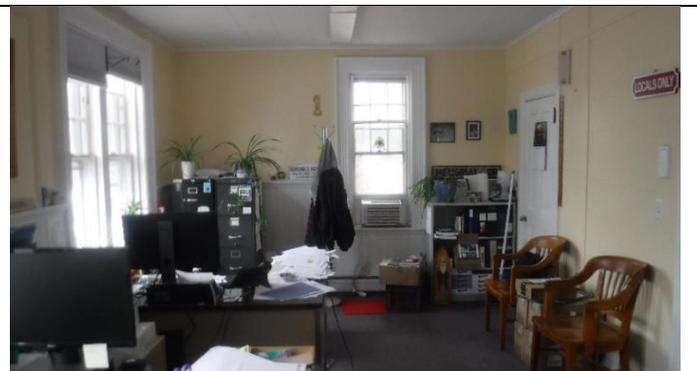
Assessors Office insufficient workspace

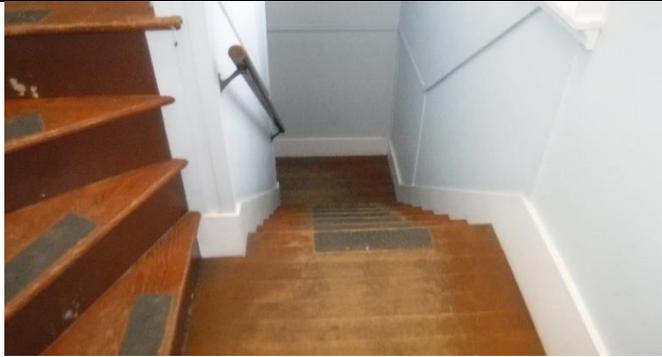
Narrow width stairs to second floor no elevator

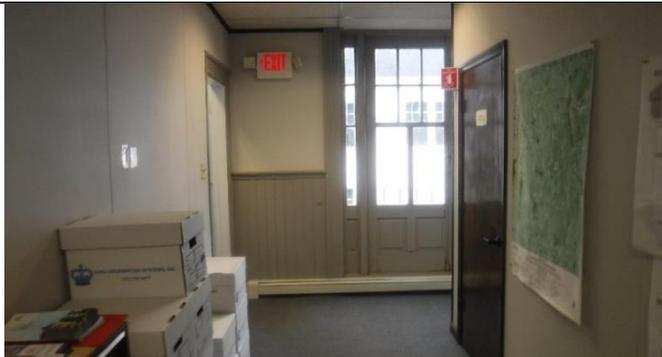
Second Floor storage in narrow corridor

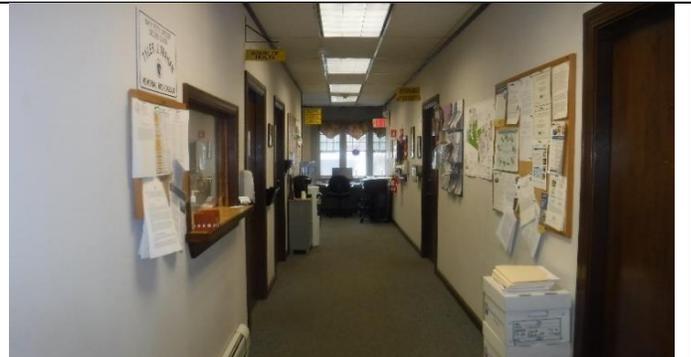
Second Floor narrow corridor width overall view

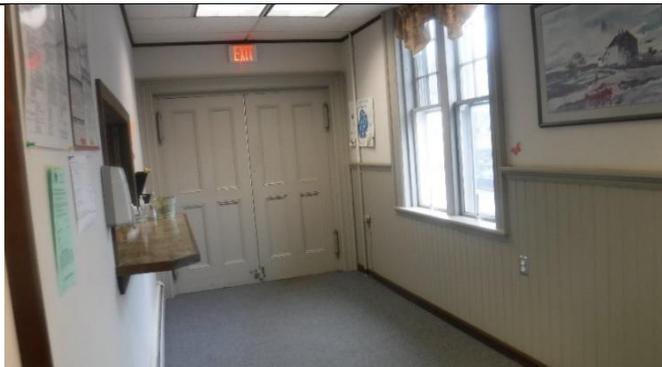
Second Floor doors to first floor exit ADA non-compliant
