February 21, 2023
Town of Freetown
Debbie Pettey, Town Administrator

Review Of Council on Aging Building:

ACG recently visited the site of the current “Town Hall Building”. Not much has changed since our initial survey of 2014. The building is a typical 1830 wood frame construction placed on a rubble stone foundation. The lot is small and has limited parking.

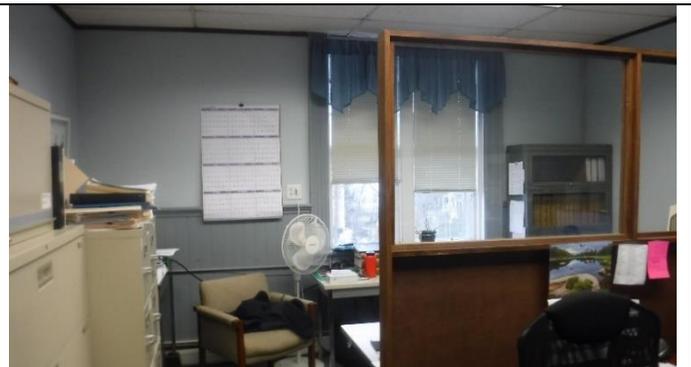
Town Accountant insufficient workspace

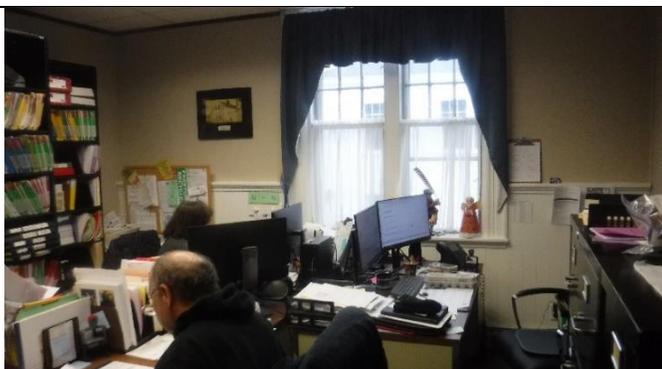
Board of Health Office lack of storage and workspace

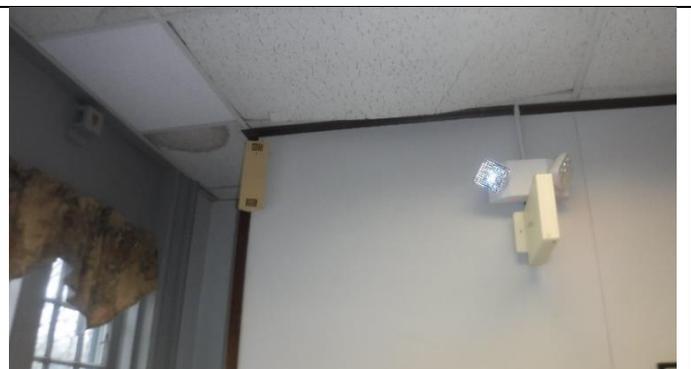
Damaged leaking, sagging ceiling

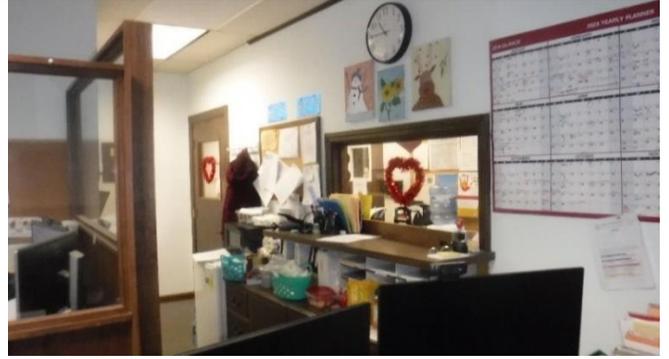
Selectmen's Office lack of work and storage space

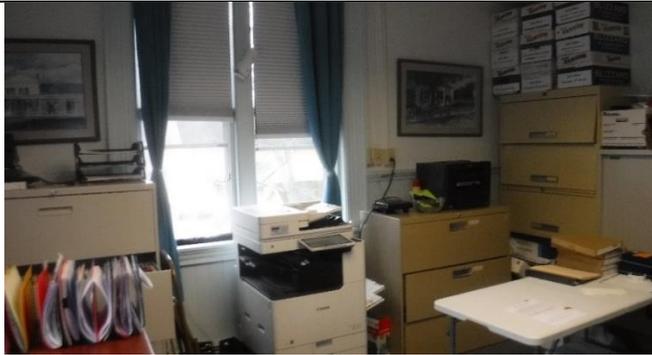
Selectmen's Office lack of work and storage space

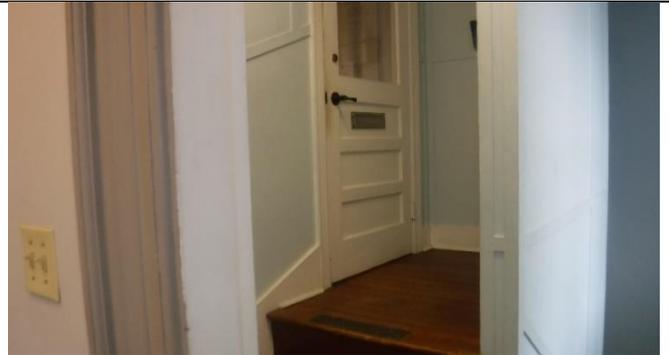
Planning Third Floor ADA noncompliant entrance

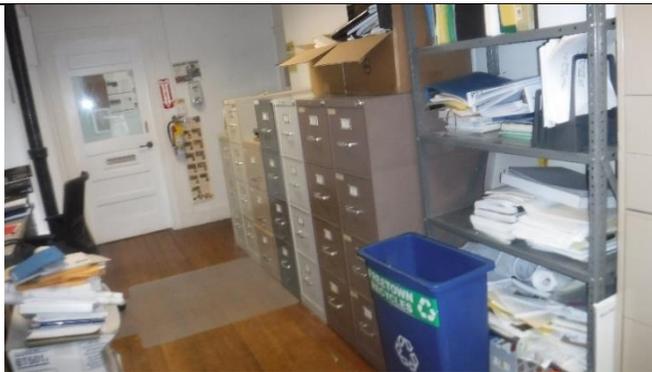
Planning Office lack of work and storage space

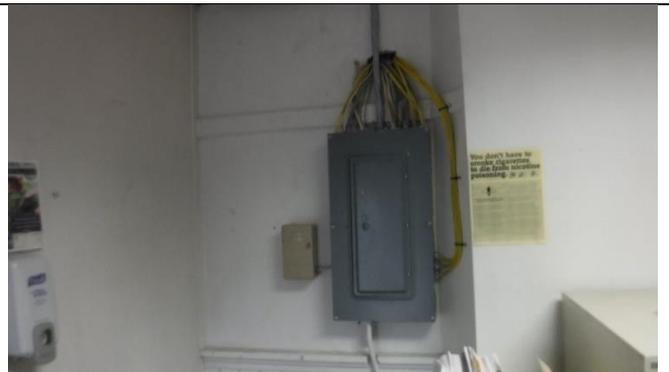
Circuit breaker panel and old wiring

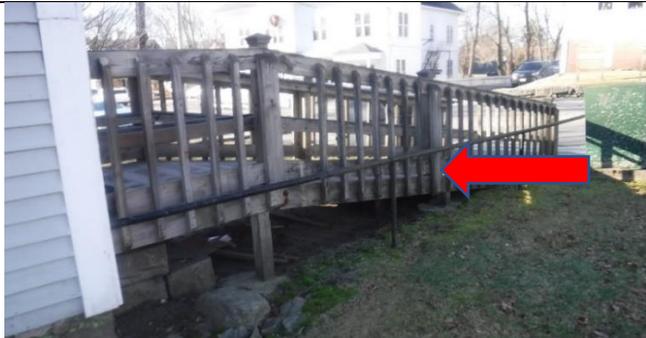
Main entrance old metal railing

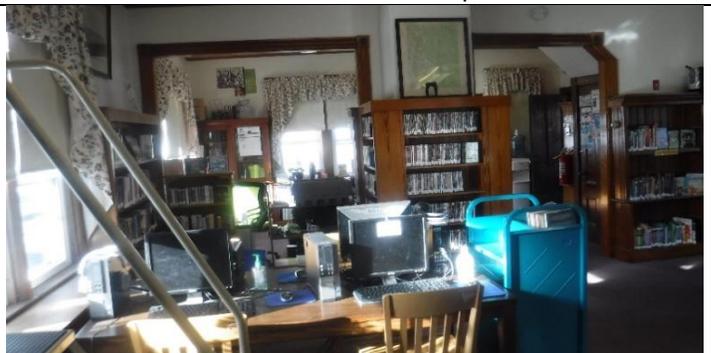
Main floor no rest rooms, no running water

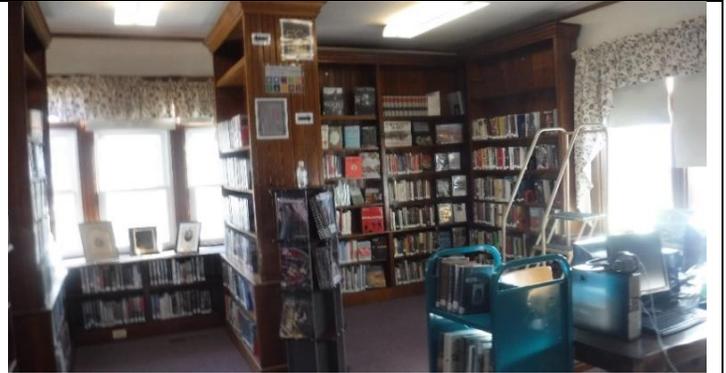
Main floor no running water in building

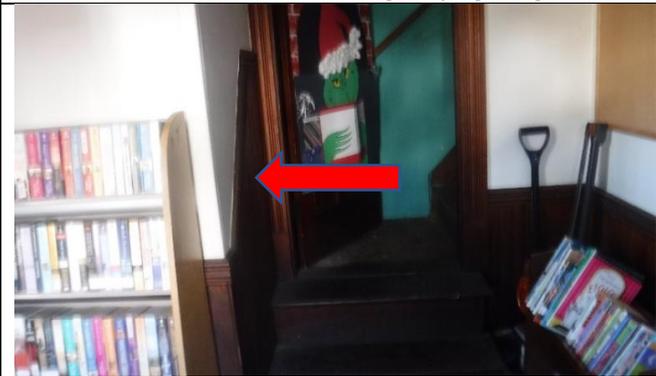
Stairs to attic no railing

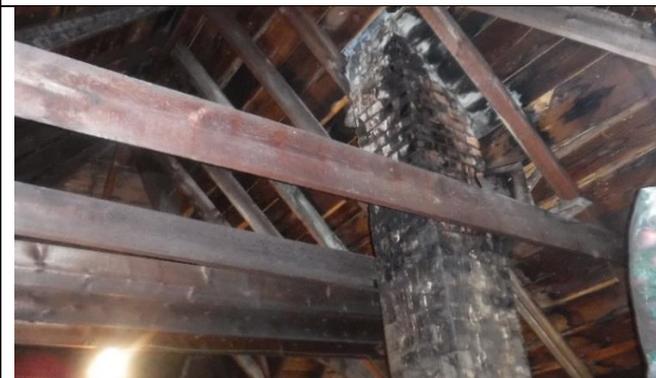
Old roof leaks around chimney

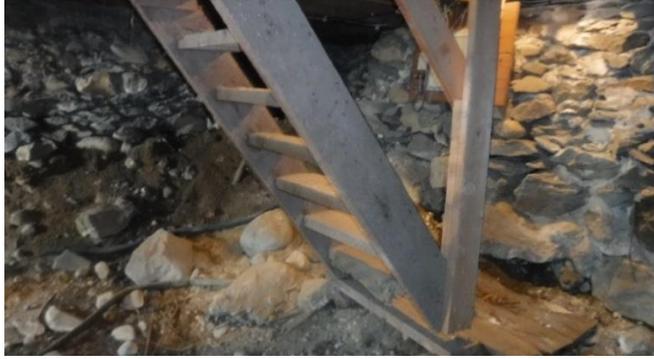
Steep stairs to basement code violation

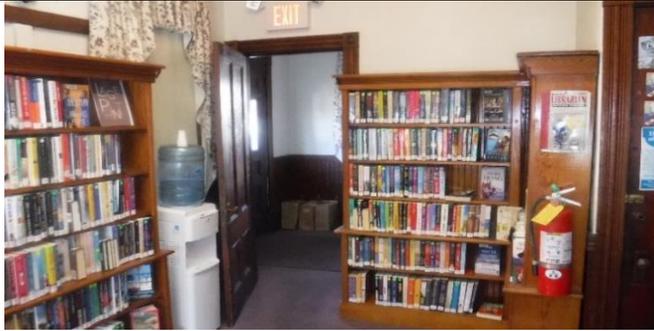
Main entrance non-ADA compliant

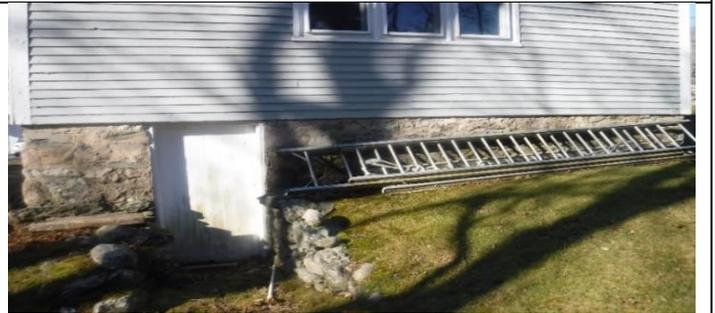
Upper-level peeling paint

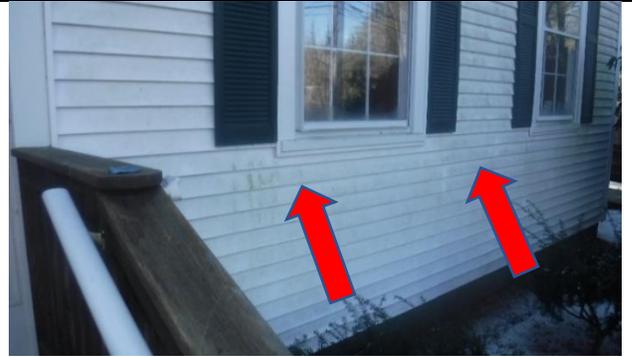
Vinyl siding mold, mildew

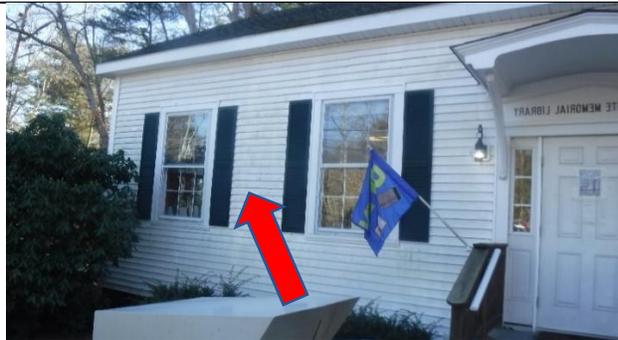
Left front mold, mildew on vinyl siding

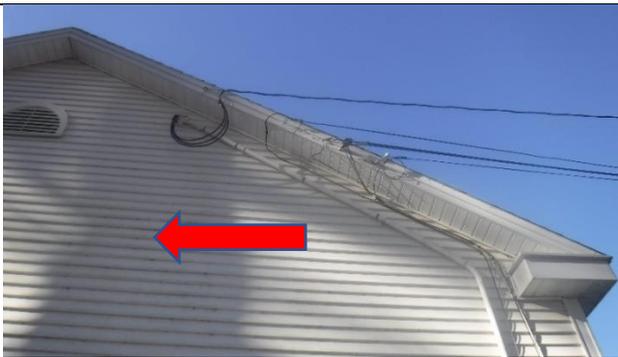
Electrical, internet, telephone wiring, mold on siding

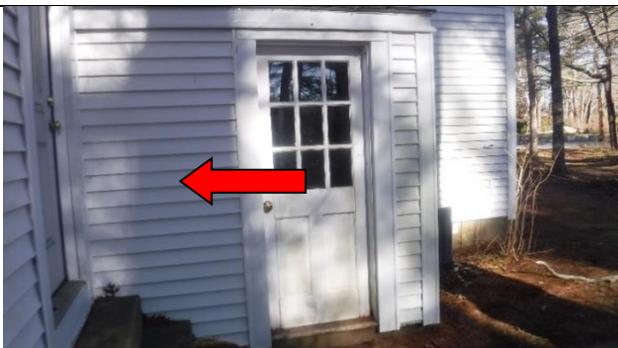
Rear door vinyl siding mold, mildew

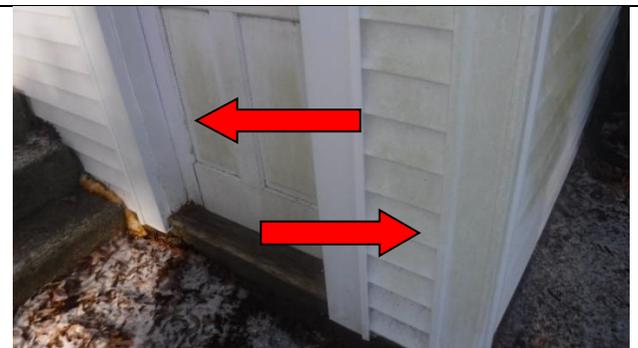
Door splitting, unpainted threshold, mold on siding

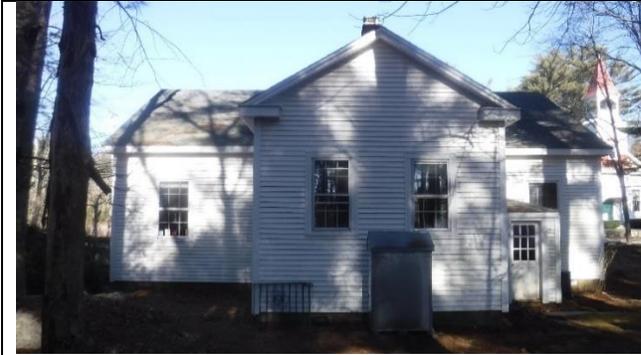
Rear of building, double wall oil tank

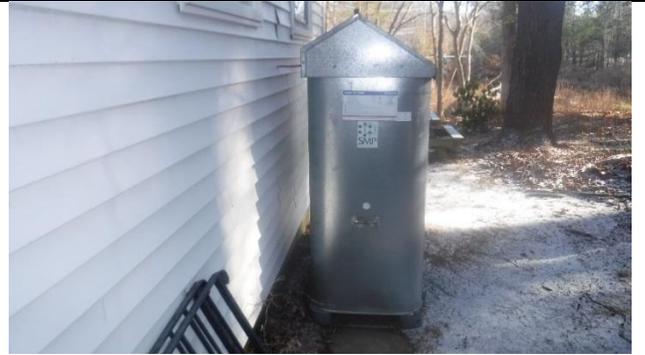
Outdoor double wall oil tank

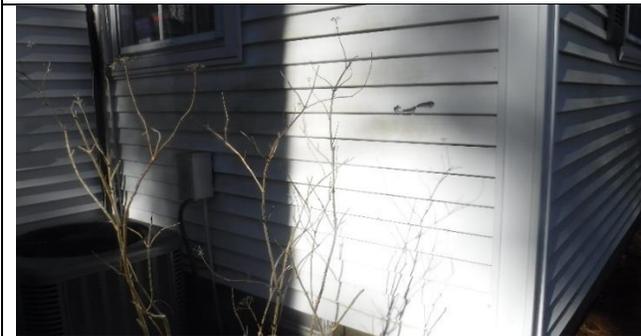
Rodent damage to siding

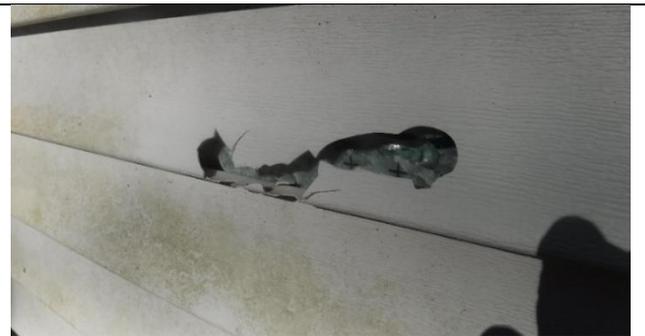
- Handicap ramp and boardwalk on west side
- Algae growing on wood deck, and on handicap ramp
- Mold, mildew growing on entire building vinyl siding. Damage to siding rear of building.

Close up of damaged siding, mold, mildew

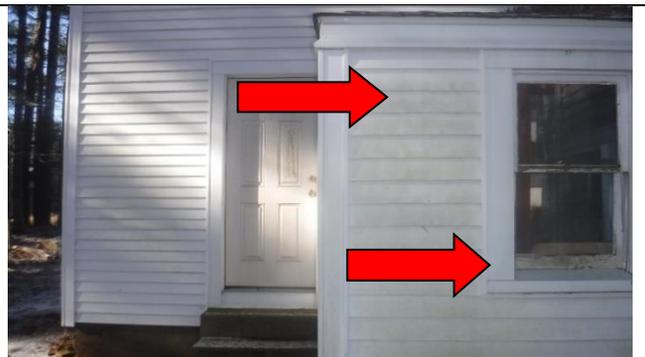
Mold and mildew on vinyl siding and window

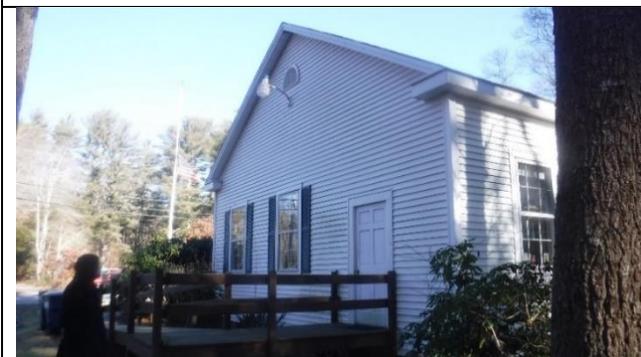
Southwest corner of building mold on siding

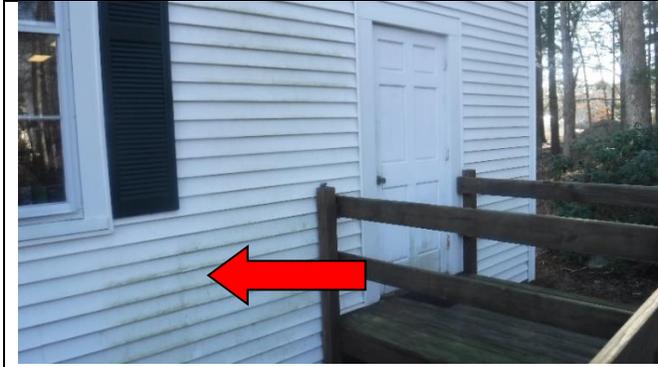
Side handicap entrance, mold on vinyl siding

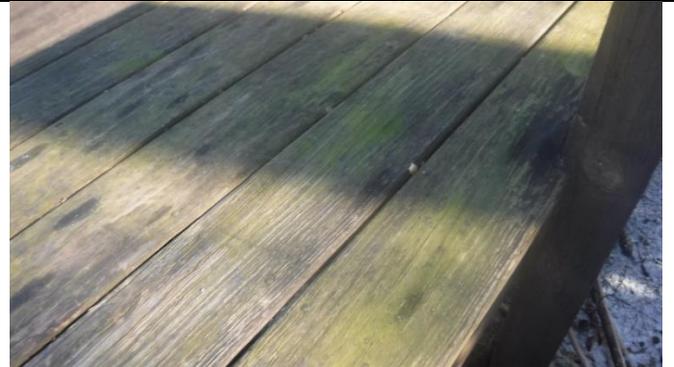
Algae growing on deck and handicap ramp

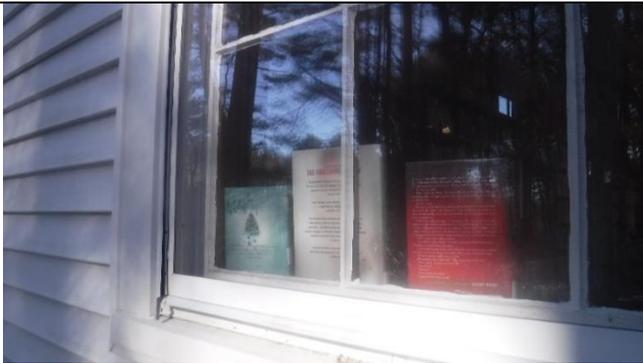
Storm window over single pane glass

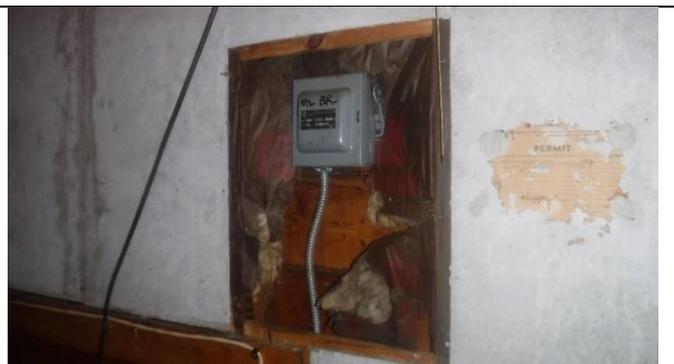
Oil burner shutoff panel removed

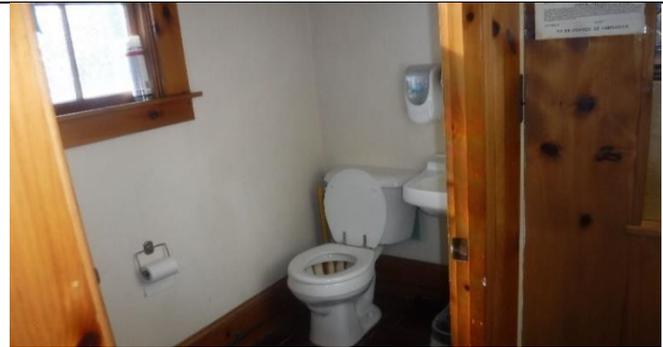
No grab bar

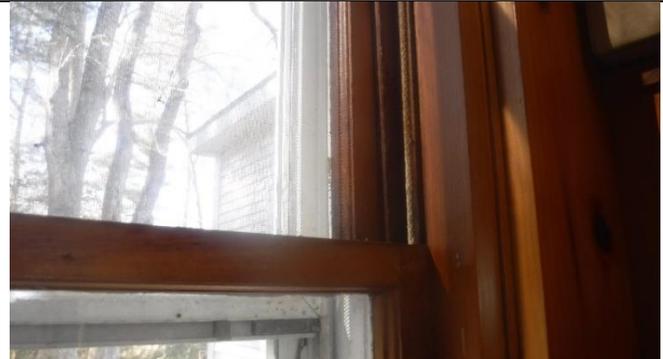
Single pane wood rope and pulley windows

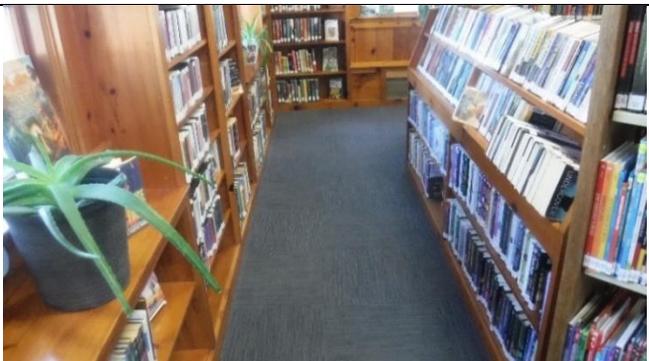
Carpet tile over VAT flooring

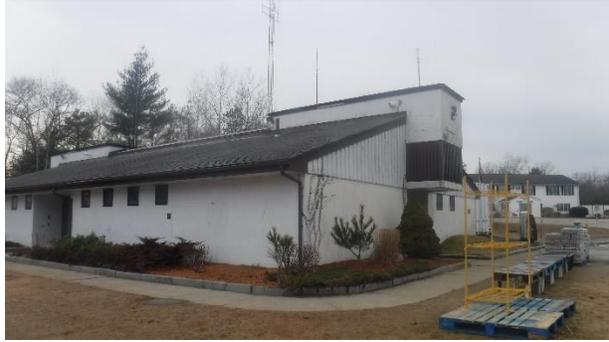
Peeling paint

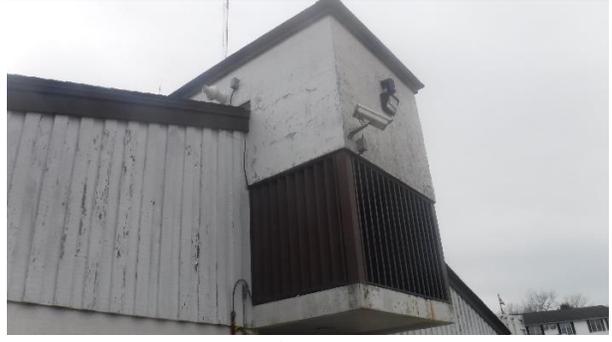
Peeling paint

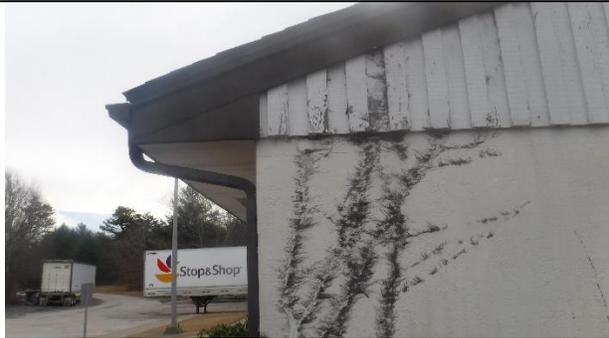
Peeling paint closeup

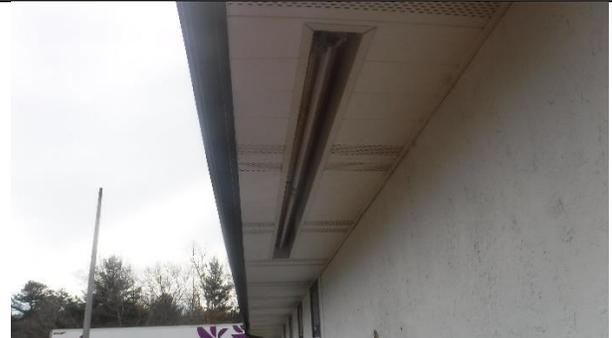
Old fluorescent lighting

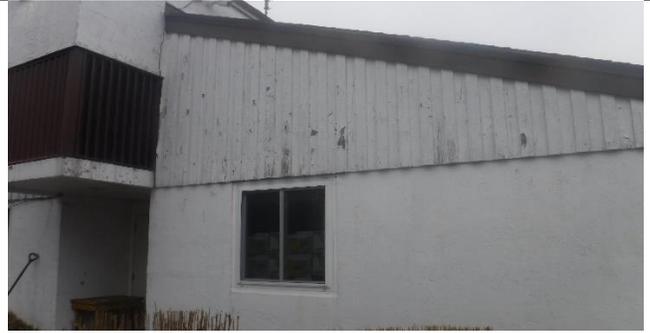
Rear of building peeling paint

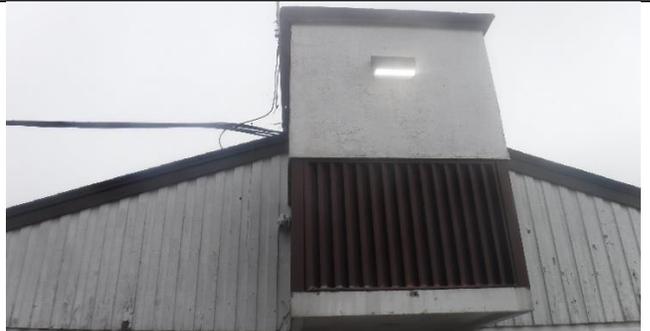
Rear of building top peeling paint

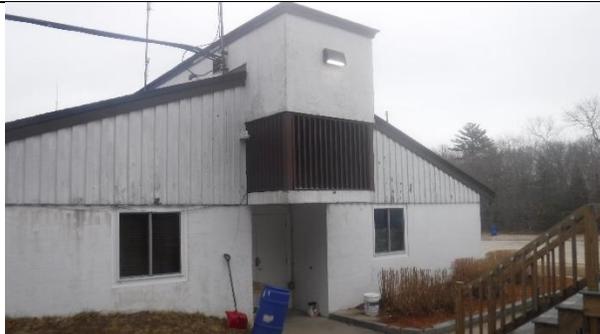
Soils placed against building

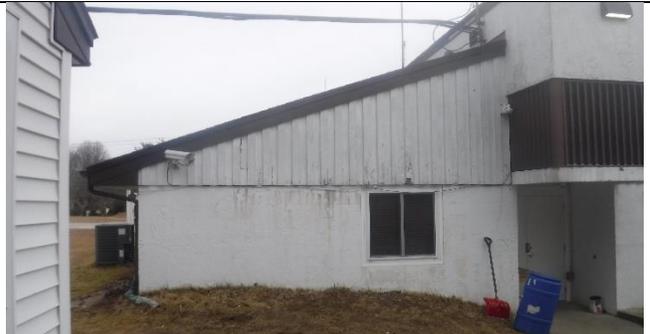
Closeup of soil against building

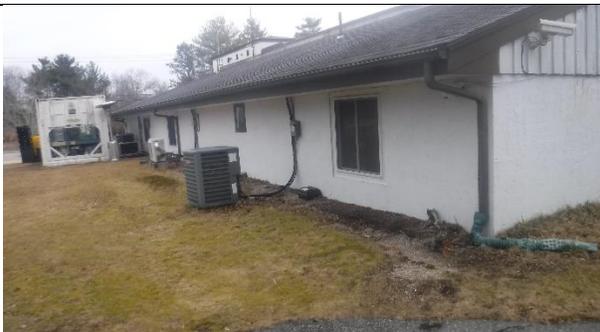
South side buried in soil piled high

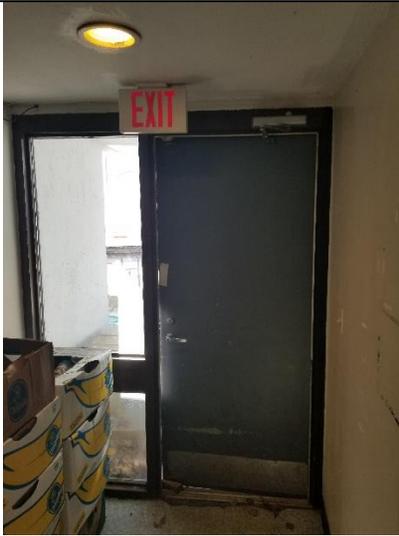
Old door damaged at bottom

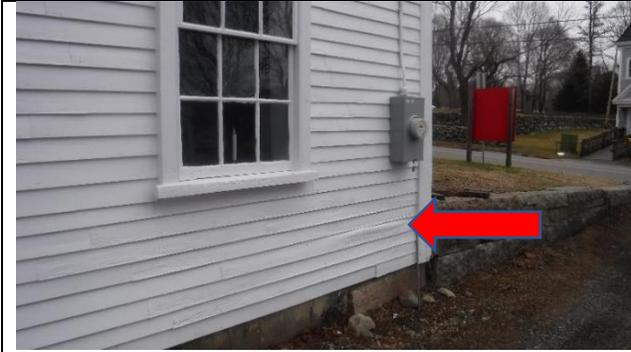
Siding protrusion

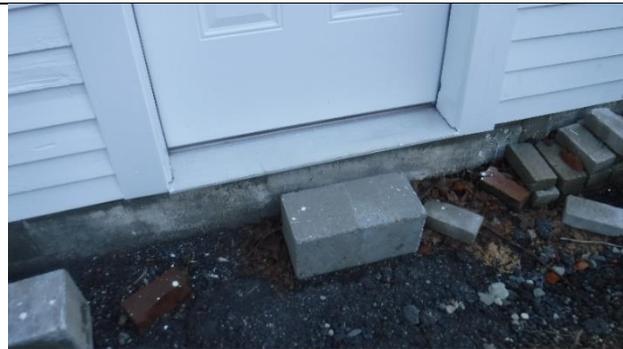
- No running water
- No bathroom facilities
- No HVAC
- ADA non-compliant building
- Low metal posts hazard front of porch at landing
- Side entrance single CMU block used as step

CMU block used as step

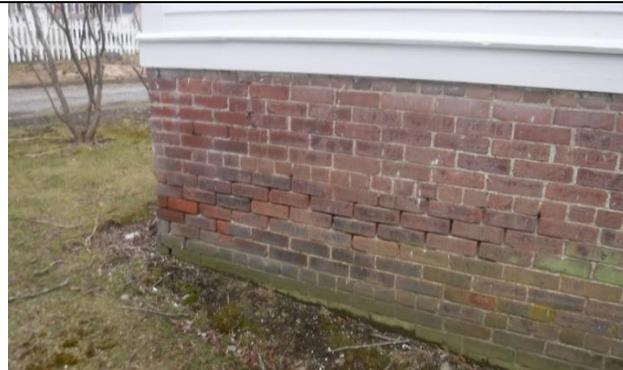
- Bricks need repointing
- Green algae growing on brick
- One classroom needs ceiling repairs plaster falling
- Peeling paint
- Old wiring
- Very old light fixtures

Rear of building bricks need repointing

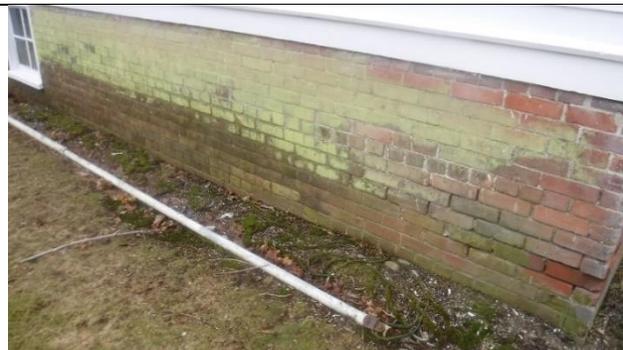
Green algae on brick

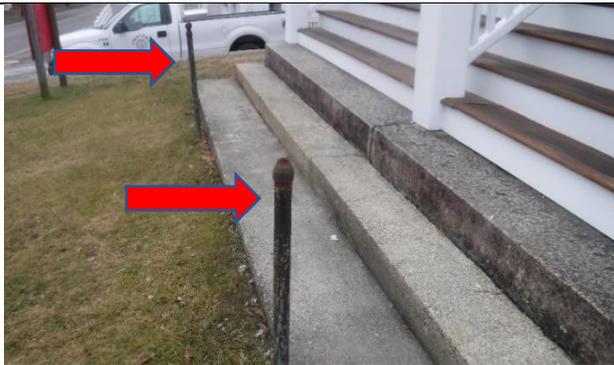
Old steel posts

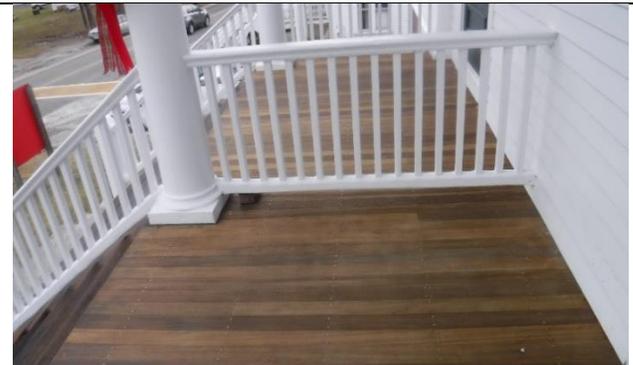
New railings and deck

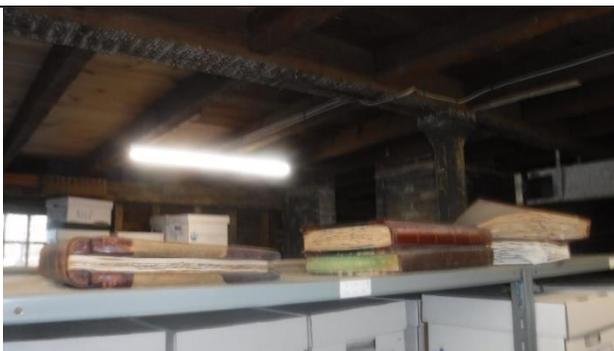
Assessors' books in damp storage

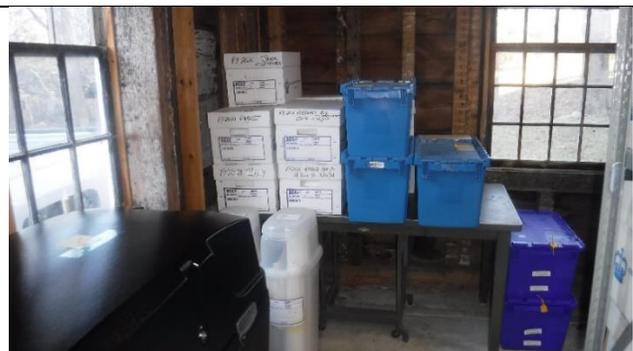
Unsecured record storage single pane windows

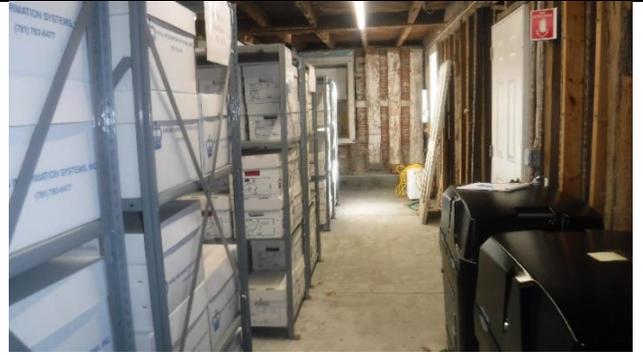
Close up of shelving in damp space

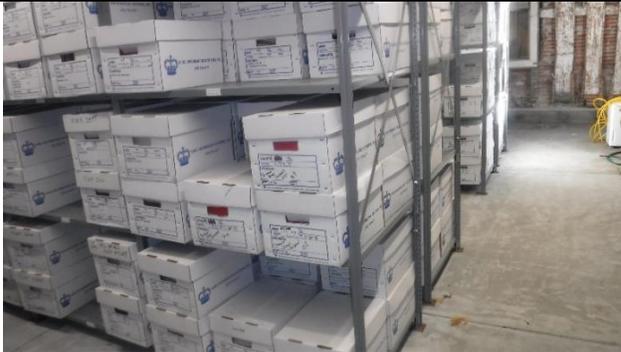
Partial demolition of interior walls

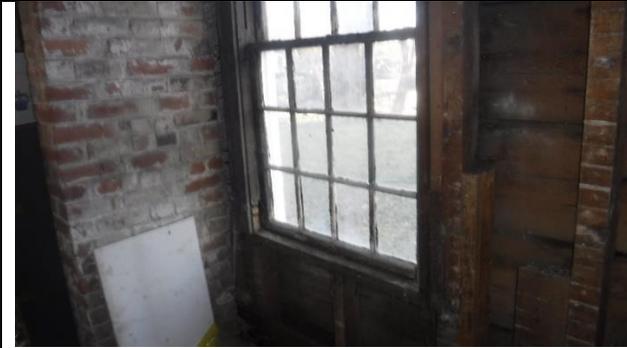
Unsealed windows, daylight in seams

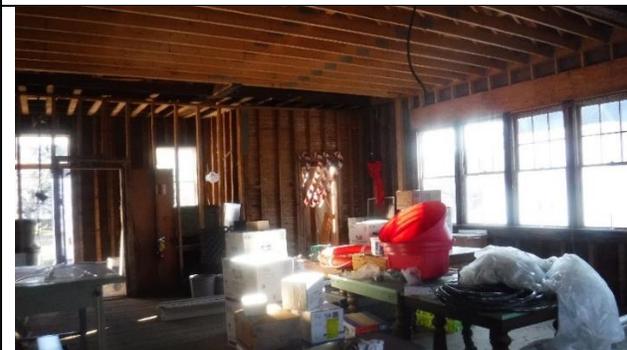
North Classroom chalkboards, falling ceiling

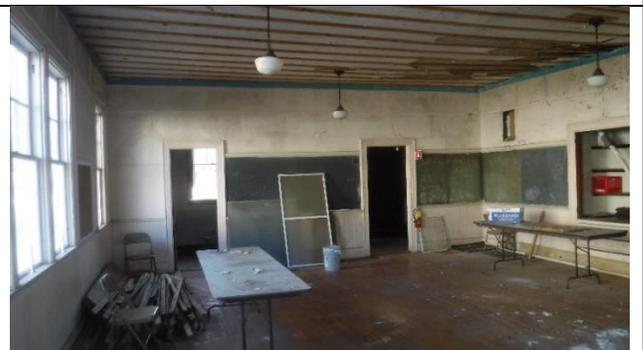
Old light fixtures, peeling paint

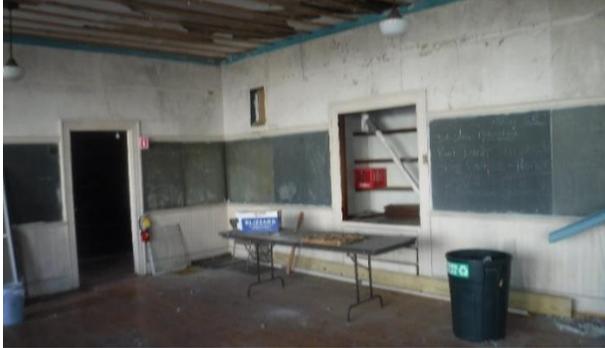
Ceiling falling apart

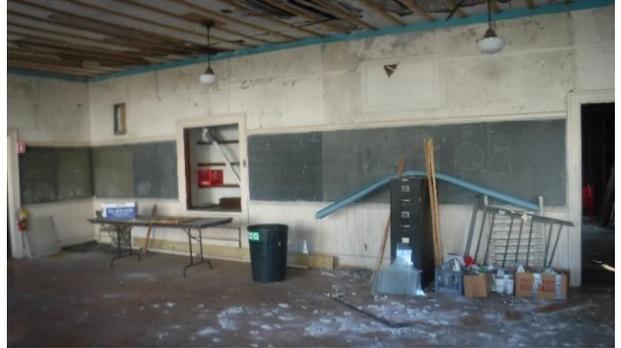
Ceiling debris on hardwood floor

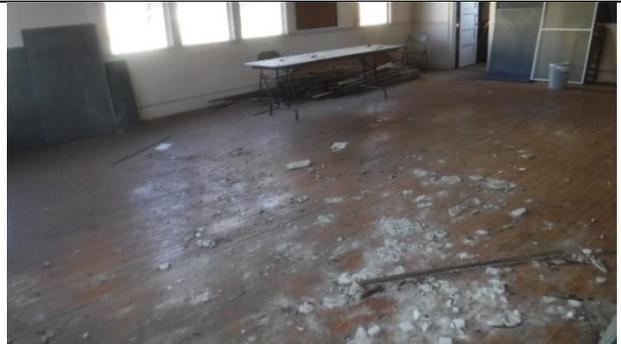
Peeling paint

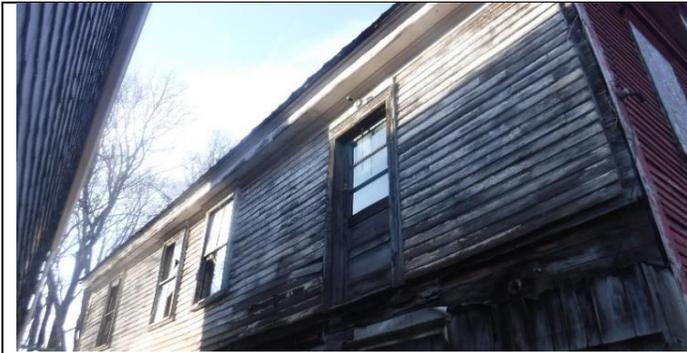
Broken windows, rotting, insect damaged wood

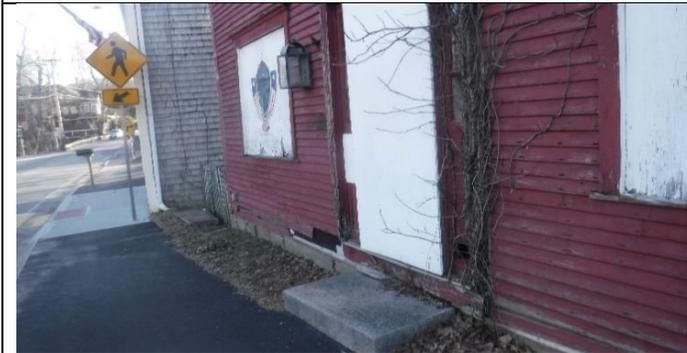
Building condemned sign on front door

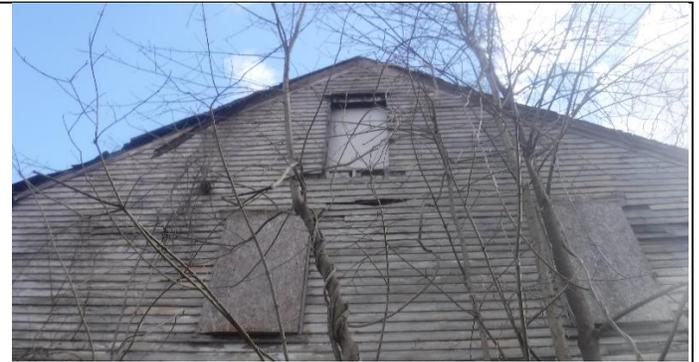
Siding falling off
