Town of Freetown Needs and Space Study

Municipal Offices, Police, Council on Aging, Library

Architectural Consulting Group, LLC, Inc.
09/24/2014

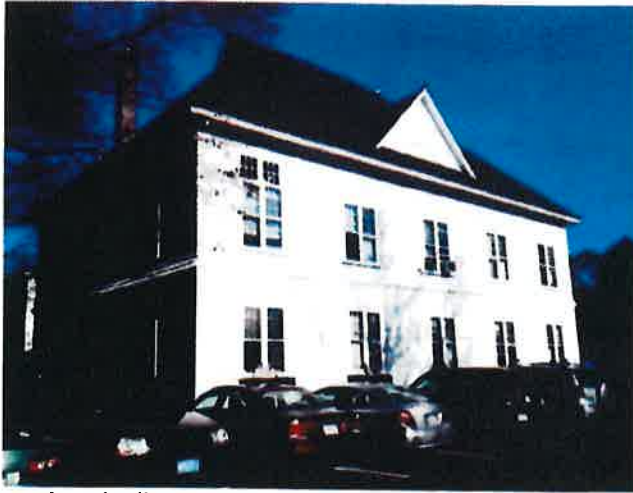
South side (limited parking), and back of building

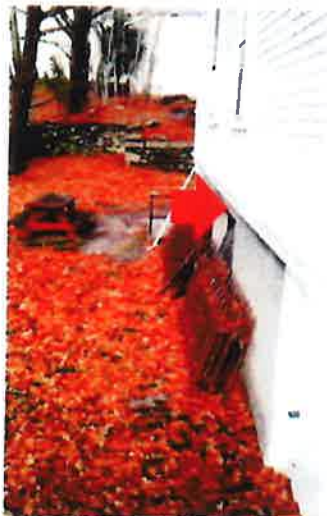
Rear of Town Hall.

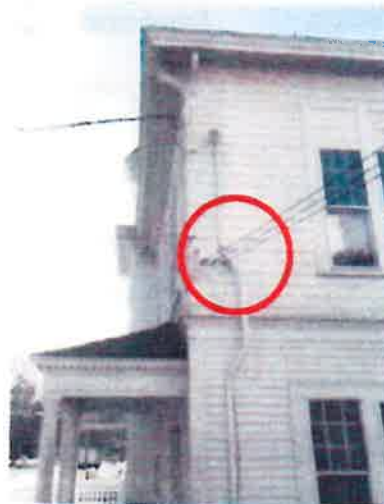
Electric service to adjacent building.

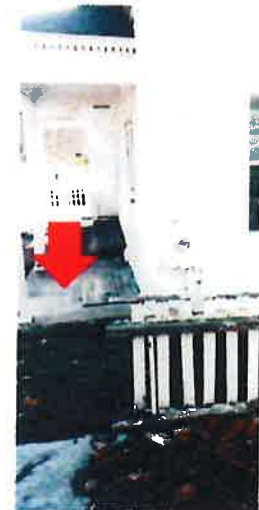
Concrete step not to code.

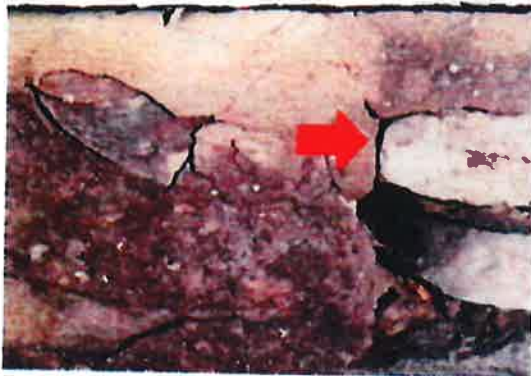
Deteriorating stone foundation.

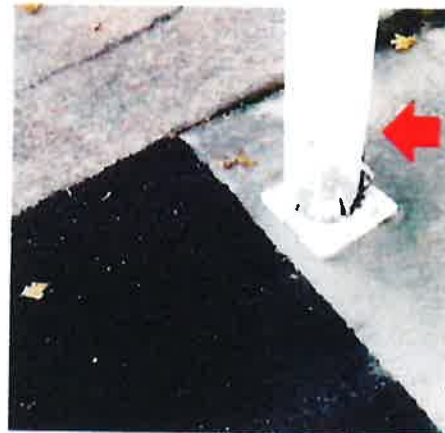
Front post base – deteriorating (all posts).

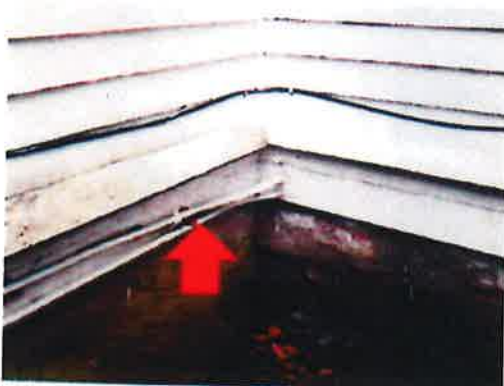
Old existing electrical service - North side
Not in current use.

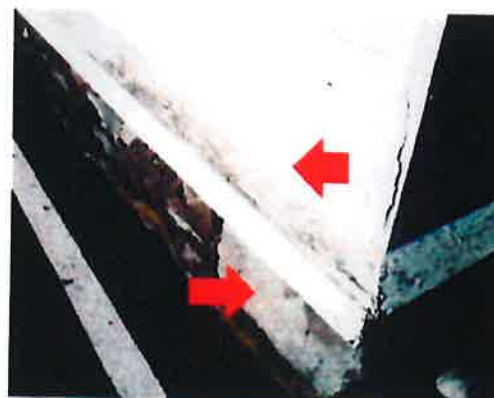
Front Southwest corner – deteriorating
wood / stone. (Water table elevation)

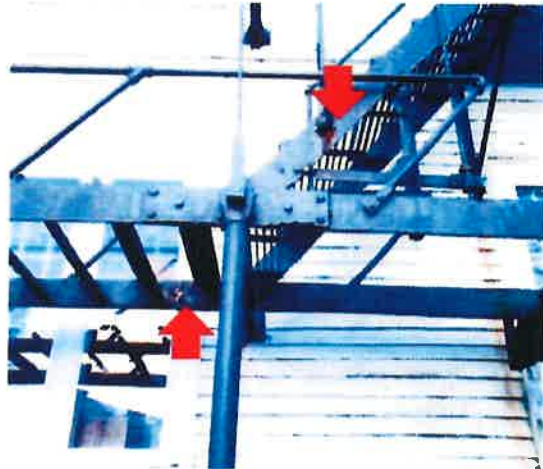
North side - Rusty fire escape components; should be tested for safety.

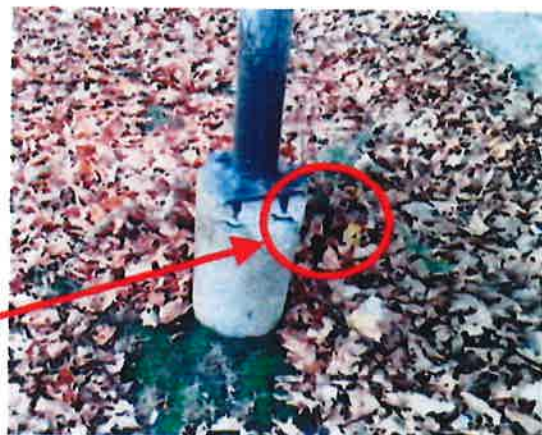
Deteriorated concrete post.

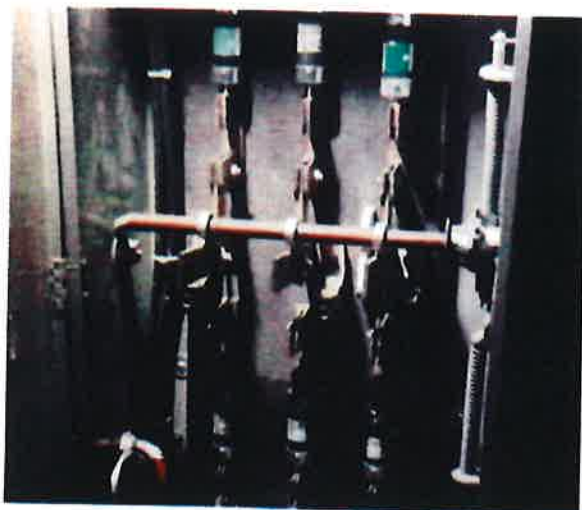
Electrical load switch for old generator.
Current use unknown; should be reviewed
by an Electrical Engineer.

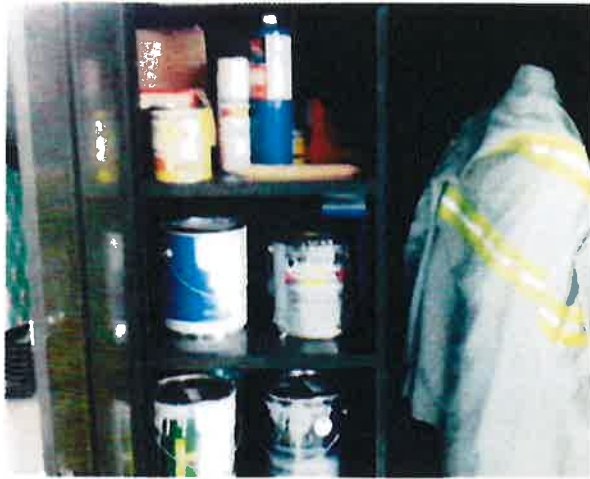
Paint storage locker – not Fire Code compliant.

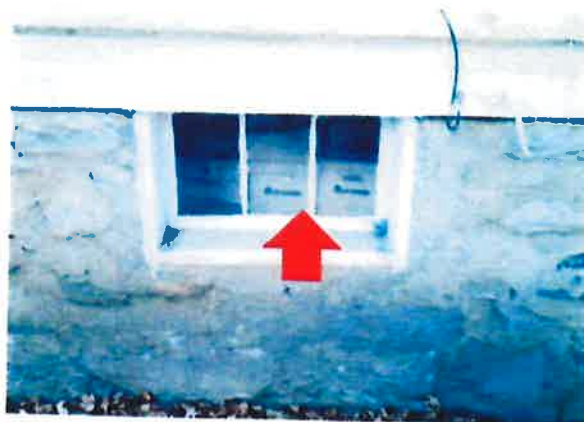
Basement window – blocked with stored materials.

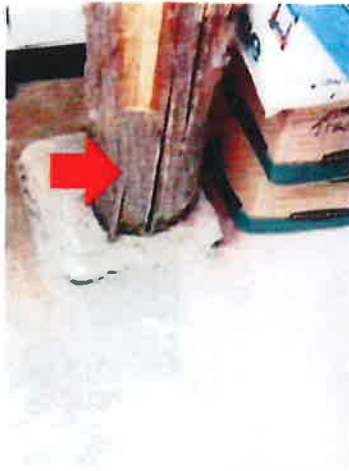
Splitting wood post.

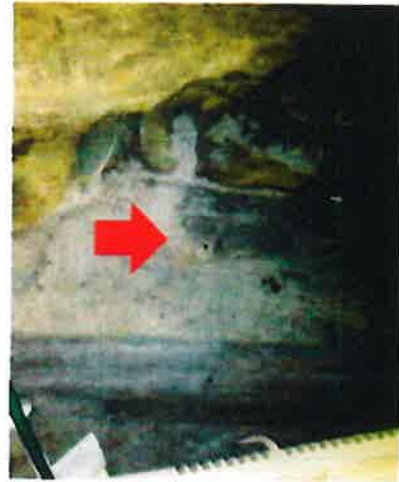
Stone foundation repair.

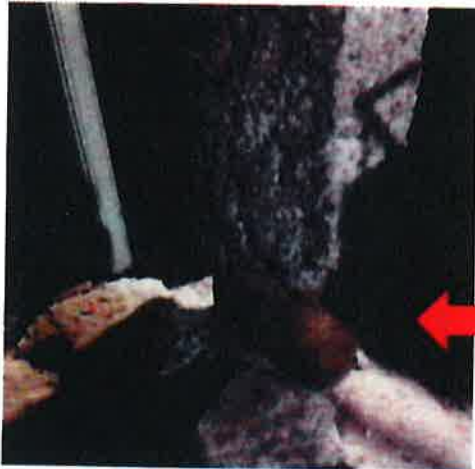
Deteriorated granite post (bottom).

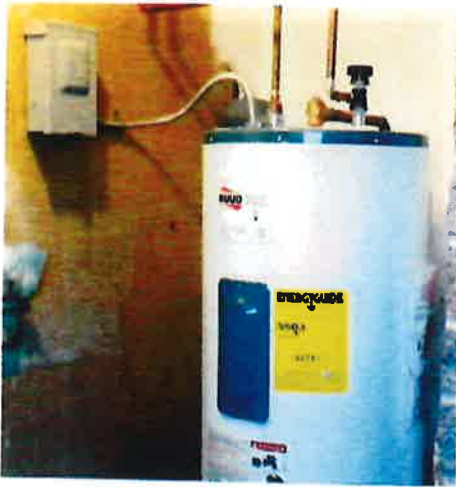
Electric hot water heater.

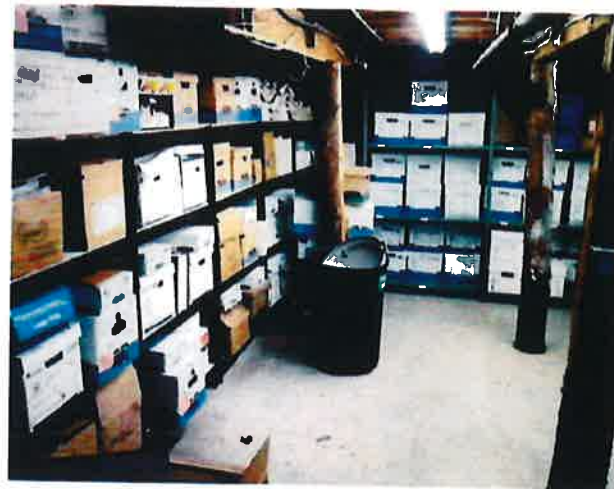
Basement file storage; at maximum capacity.

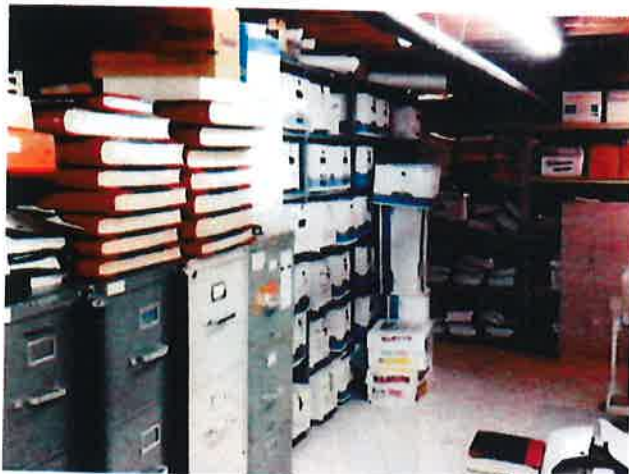
Basement file storage; at maximum capacity.

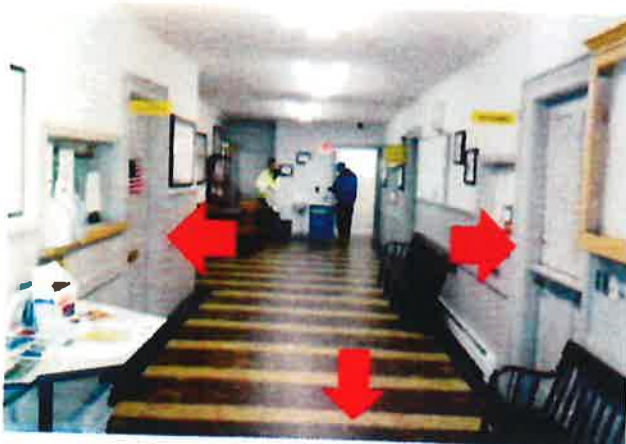
Main hall looking towards back of building; office service counters too high and suspected asbestos containing VAT tiles.

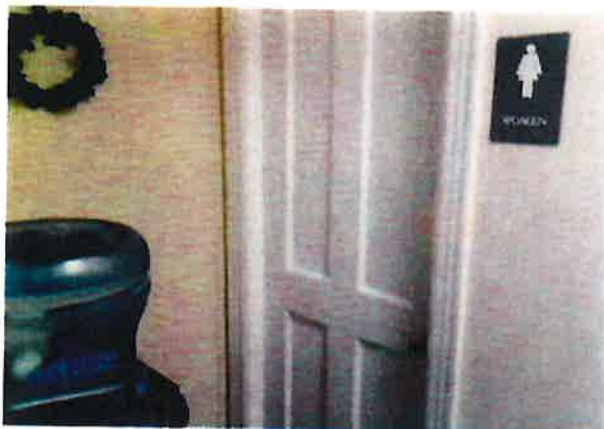
Women's room entrance – not ADA compliant.

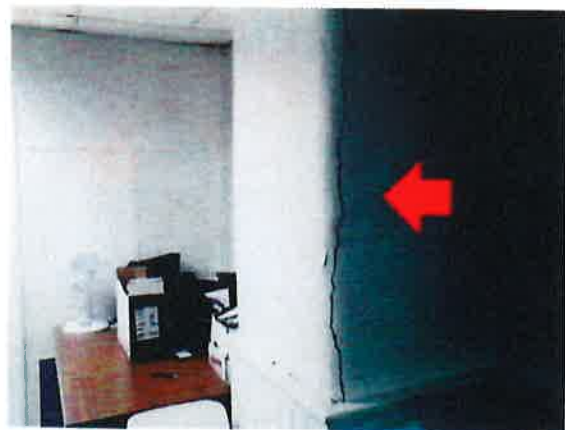
Cracked wall plaster surrounding the chimney.

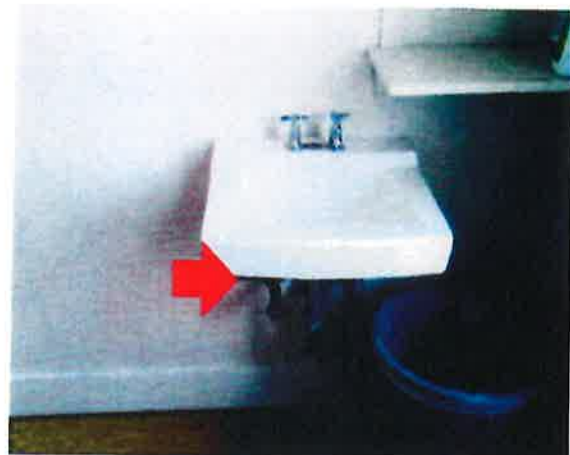
Men's room sink- height not ADA compliant, and no lavatory guard (cover) for drain pipes.

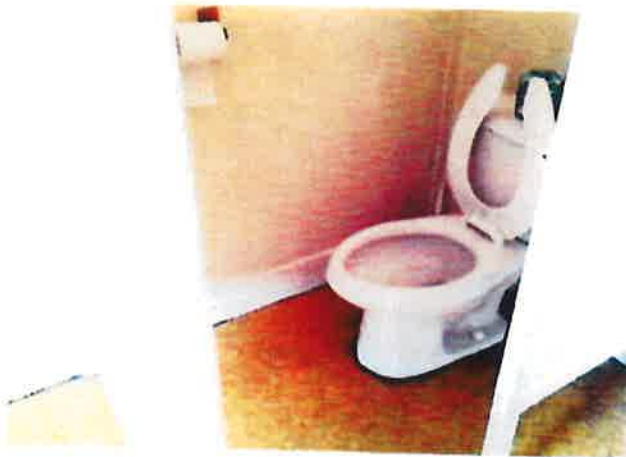
Toilet stall in Men's room – not ADA compliant.

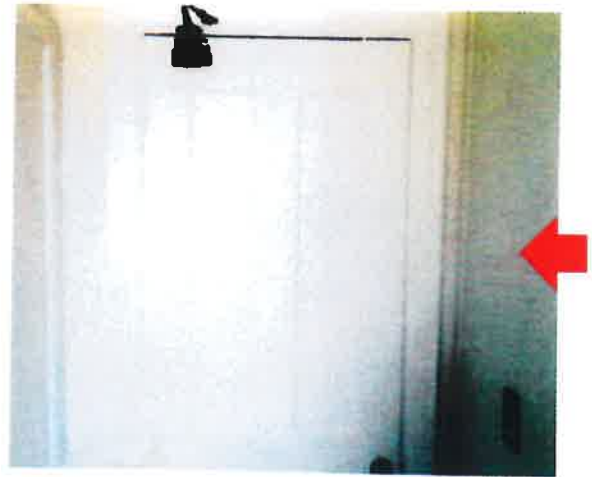
Men's room - door not ADA compliant, and not 18" on the 'pull side' of the door.

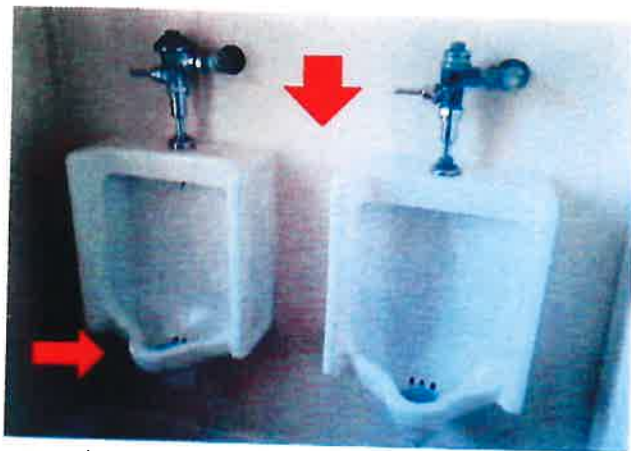
Men's room urinals – height not ADA compliant, and no privacy screen.

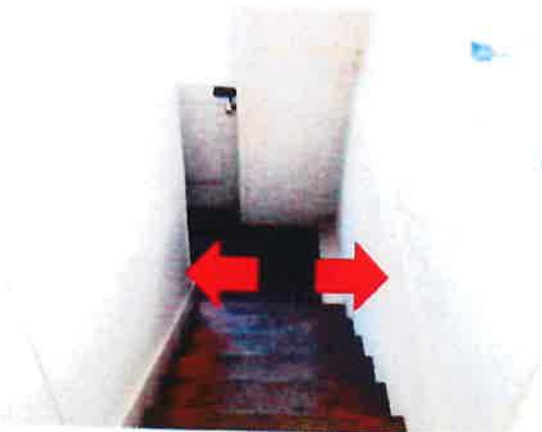
Rear entrance hall and stairs to first floor – no handrails, and lower wall panels (only) are suspected to contain asbestos.

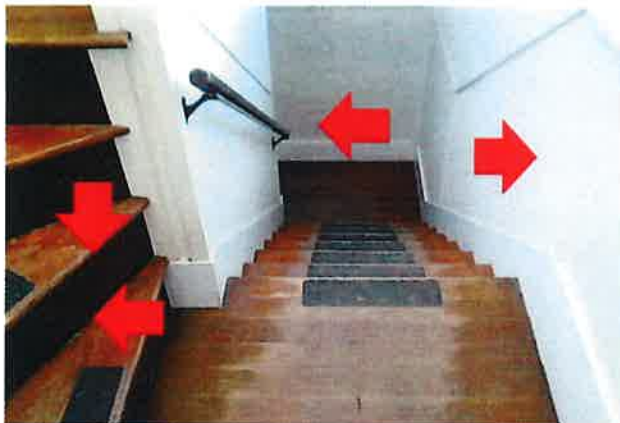
Rear stairway – 2nd floor down to 1st floor; railings, panels, and stair risers / treads; not all are code compliant (to today's standard).

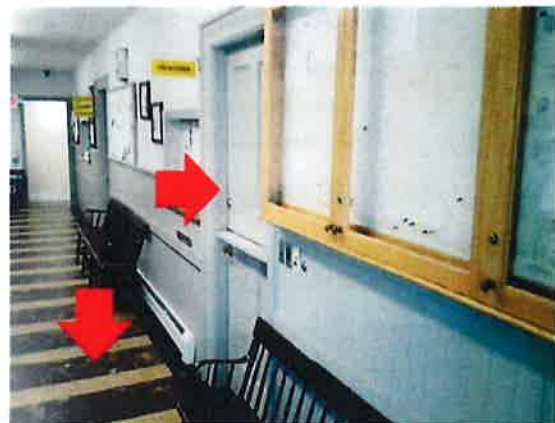
First floor hallway looking towards back of building; suspected asbestos VAT tile, and counter heights.

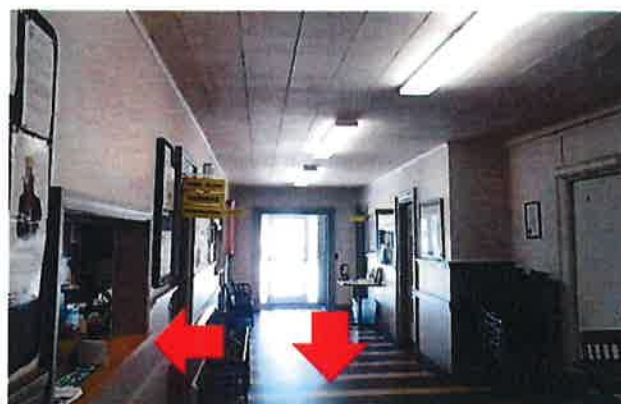
First floor hallway looking towards front entrance; service counter heights, and VAT tile.

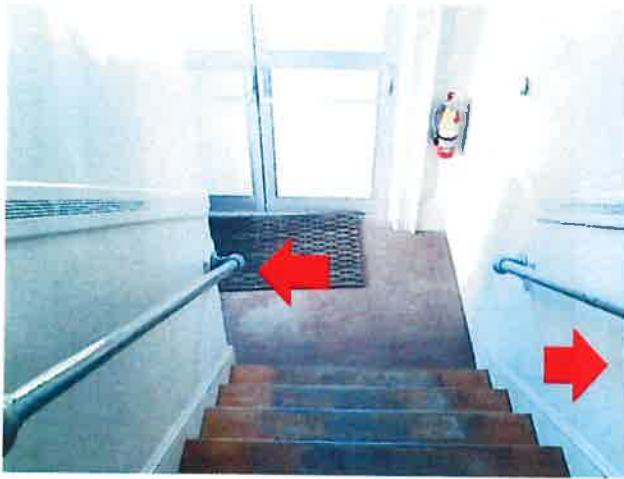
Second floor front stairs; not all railings are code compliant (to today's standards).

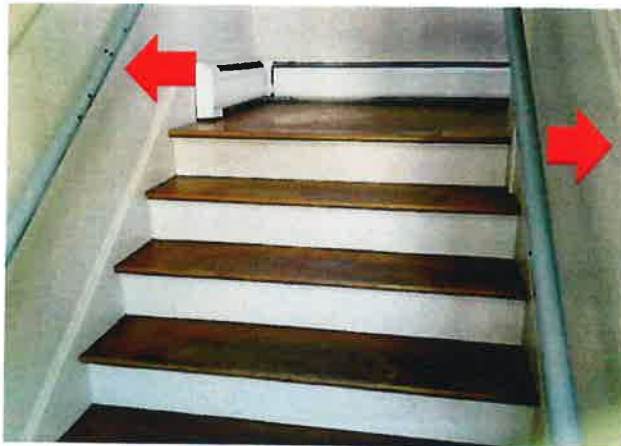
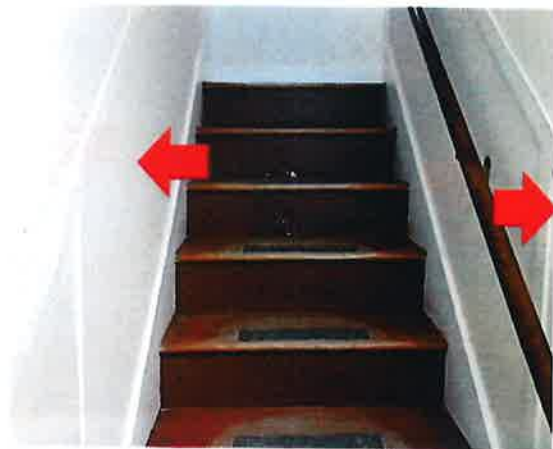
Second floor rear stairs - lower wall panels; suspected asbestos, and not all railings code compliant.

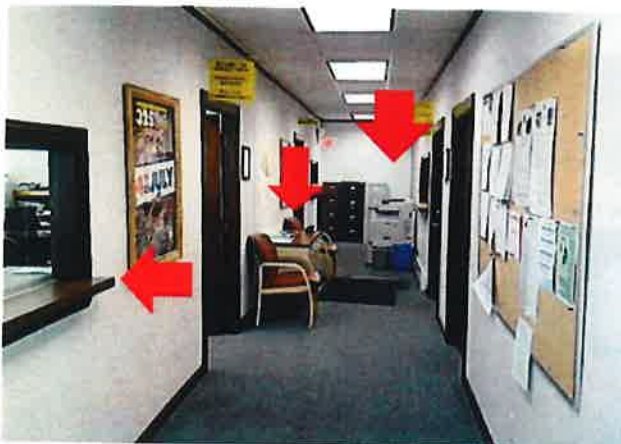
Second floor West view; service counter height, files/copier in hallway, and work table height.

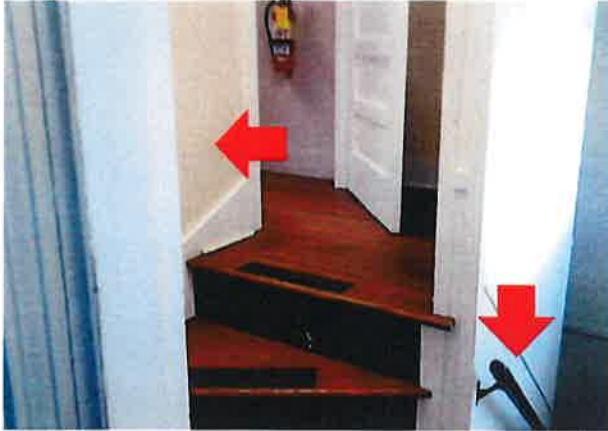
Stairs to Planning Office; lower wall panels, and railings.

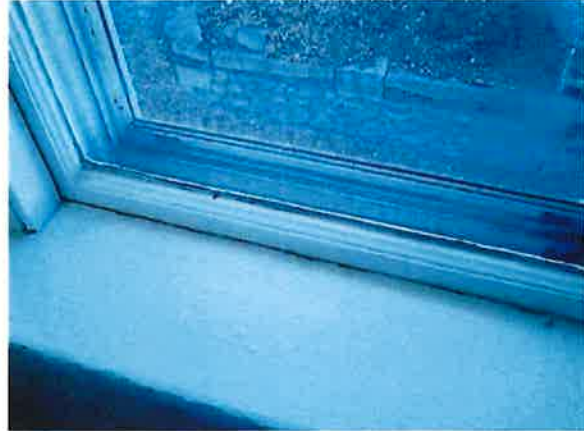
Exterior storm window; single glazed, and air infiltration.

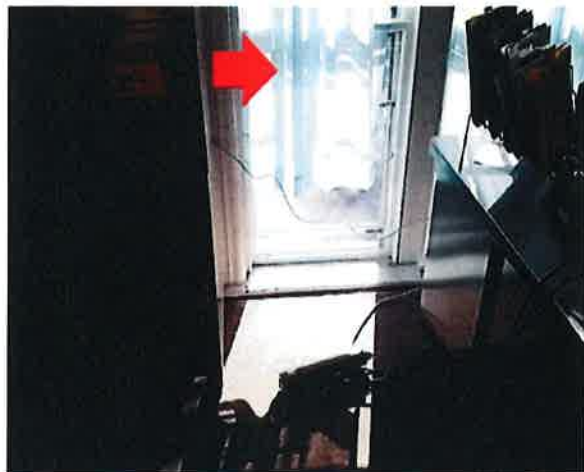
Planning Office window - no guard.

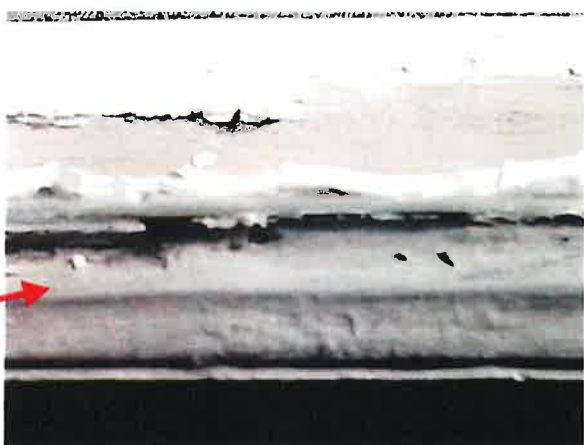
Deteriorating window frame and caulking.

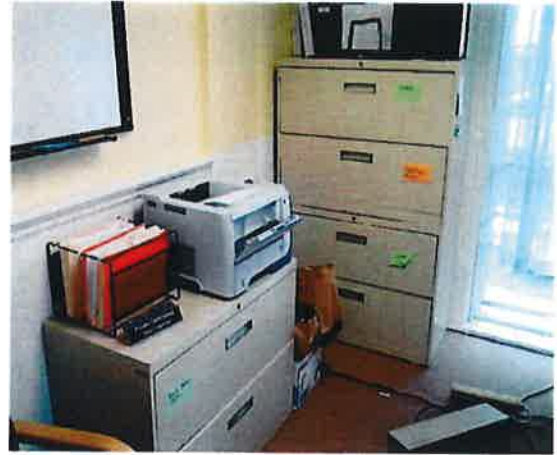
Inadequate file storage; files on tops of cabinets, and in boxes on floor.

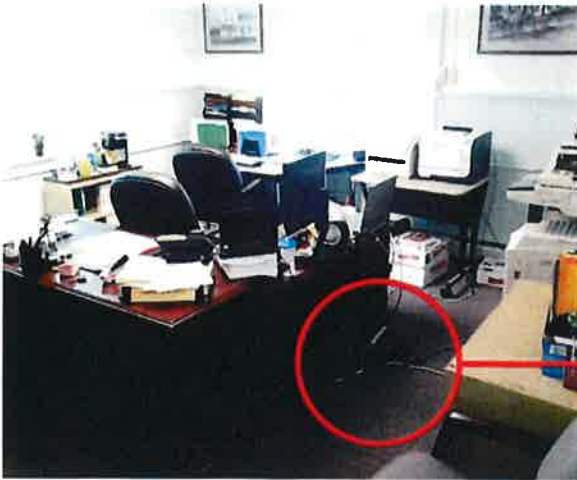
Manager's Secretary Office – not enough working space or file storage.

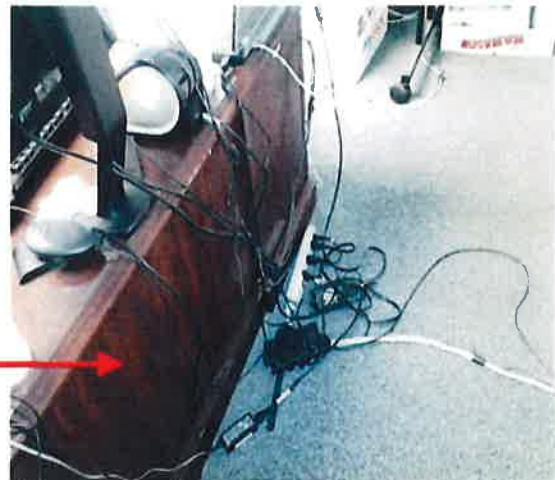
Not enough electrical outlets; using power strip and/or extension cord.

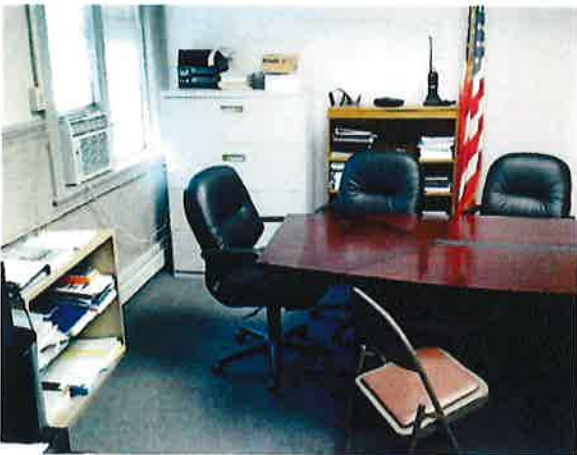
Conference Area – meeting area and file storage insufficient.

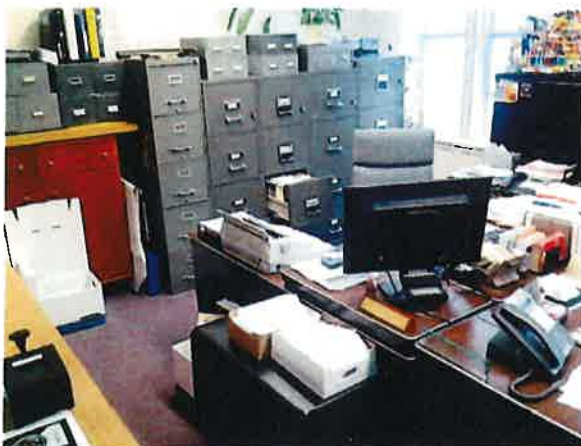
Working space, equipment space and file storage insufficient.

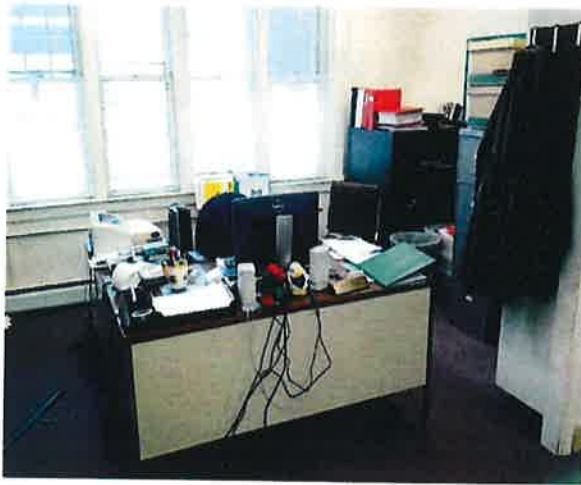
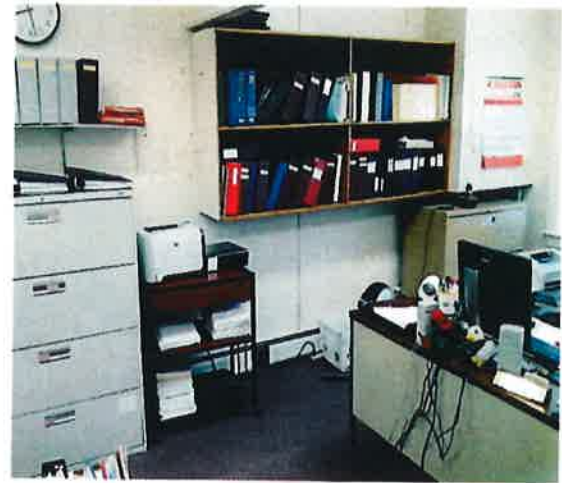
TOWN HALL – TREASURER’S OFFICE

Manager’s Secretary Office – not enough working space or file storage.

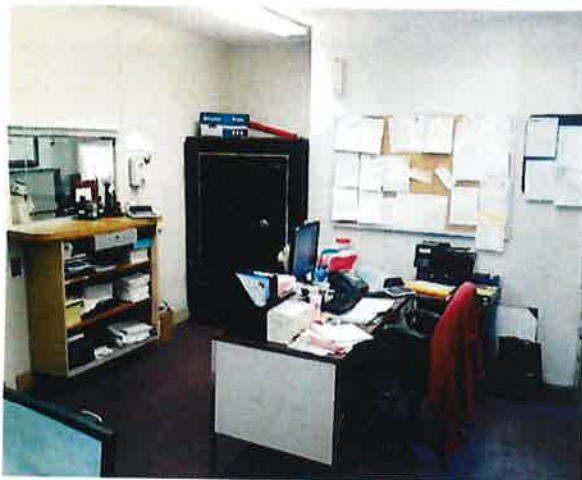
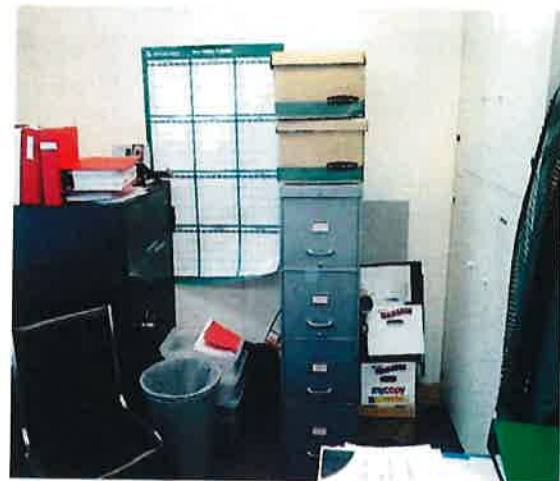
Conference Area – meeting area and file storage insufficient.

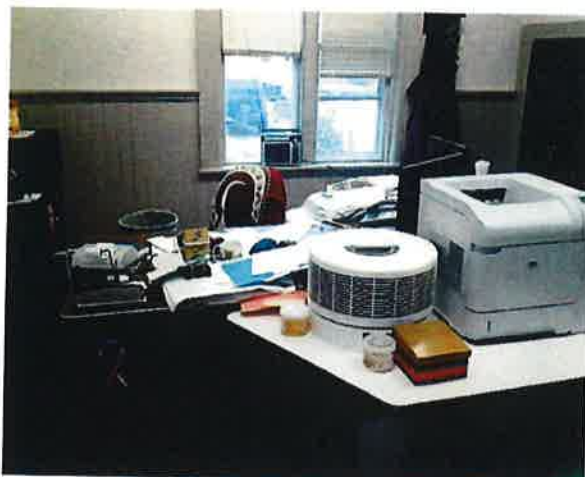
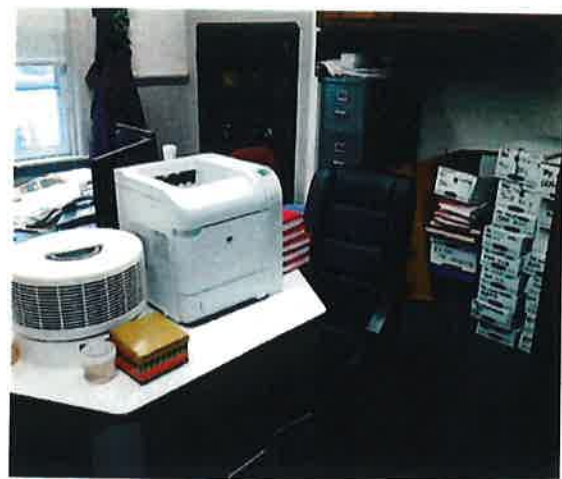
TOWN HALL – TAX COLLECTOR’S OFFICE

Working space, equipment space and file storage insufficient.

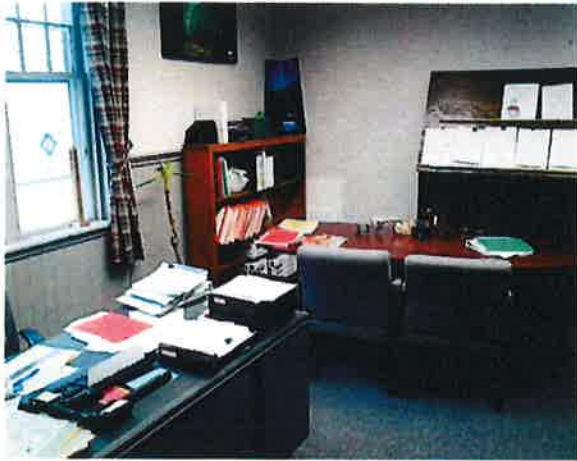
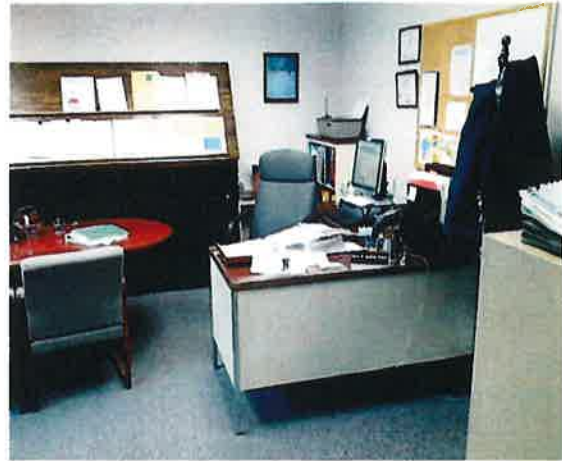
TOWN HALL – BUILDING DEPARTMENT

Not enough meeting and working space or file storage.

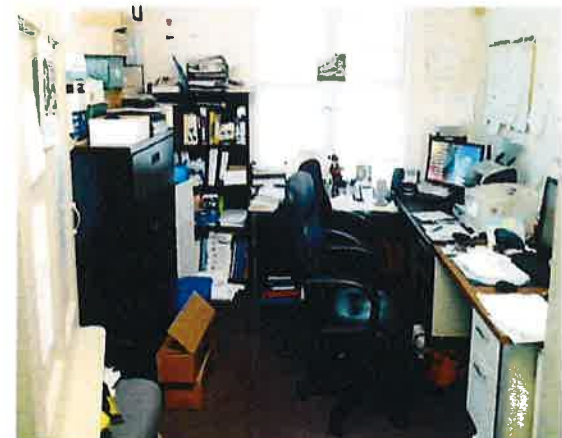
TOWN HALL – WATER DEPARTMENT

Working space and file storage insufficient.

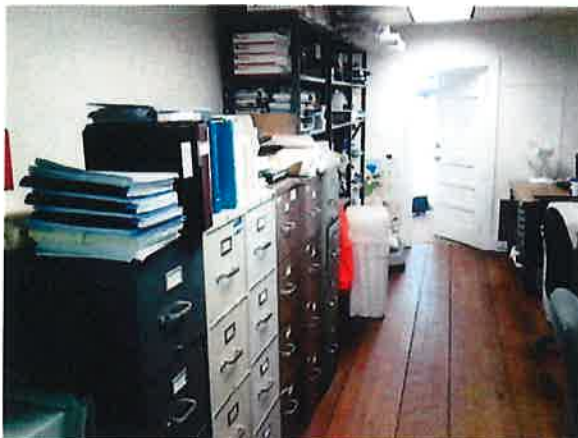
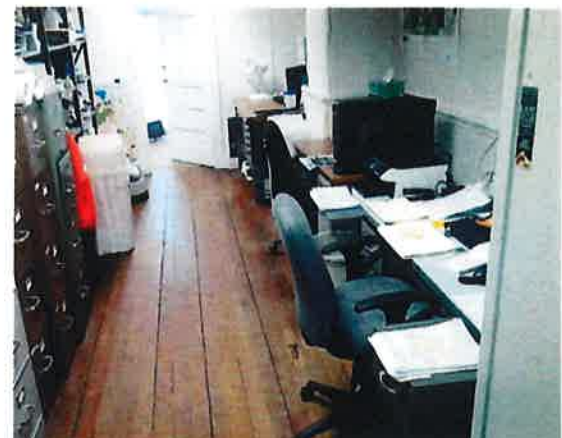
TOWN HALL – CONSERVATION OFFICE

Working space, equipment space and file storage insufficient.

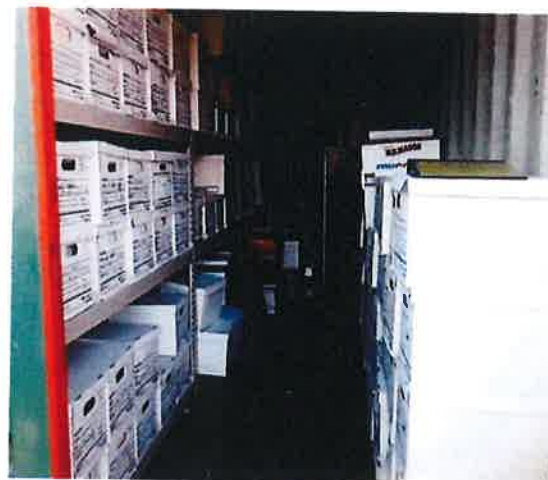
8 X 8 x 20 Container for file storage; moisture issues.

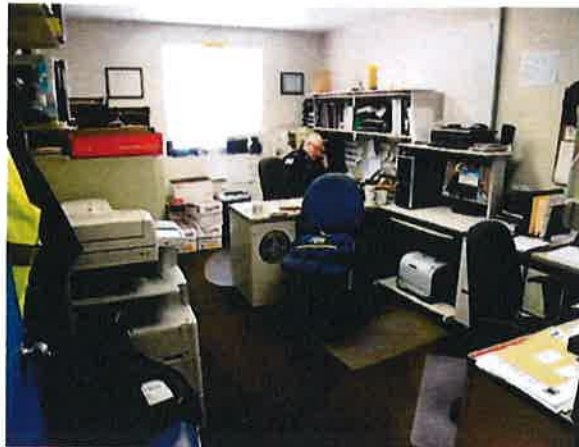
Officer in Charge room; limited working area and storage space.

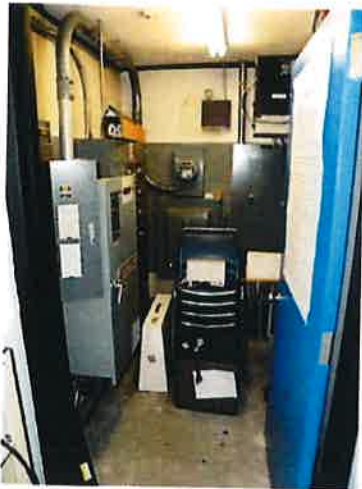
Electrical room.

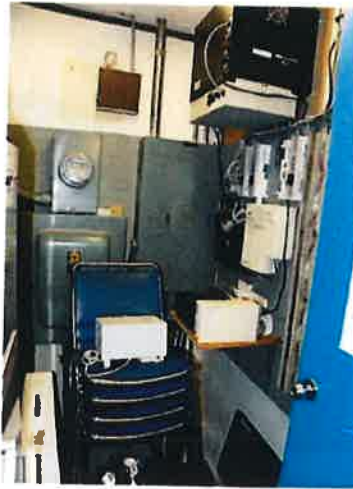
Utility room.

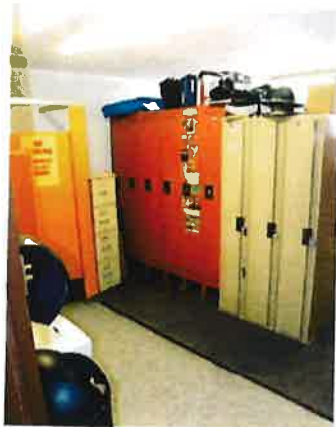
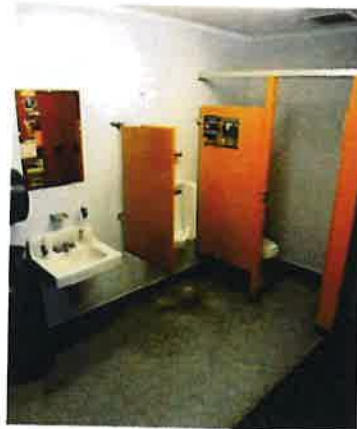
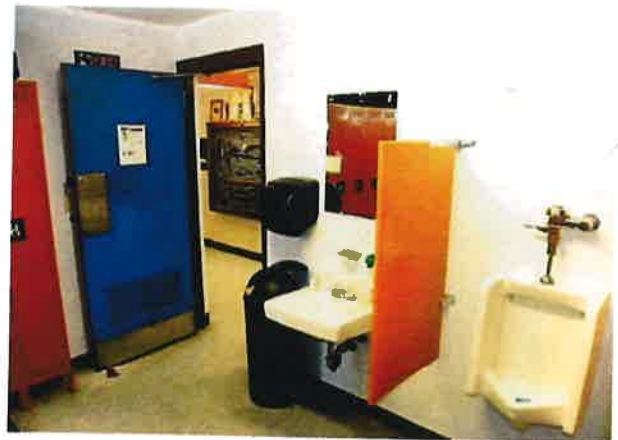
Employee restroom/lockers & file storage; stalls not ADA compliant, and limited space.

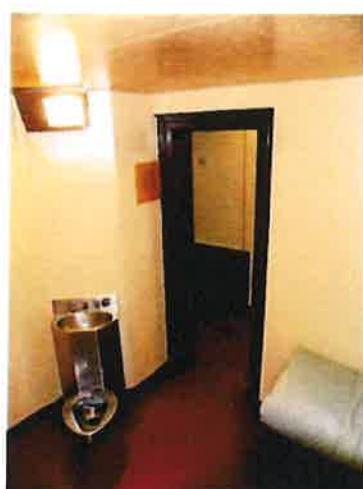
Interior of Cell #1

- d) **Cells:** Not enough holding space (or properly equipped) for: juvenile, suicide, or ADA situations. Comment was made that a cell door 'fell' off its' hinges.
- e) **Windows:** Loose and some broken.
- f) **Moving Prisoners:** No sally port for properly and securely moving prisoners.

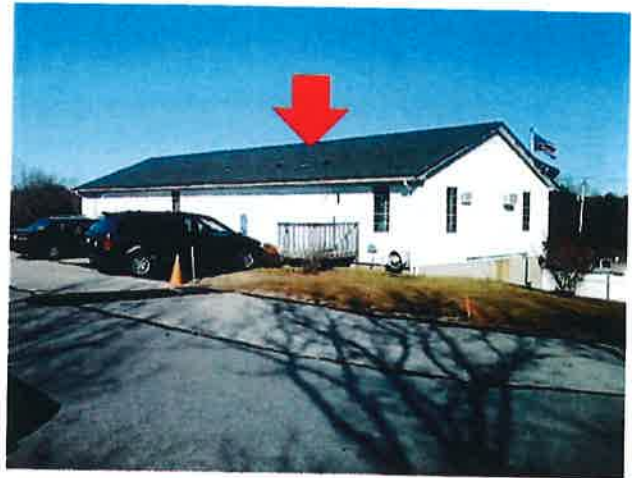
Southeast view; plumbing vents are too short.

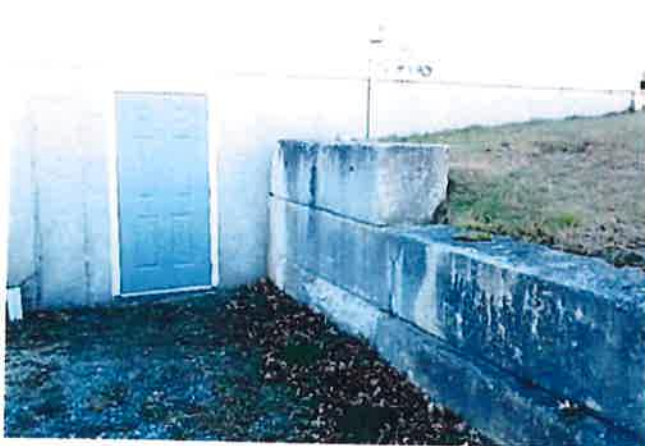
Lower level West emergency egress door.

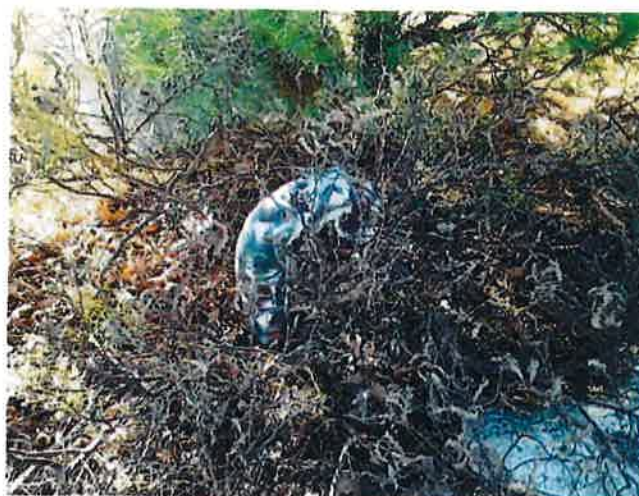
Leach field vent pipe.

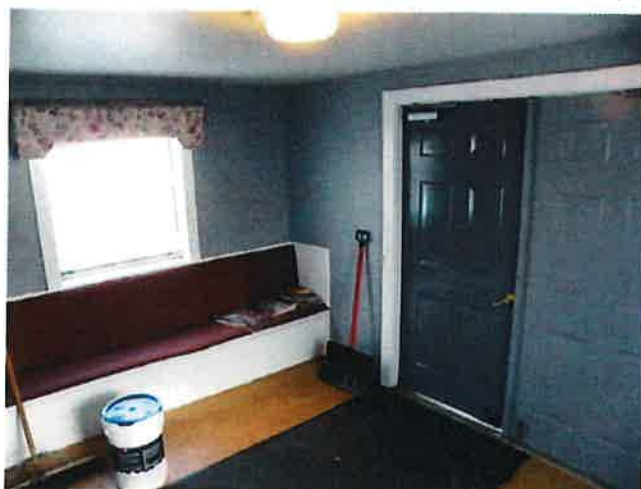
Lower level – Vestibule; Exterior door.

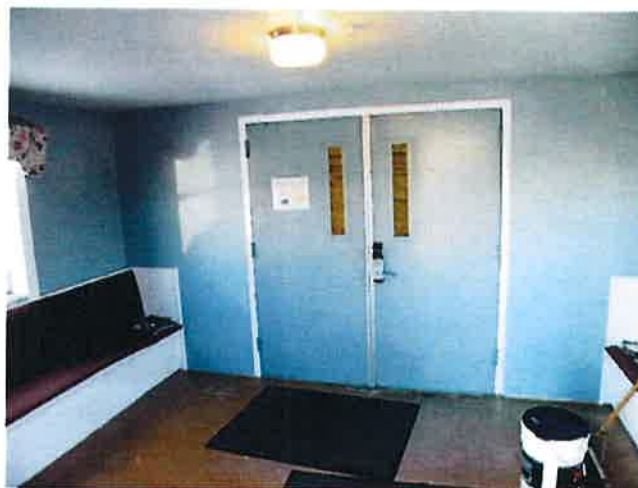
Lower level – Vestibule; Interior door.

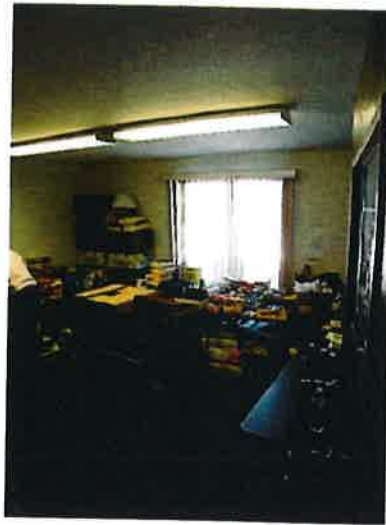
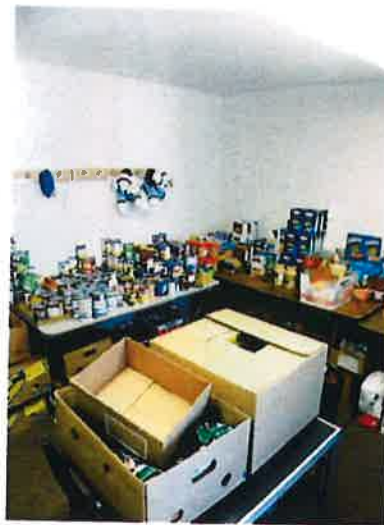
Newly added scope of services now includes a food pantry, which serves the general public. Donated food items are received and currently stored inadequately. Structure was not designed to carry unusual live loads.

Meeting Room A – Storage (Food Pantry)

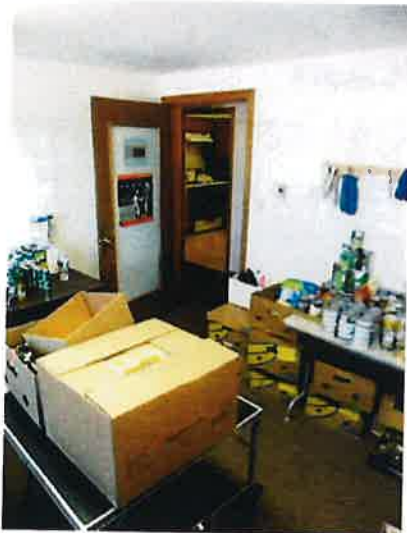
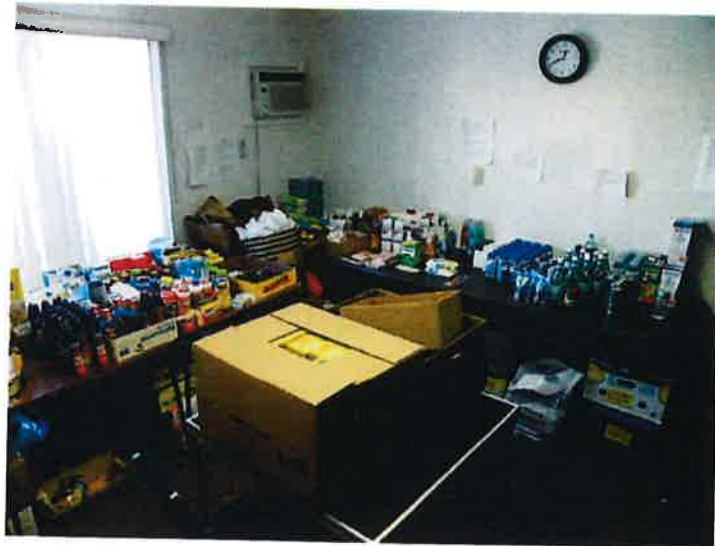
Meeting Room A – Storage (Food Pantry)

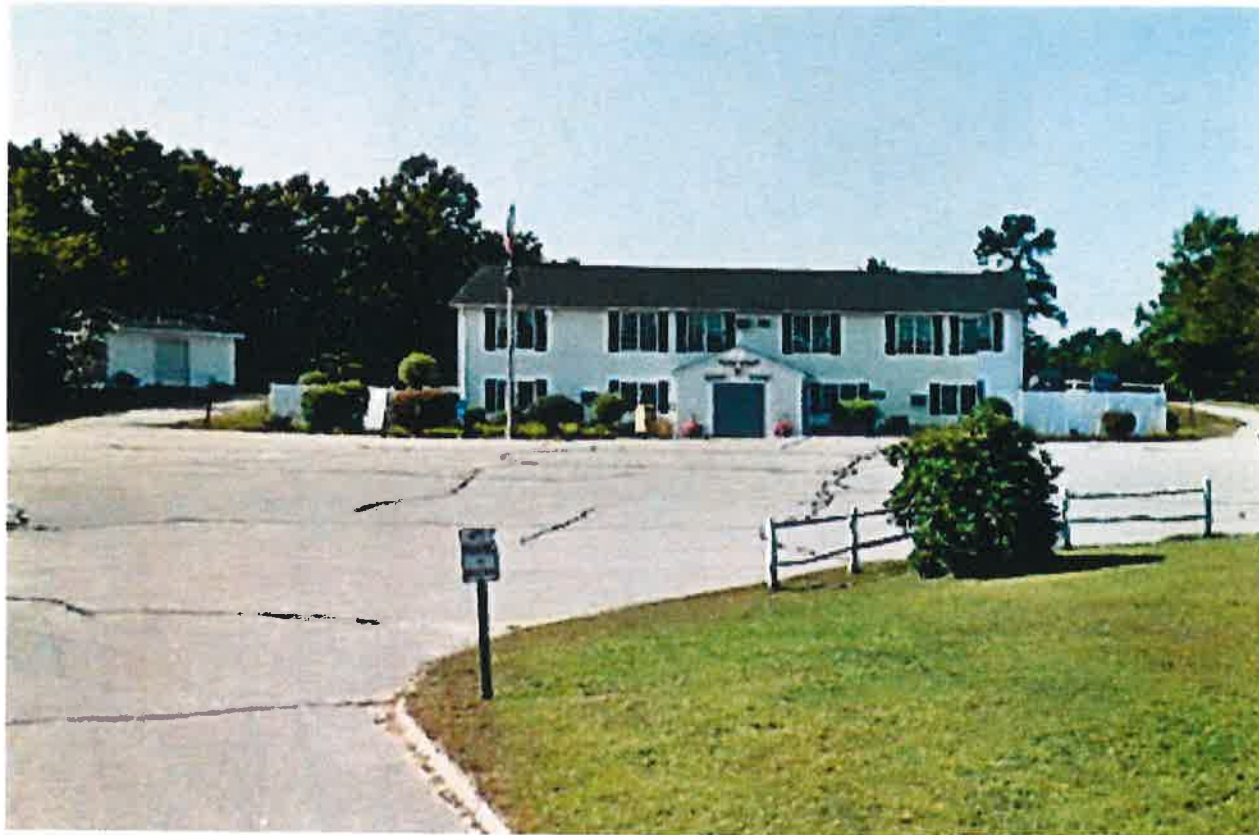
B. Photo of Existing Council On Aging.

The existing structure appears to be a residential two part modular home that was purchased and fit on top of a poured concrete foundation. The building itself is made of low end residential wood frame construction with Romex wiring and residential heating equipment. The structure does not meet the needs of the COA and although it is in decent physical shape, it would need additions and alterations. The building exterior and interior could be gutted to the bearing walls, and new systems installed. A new addition to accommodate the increase program spaces can be attached to the front of the structure and roof lines could incorporate the old structure with the new. An elevator would be required as the current configuration of driving up the hill to get to the second floor is not meeting current codes.

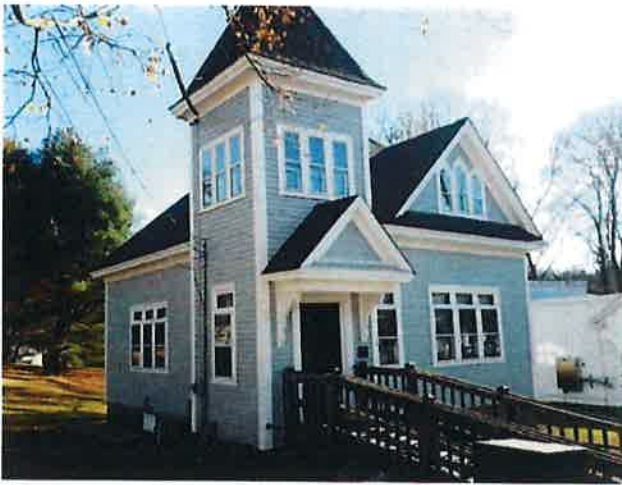
Northwest view

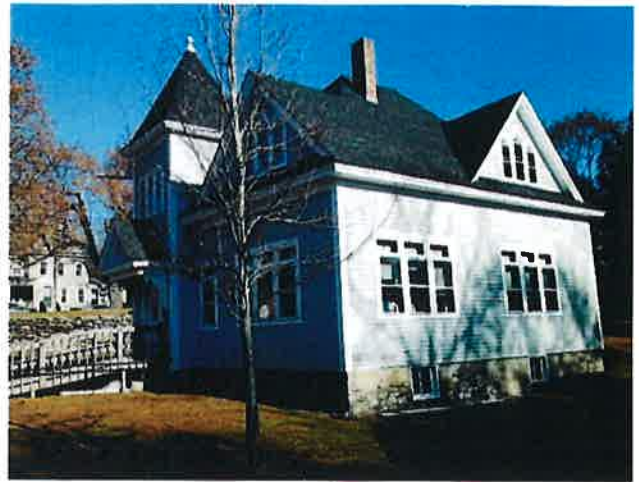
Southwest view

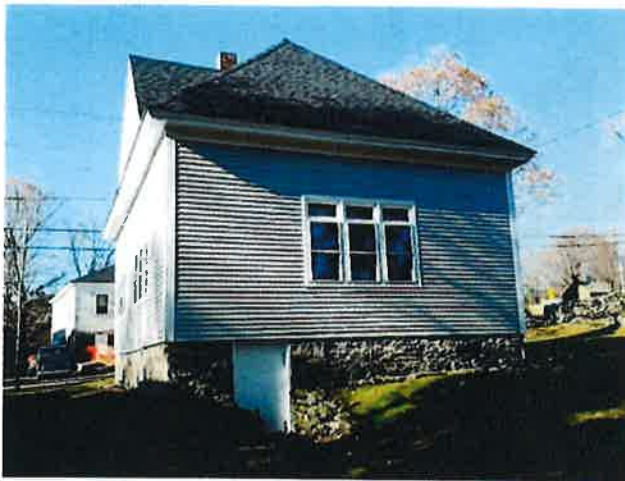
South view

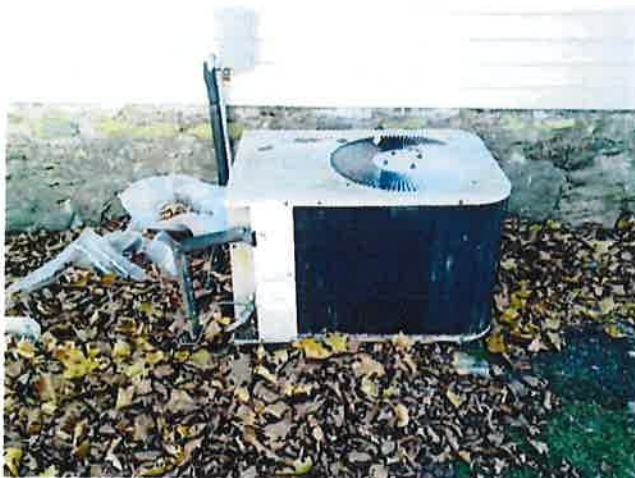
Exterior air conditioning unit.

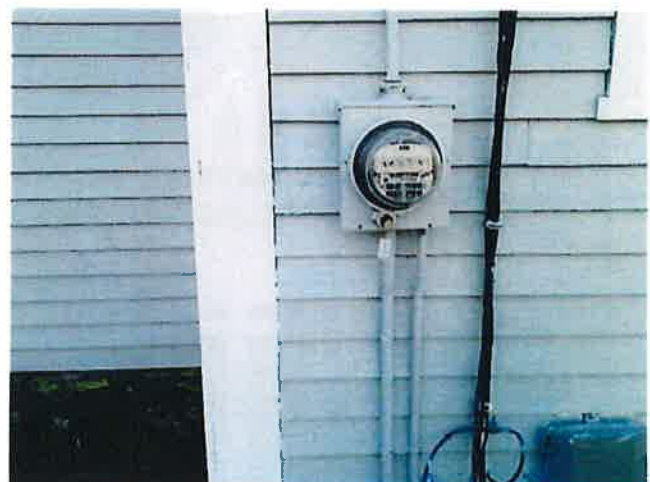
Electric service meter – North side.

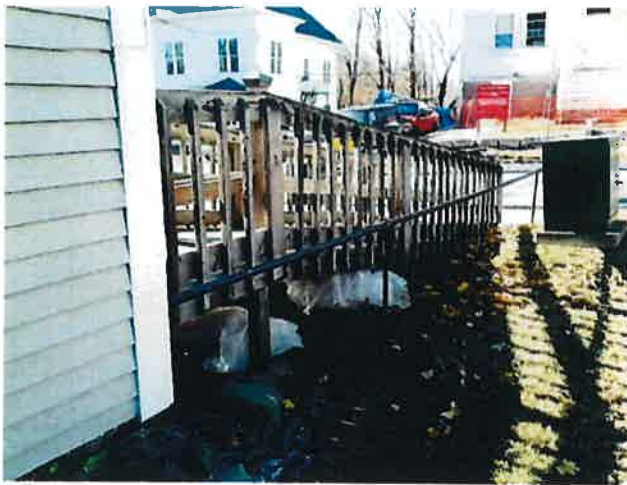
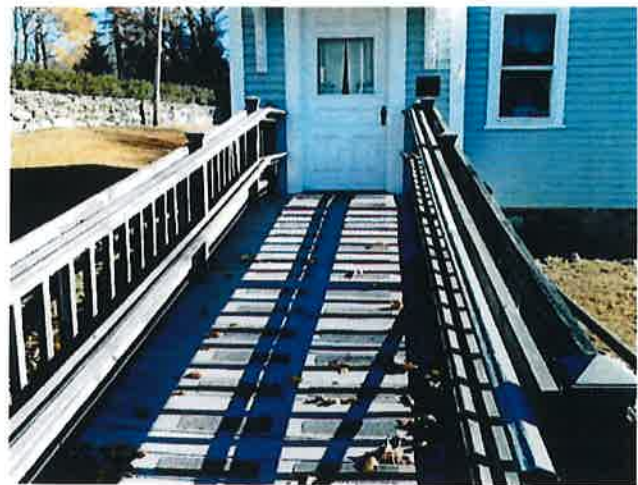
- j) **ADA:** Handicap ramp slope, bathrooms, and wheel chair clear space.
- k) **Fire Code:** Sprinkler system, pull stations, horns, and strobes. Only one means of egress.
- l) **Building Code:** Suspected asbestos containing materials; pipe insulation. No hot water. Structural deterioration; water/insect damaged wood and rusted steel support columns in basement. Basement and attic railings are not code compliant.
- m) **FEMA Flood Hazard Designation:** Basement elevation falls within the limits of the FEMA designation Base Flood Elevation.

North side - entrance ramp; slope is not ADA compliant. Entrance ramp to front door.

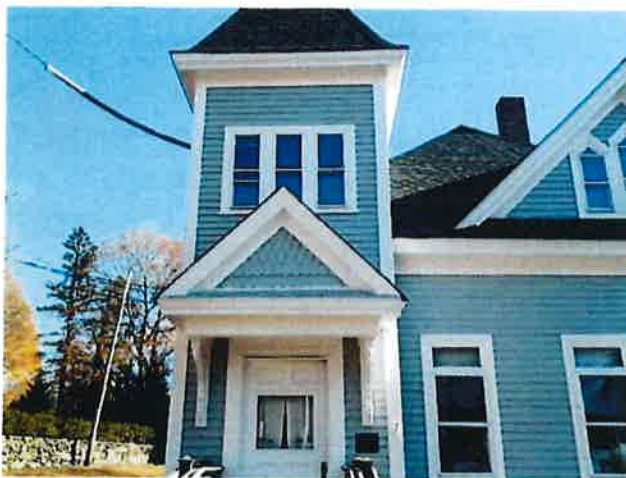
Main front entrance

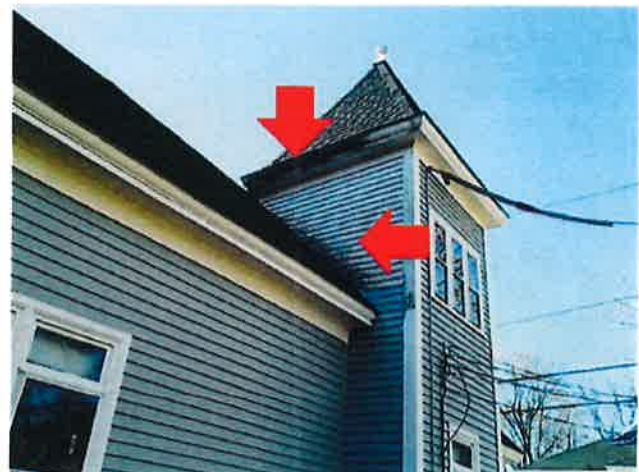
North side - Electrical service to building. Exterior painting not completed - some mold buildup.
