Town of Freetown Needs and Space Study

Municipal Offices, Police, Council on Aging, Library

Architectural Consulting Group, LLC, Inc.
09/24/2014

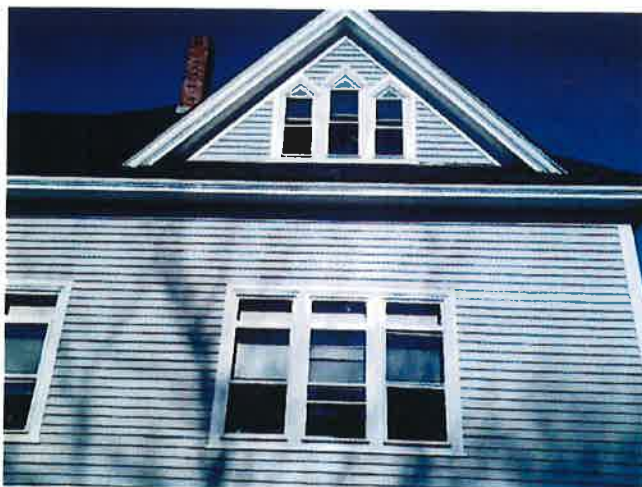
South side of building

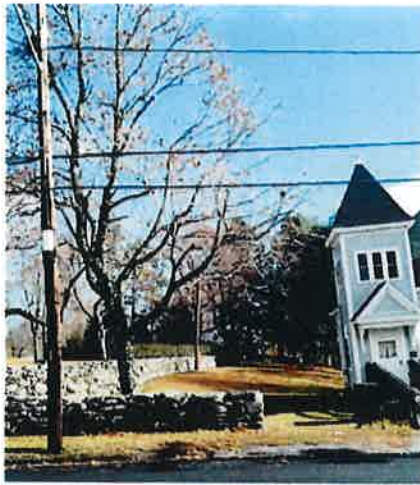
Electrical service from the pole.

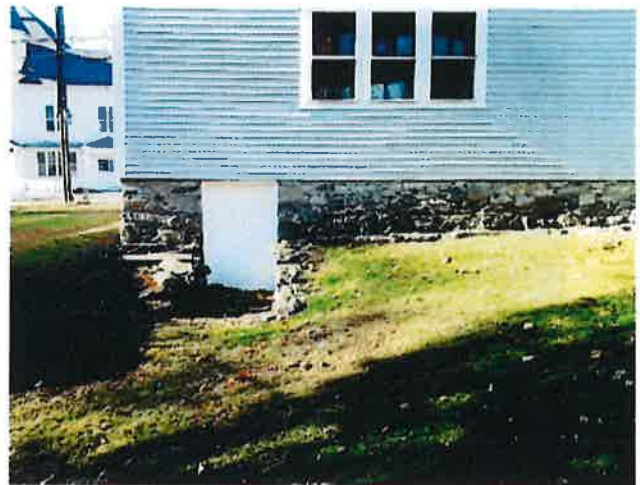
Rear of building

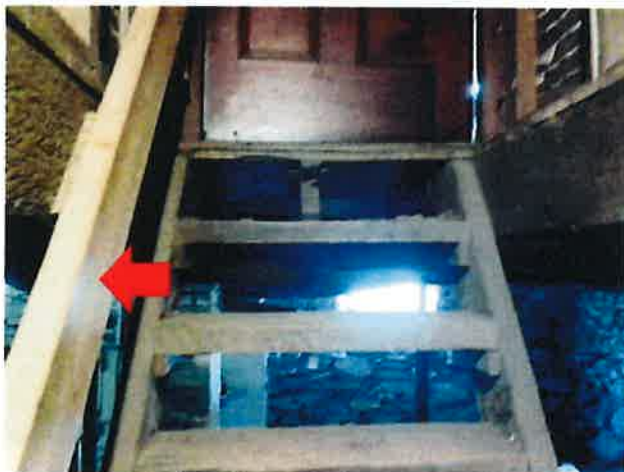
- y) **Space:** Inadequate working, foot traffic, meeting (private), seating and computer area(s), storage space (having to stack books on floor, and throw out some books to make room for newer ones).
- z) **Heating/Cooling Systems:** Heating/cooling not uniform throughout facility.
- aa) **Windows:** Single pane and drafty.
- bb) **Parking:** Inadequate number of spaces (and van access).
- cc) **Water:** No restrooms and no hot water.
- dd) **Stairs, Railings, and Landings:** Basement stairs and landings are deteriorated. Basement and attic railings are not code compliant.

Basement stairs to first floor; railing not compliant.

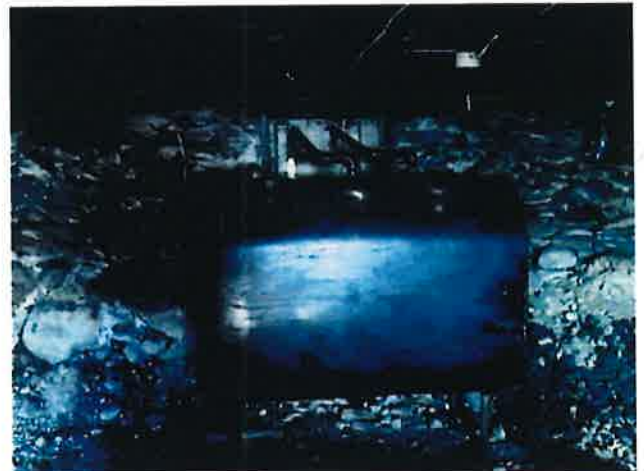
Fuel oil storage tank.

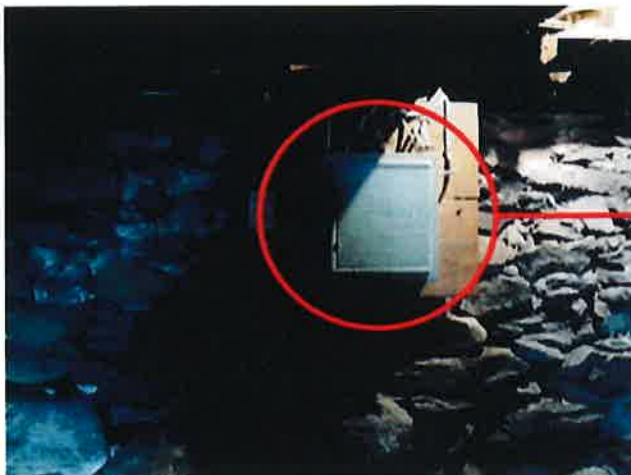
Electric panel – 60 amp.

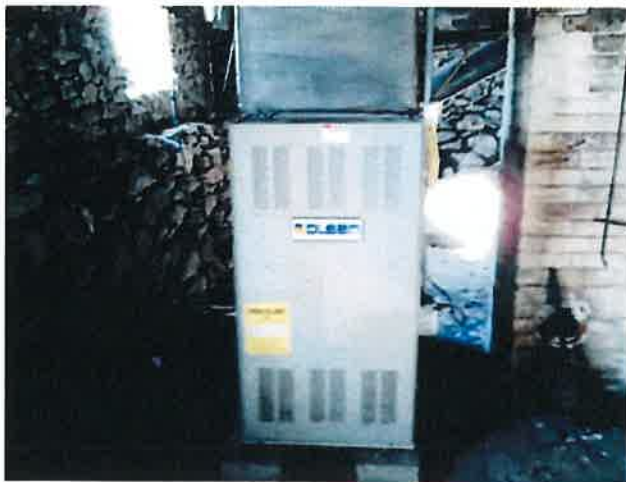
Hot air furnace

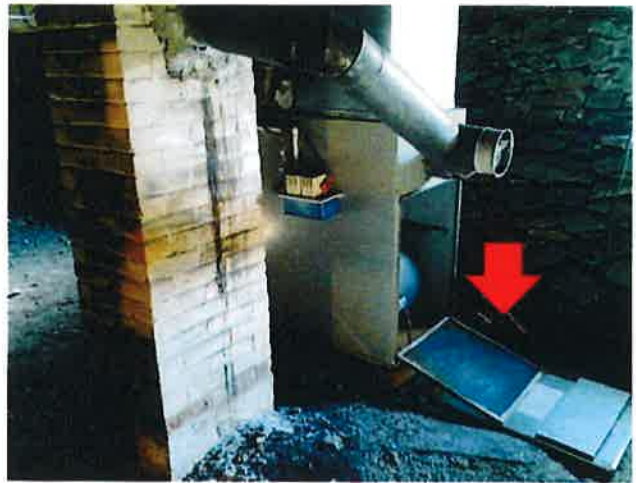
Rear of hot air furnace; filter not in place.

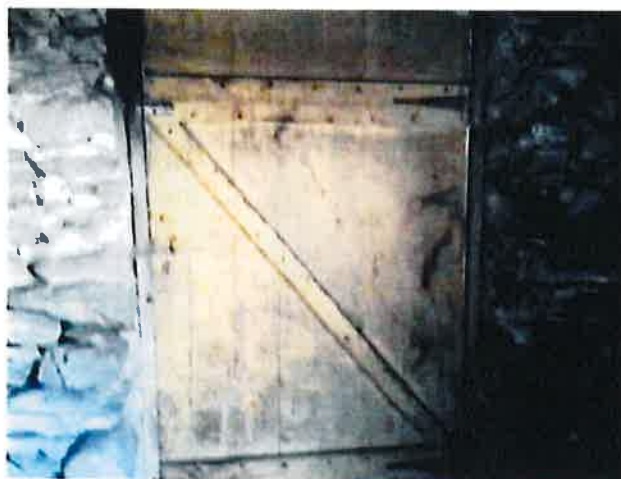
Basement rear door.

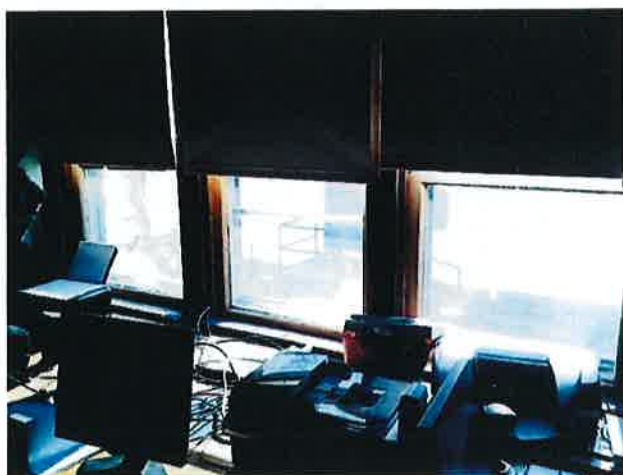
Interior windows; single glazed – South side.

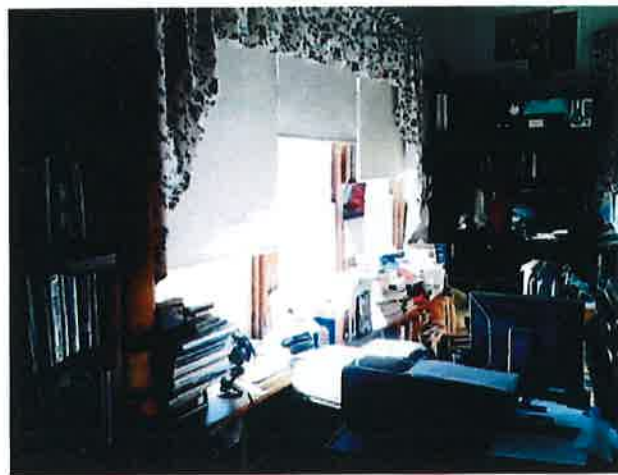
Interior windows; single glazed.

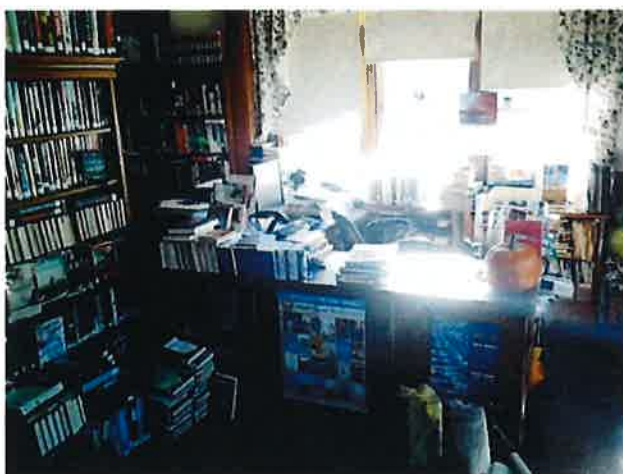
Librarian office area; limited space/books stacked.

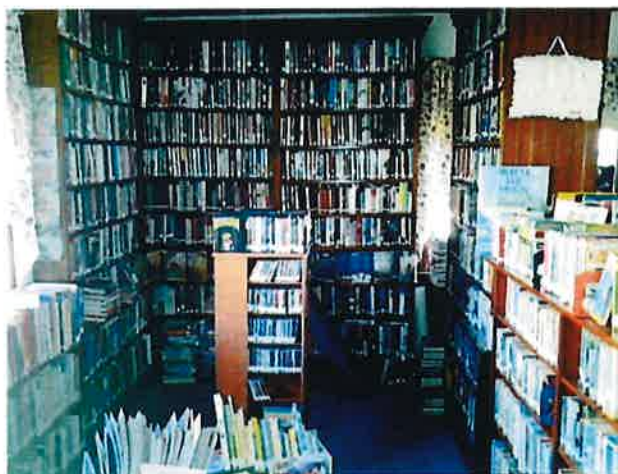
Book storage; at max capacity/books stacked.

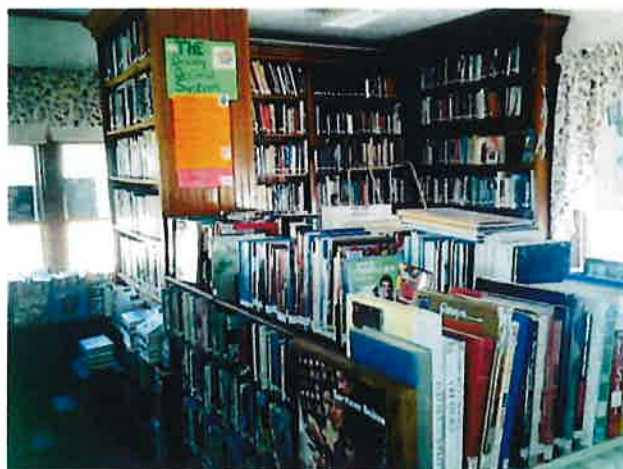
Book storage; at max capacity/books stacked.

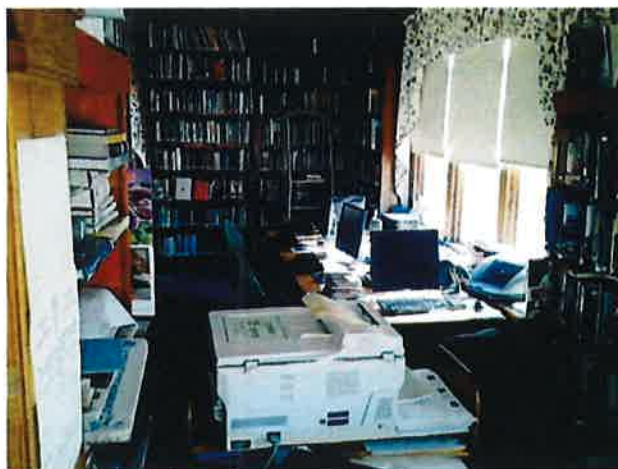
Computer area; limited space.

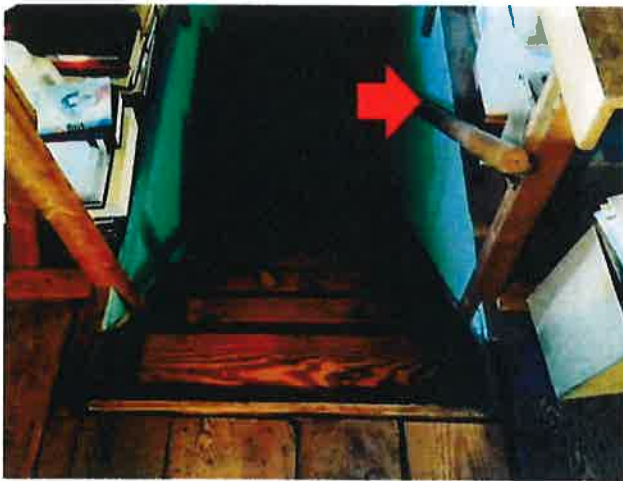
Attic stairs – looking down towards first floor. Railing not complaint.

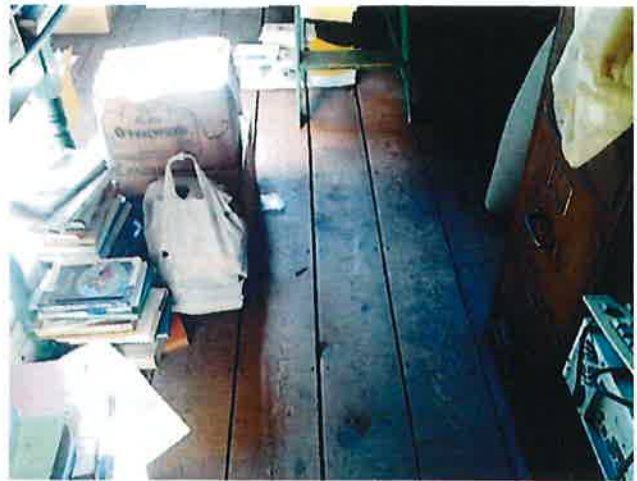
Attic – used as storage area.

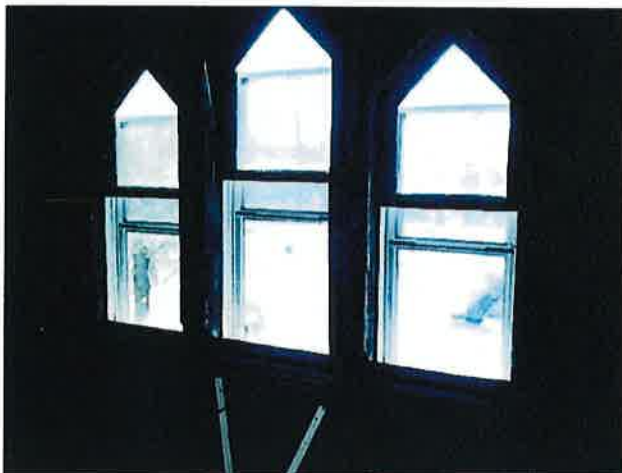
South side attic windows; single pane.

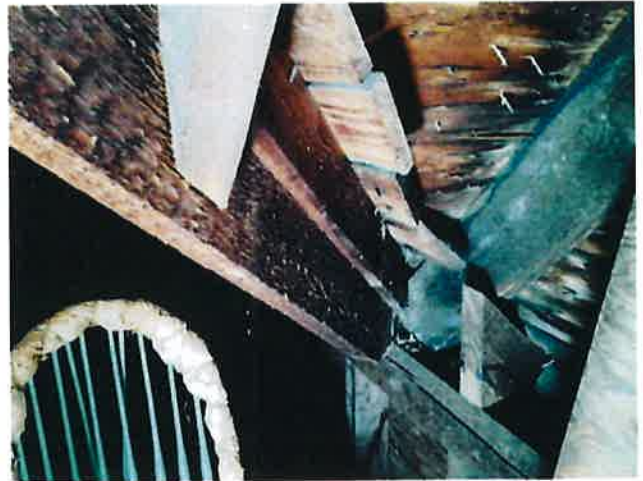
Roof framing

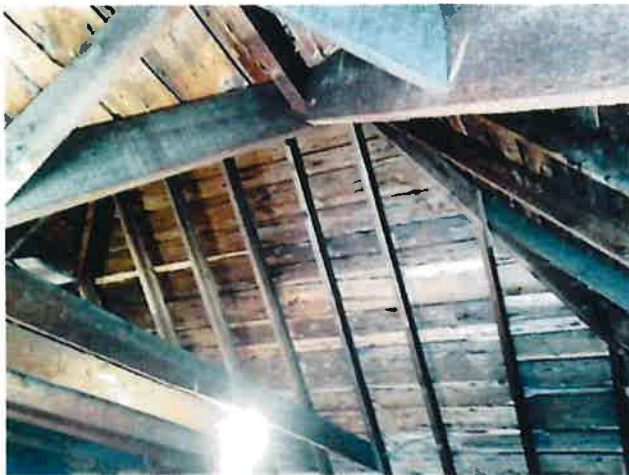
Roof framing

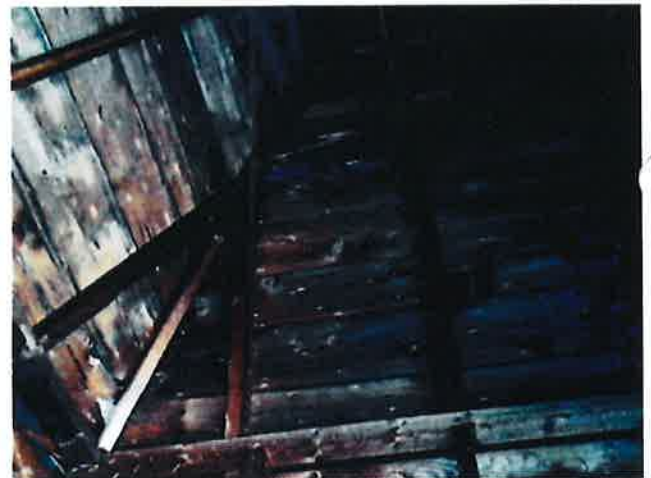
Roof boards overlaid with plywood.

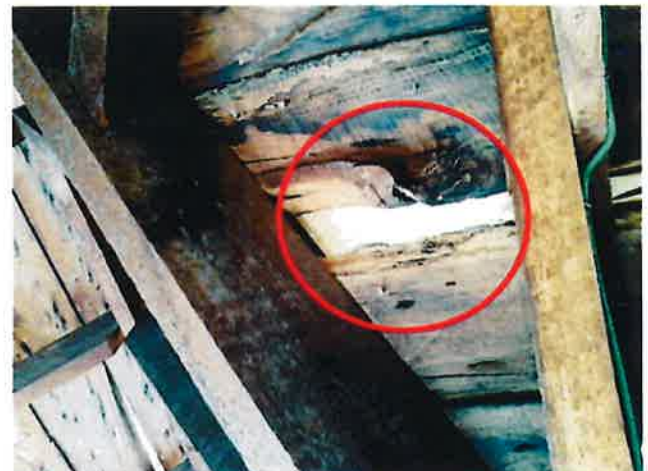
Roof overlay seen through roof boards.

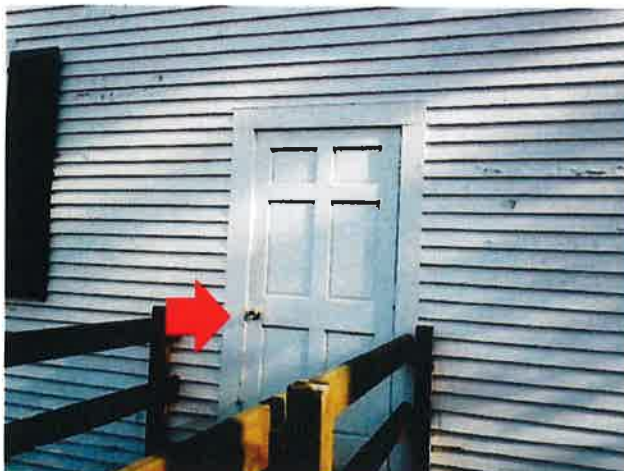
ADA ramp side door; no ADA hardware, and door swollen / hard to open.

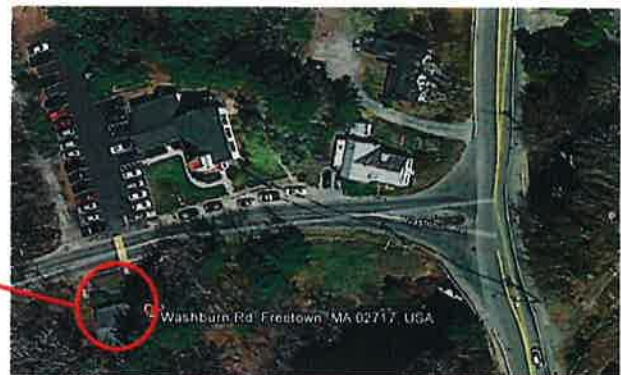
Floodplain map showing the building is located within the floodplain.

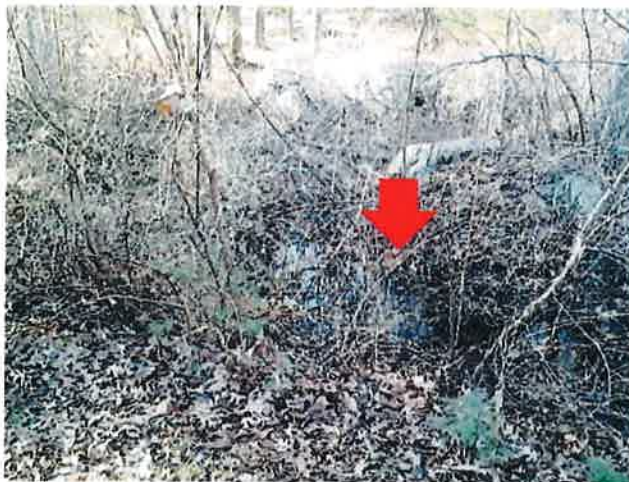
Wet area with standing water.

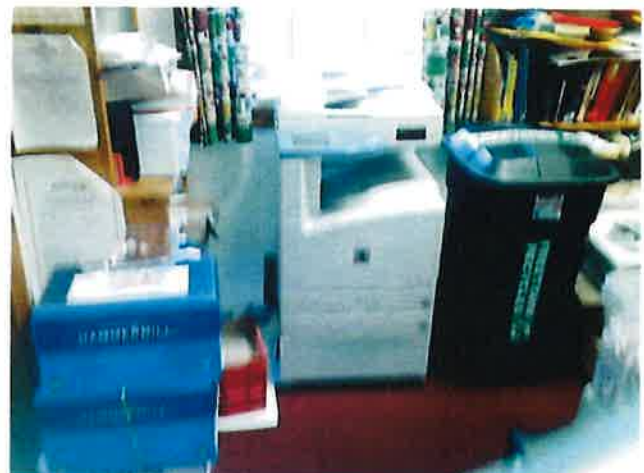
Office equipment area; limited space available.

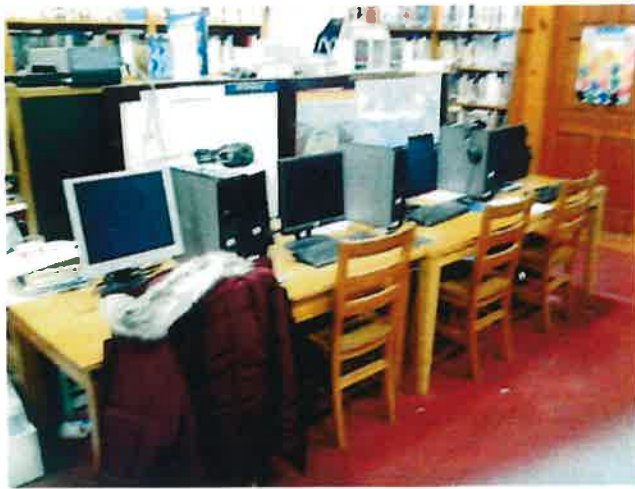
Computer area; limited space available.

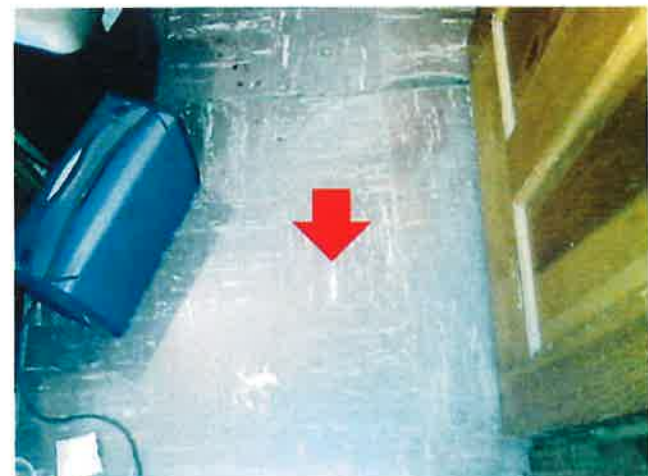
Corridor to bathroom / Mechanical Room; suspected asbestos containing VAT tile.

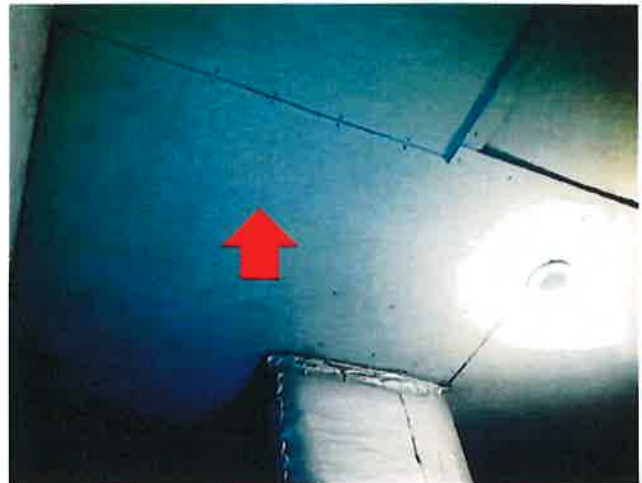
Ceiling; suspected asbestos containing panels.

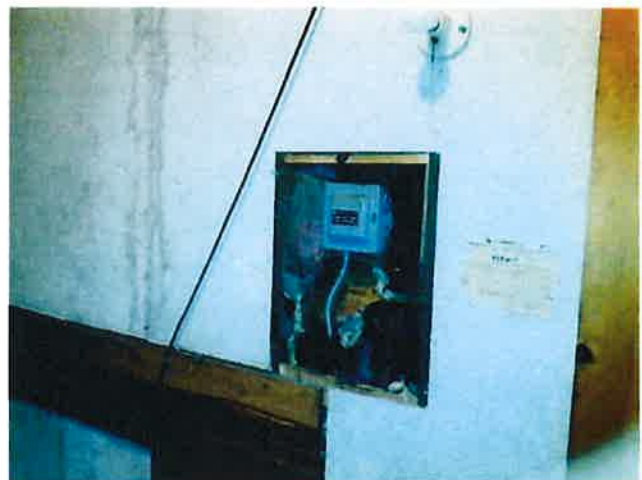
Electrical in Mechanical room; exposed wire.
